CHRISTMAS VALLEY AIRPORT

This report describes how your Pavement Maintenance Management Program (PMMP) was developed. Your Program was developed as part of the Oregon Continuous Aviation System Plan sponsored in part by the Oregon Department of Aviation and the Federal Aviation Administration (FAA). The information and data contained in this report ensures you comply with the requirements of FAA Grant Assurance Number 11 which states that any airport requesting federal funds for pavement improvement projects must have implemented a pavement maintenance management program.

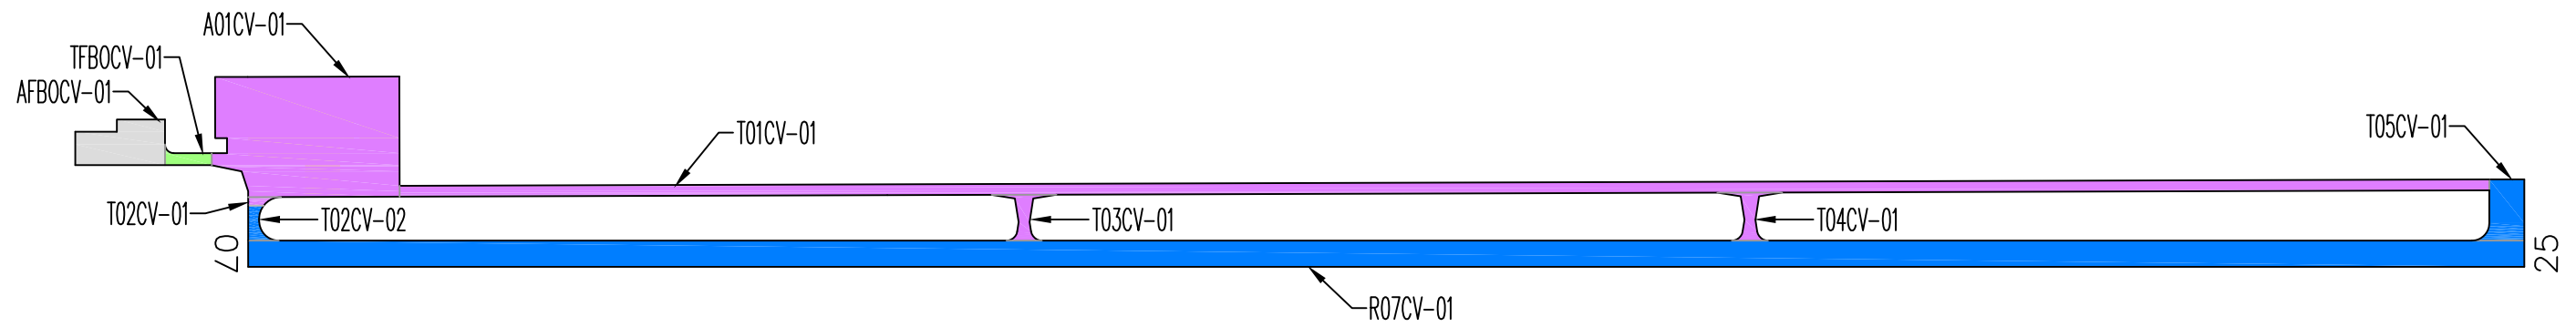
Figure CV-3. Pavement Condition in May 2019.
Christmas Valley Airport

Section PCIs at Christmas Valley Airport range from a low of 20 (a PCR of “Serious”) to a high of 98 (a PCR of “Good”). The area-weighted average PCI for all airport pavements is 74, corresponding to an overall PCR of “Satisfactory”. Figure CV-4 shows how much pavement area is associated with each Pavement Condition Rating category and also shows pavement condition distribution from the inspections conducted in 2013 and 2016.

The primary distresses observed during the inspection were: longitudinal and transverse cracking, block cracking, depression, and isolated occurrences of raveling and weathering.
