# COTTAGE GROVE STATE AIRPORT

This report describes how your Pavement Maintenance Management Program (PMMP) was developed. Your Program was developed as part of the Oregon Continuous Aviation System Plan sponsored in part by the Oregon Department of Aviation and the Federal Aviation Administration (FAA). The information and data contained in this report ensures you comply with the requirements of FAA Grant Assurance Number 11 which states that any airport requesting federal funds for pavement improvement projects must have implemented a pavement maintenance management program.

Using the branch, section and sample unit divisions established, a visual condition survey was conducted at Cottage Grove State Airport in May 2019. During the inspection, pavement defects were identified and measured in accordance with the methodology outlined in ASTM D5430. This inspection ensures your airport complies with the “detailed inspection” requirement of FAA’s PMMP guidelines. After collection, the data were entered into the PAVER software for analysis. These data are reproduced in the Re-Inspection Report attached as Appendix 4.

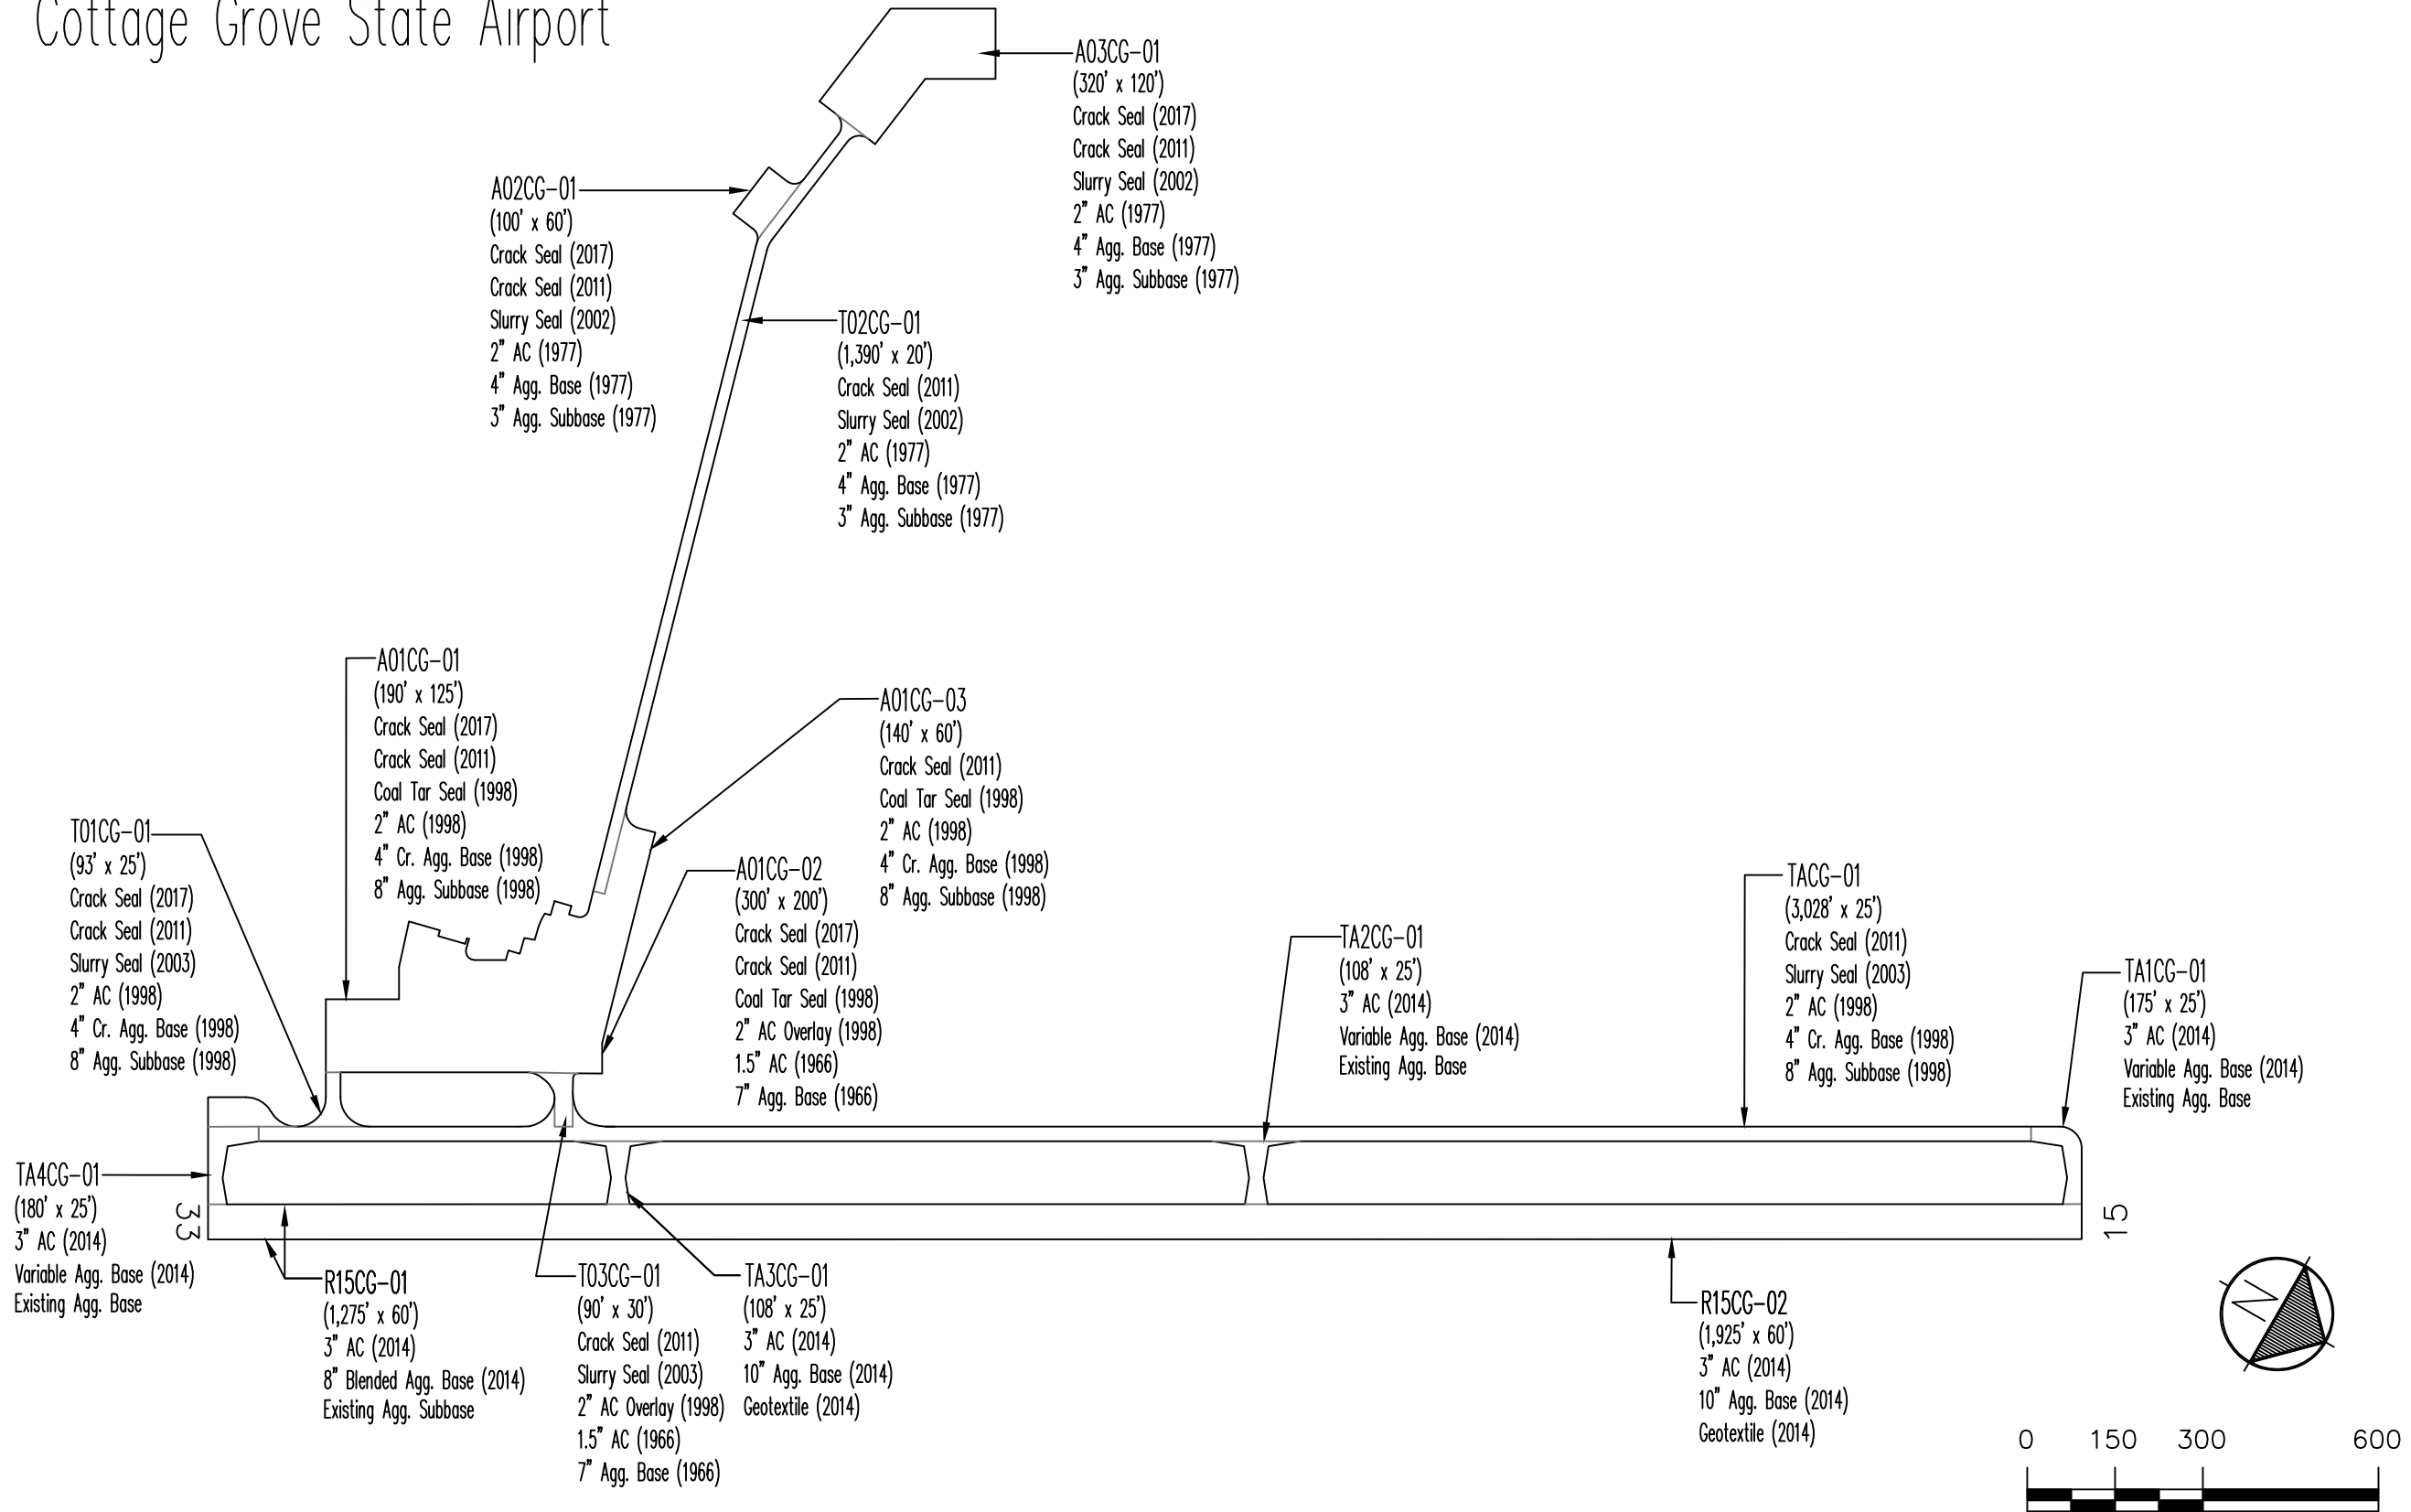
Figure CG-1. Airport Layout, Dimensions and Pavement Cross-Sections.

To determine how your pavements were constructed and their age, a records review was conducted. Figure CG-1 shows the records review results. This figure identifies pavement boundaries, dimensions, pavement layer types, thicknesses and dates of construction. The most recent construction date for each pavement can also be found in the Section Condition Report in Appendix 2. Figure CG-1 and the information contained in Appendices 1, 2 and 4 ensure that your airport complies with the “pavement inventory” requirement of FAA’s PMMP guidelines.

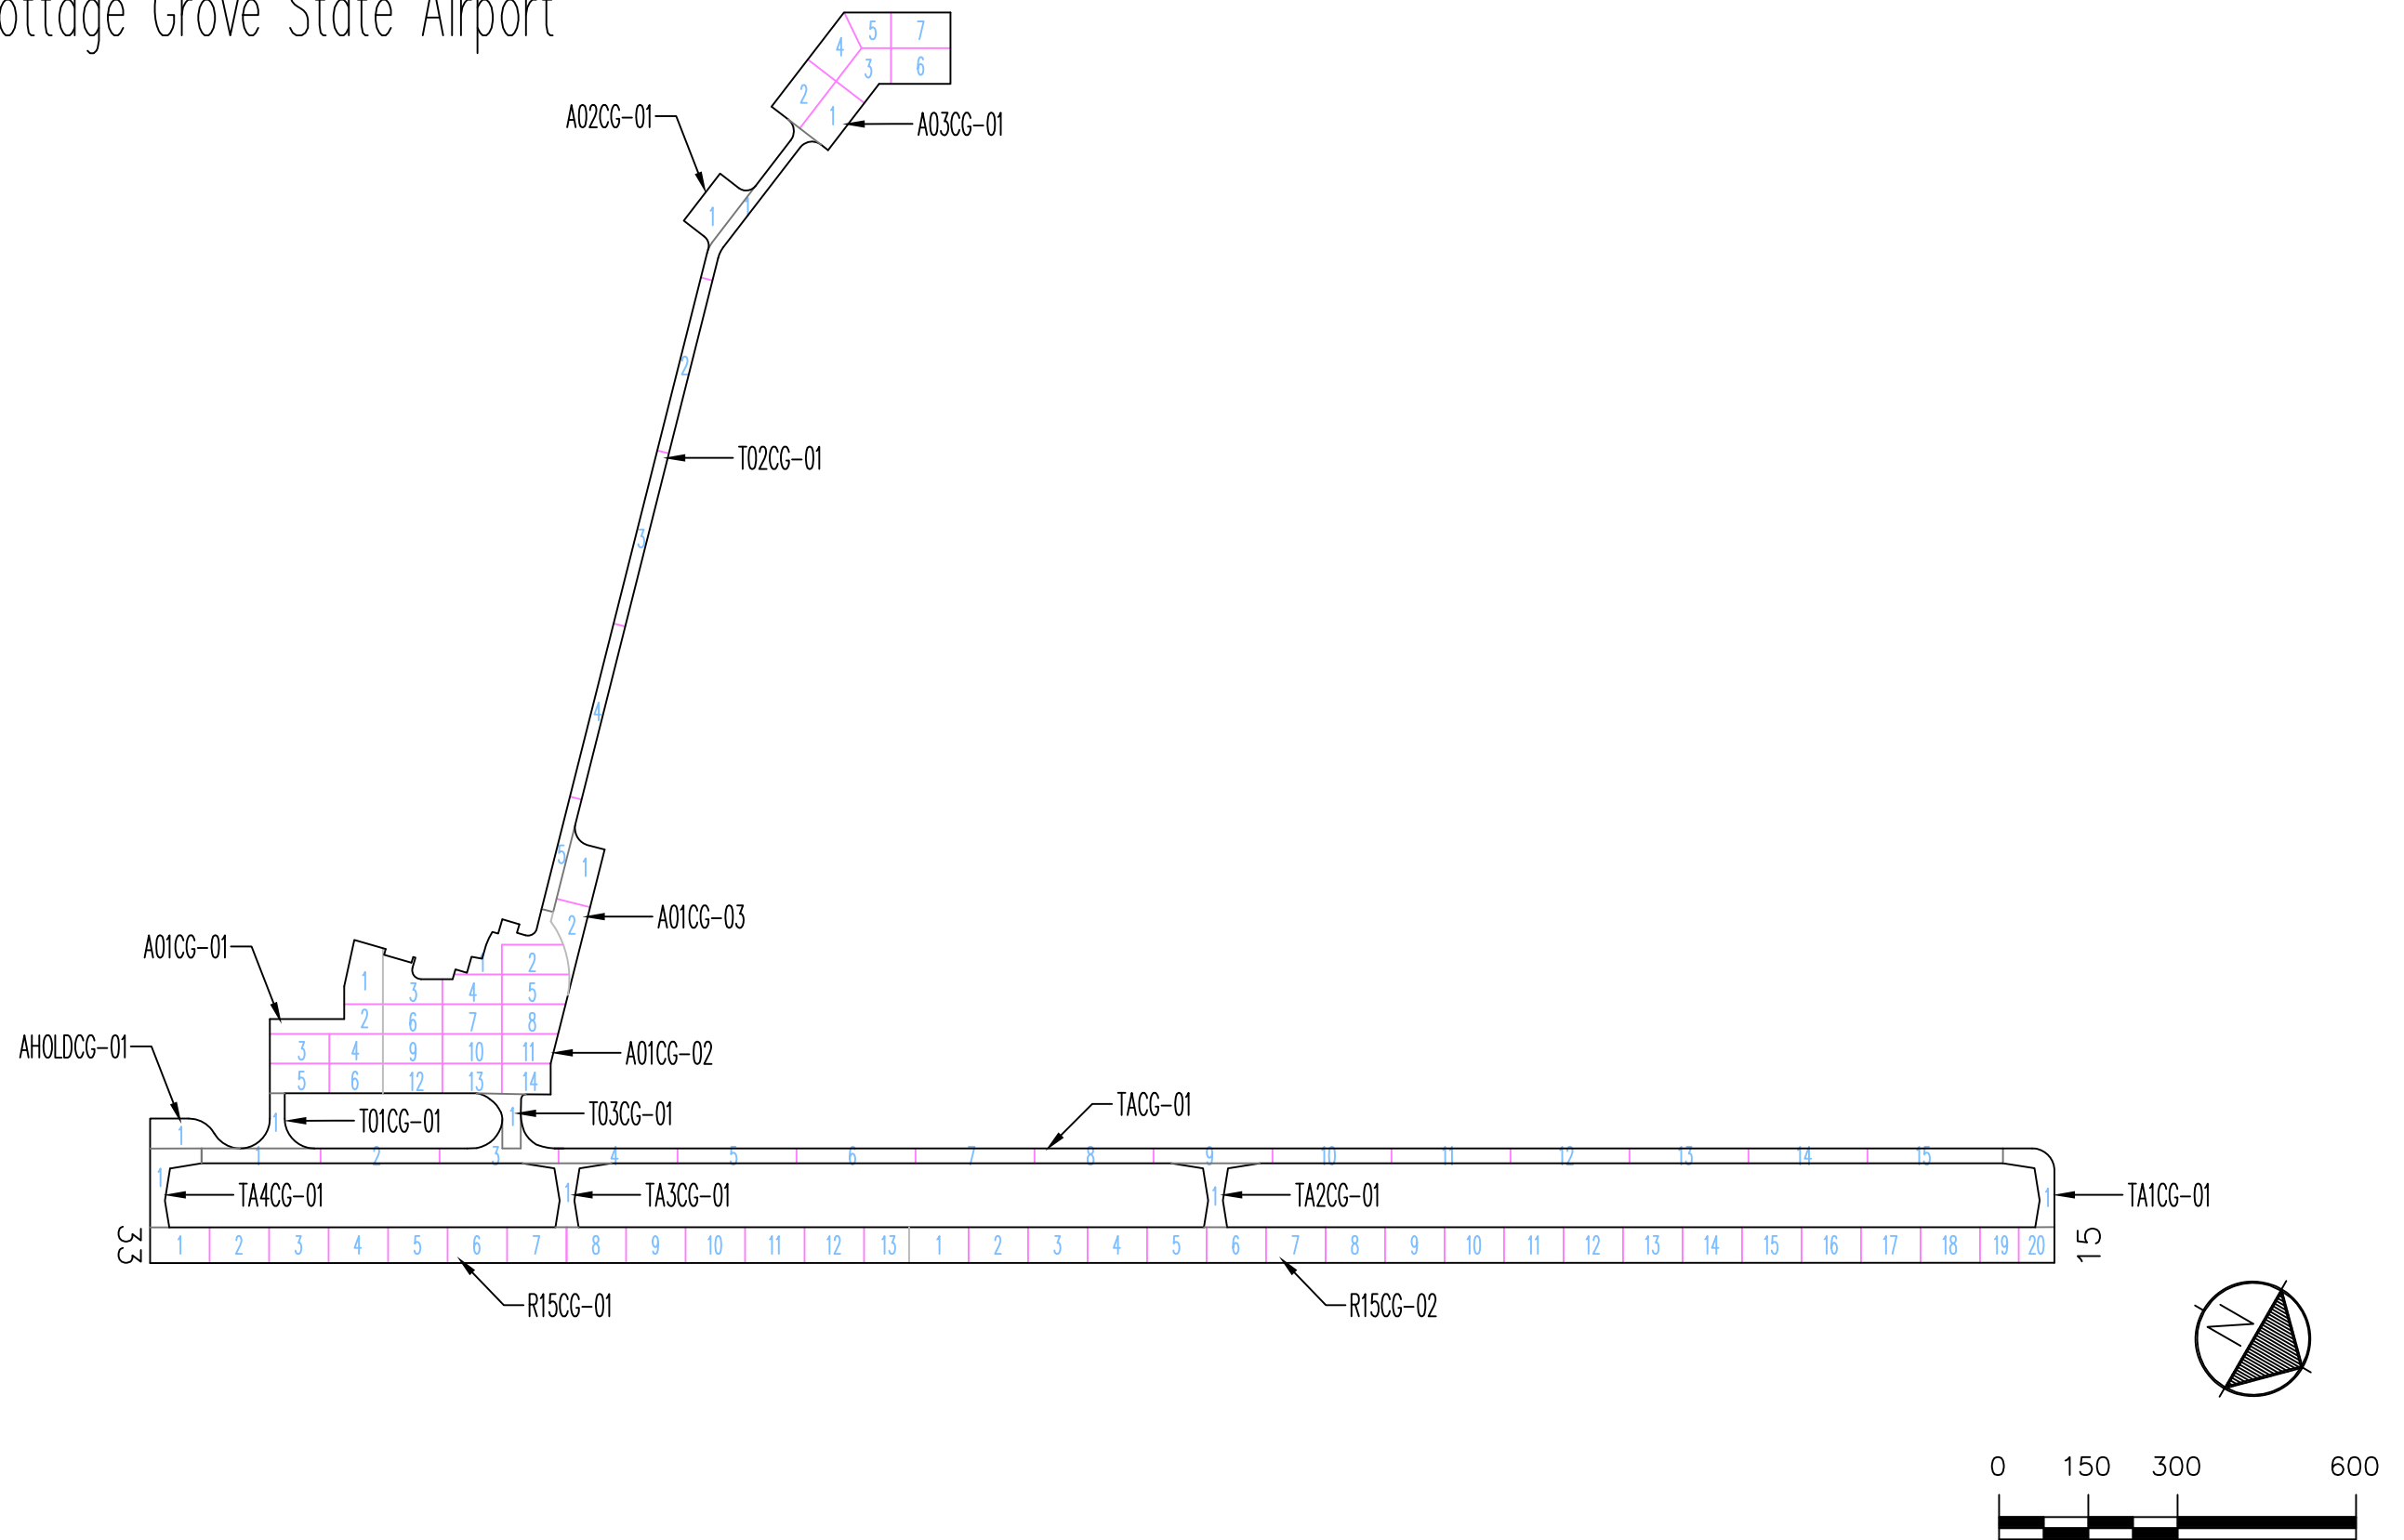
Figure CG-2. Pavement Branch, Section and Sample Unit Layout.  
Cottage Grove State Airport

The pavements at your airport were divided into branches, sections and sample units in accordance with the methodology outlined in the current edition of ASTM D5430, *Standard Test Method for Airport Condition Index Surveys*. The branches, sections and sample units established at your airport are shown in Figure CG-2. A Branch Condition Report showing all branches, their associated areas, and their area-weighted average condition is provided in Appendix 1. Additionally, the Appendix 2 Section Condition Report provides information used to define each branch and section in the PAVER database.

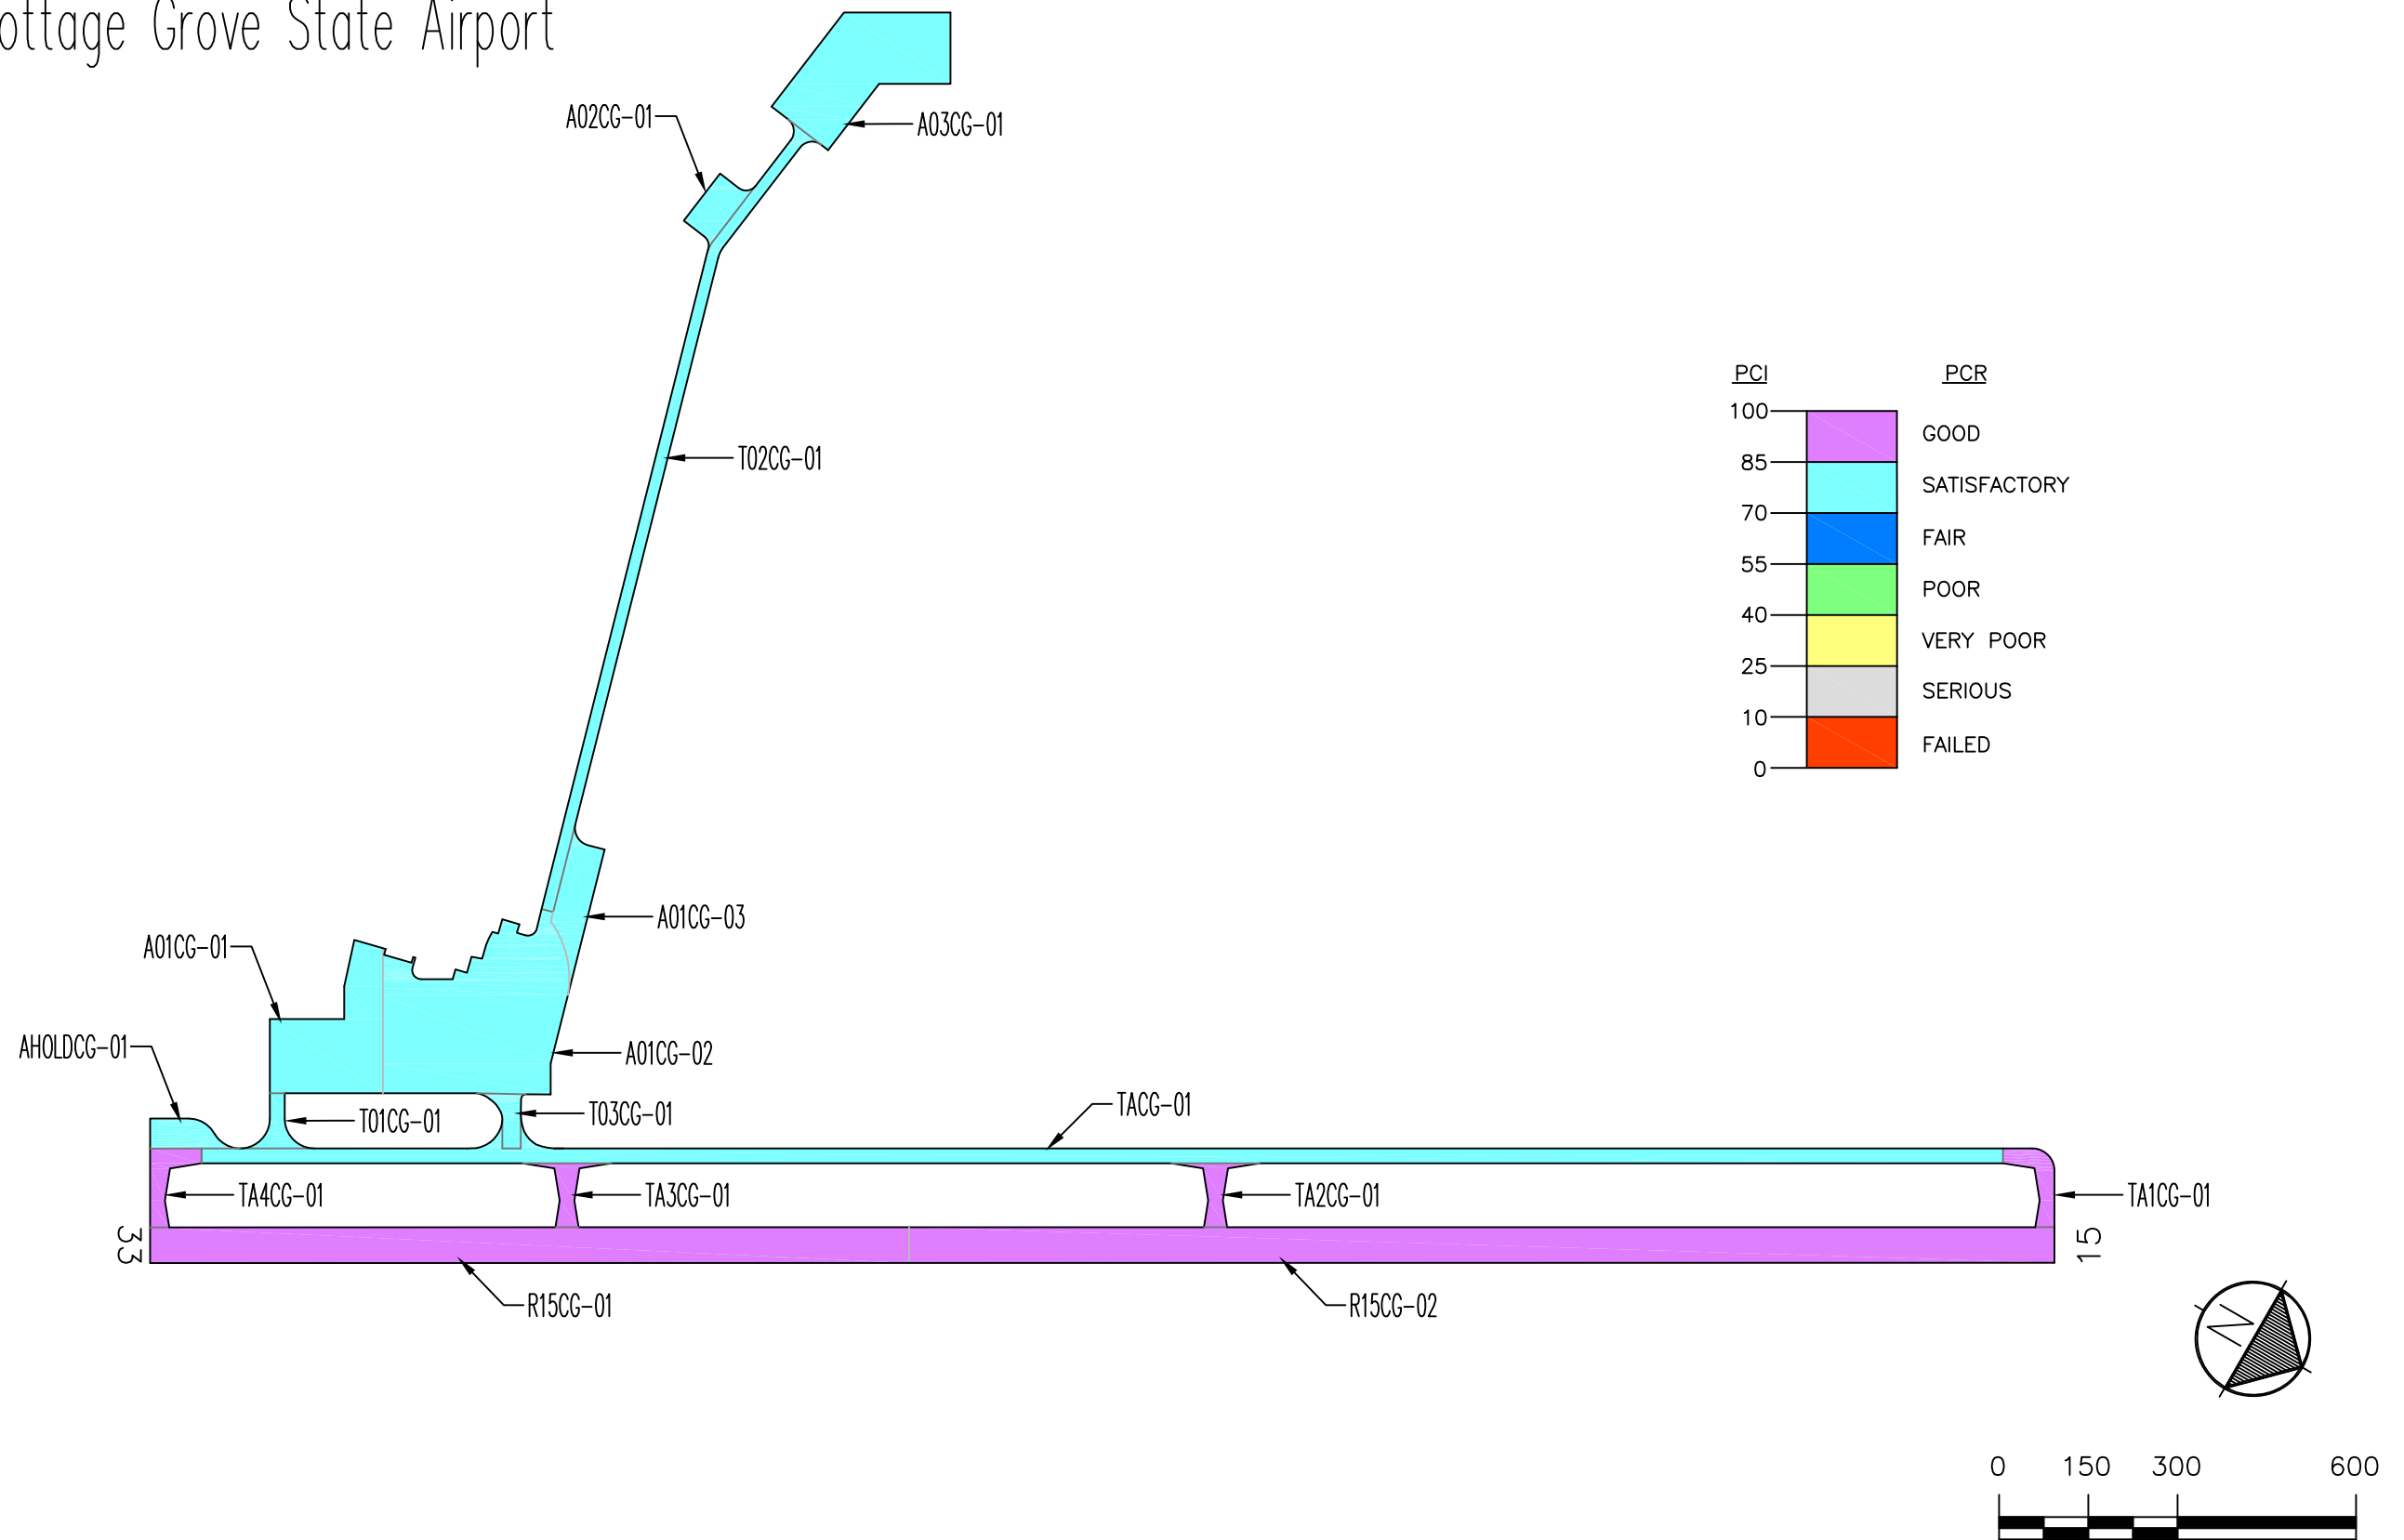
Figure CG-3. Pavement Condition in May 2019.  
Cottage Grove State Airport

The Branch Condition Report in Appendix 1 summarizes current pavement condition by branch while the Section Condition Report in Appendix 2 lists pavement condition by section. The current Pavement Condition Rating (PCR) is shown graphically in Figure CG-3.

Section PCIs at Cottage Grove State Airport range from a low of 73 (a PCR of “Satisfactory”) to a high of 97 (a PCR of “Good”). The area-weighted average PCI for all airport pavements is 86, corresponding to an overall PCR of “Good”. Figure CG-4 shows how much pavement area is associated with each Pavement Condition Rating category and also shows pavement condition distribution from the inspections conducted in 2016. Cottage Grove State Airport was not inspected in 2013.

The primary distresses observed during the inspection were longitudinal and transverse cracking and weathering, with isolated occurrences of patching and alligator cracking.

Data collected during the visual condition survey were used by the PAVER software to generate the Network Maintenance Report contained in Appendix 3. This report identifies, for each pavement section, the recommended localized maintenance activities (i.e.-crack sealing, patching) that should be completed to repair the defects observed during the visual inspection. The repair quantities identified in the report were extrapolated to cover the entire pavement section, based on the distresses measured in the inspected sample units. If the repair activities identified are completed, the pavement deterioration rate will be slowed.

The recommended localized maintenance activities to be applied are selected by the PAVER software based on a Distress Maintenance Policy established for the Oregon airport system. The report results indicate that, over your entire airport, the following quantity of localized maintenance is needed:

- 6,150 linear feet of asphalt concrete crack sealing.

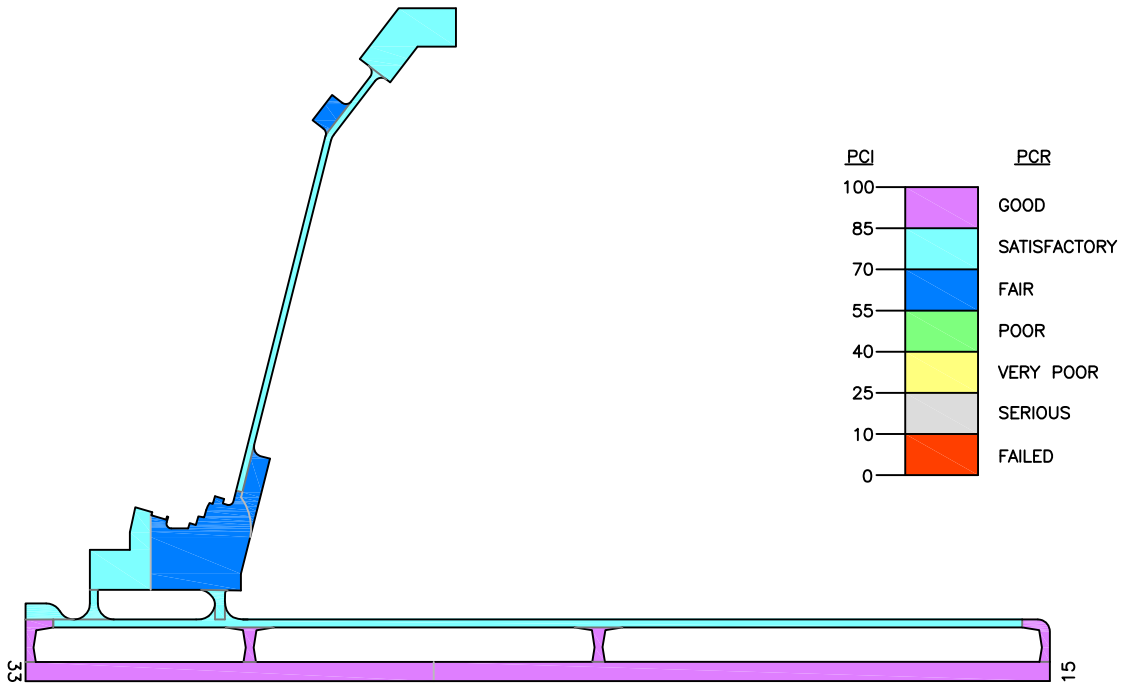
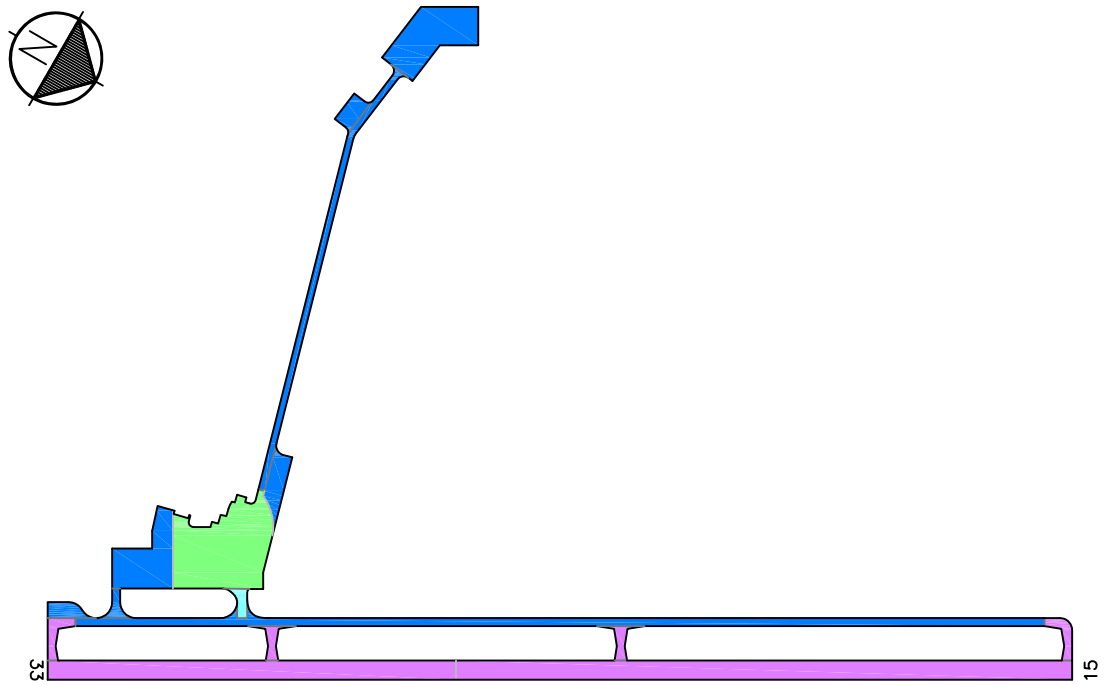
**Figure CG-5. Future Pavement Condition.**

A graphical representation of the projected PCIs listed in Table 1 is shown in Figure CG-5.
