CRESWELL HOBBY FIELD

This report describes how your Pavement Maintenance Management Program (PMMP) was developed. Your Program was developed as part of the Oregon Continuous Aviation System Plan sponsored in part by the Oregon Department of Aviation and the Federal Aviation Administration (FAA). The information and data contained in this report ensures you comply with the requirements of FAA Grant Assurance Number 11 which states that any airport requesting federal funds for pavement improvement projects must have implemented a pavement maintenance management program.

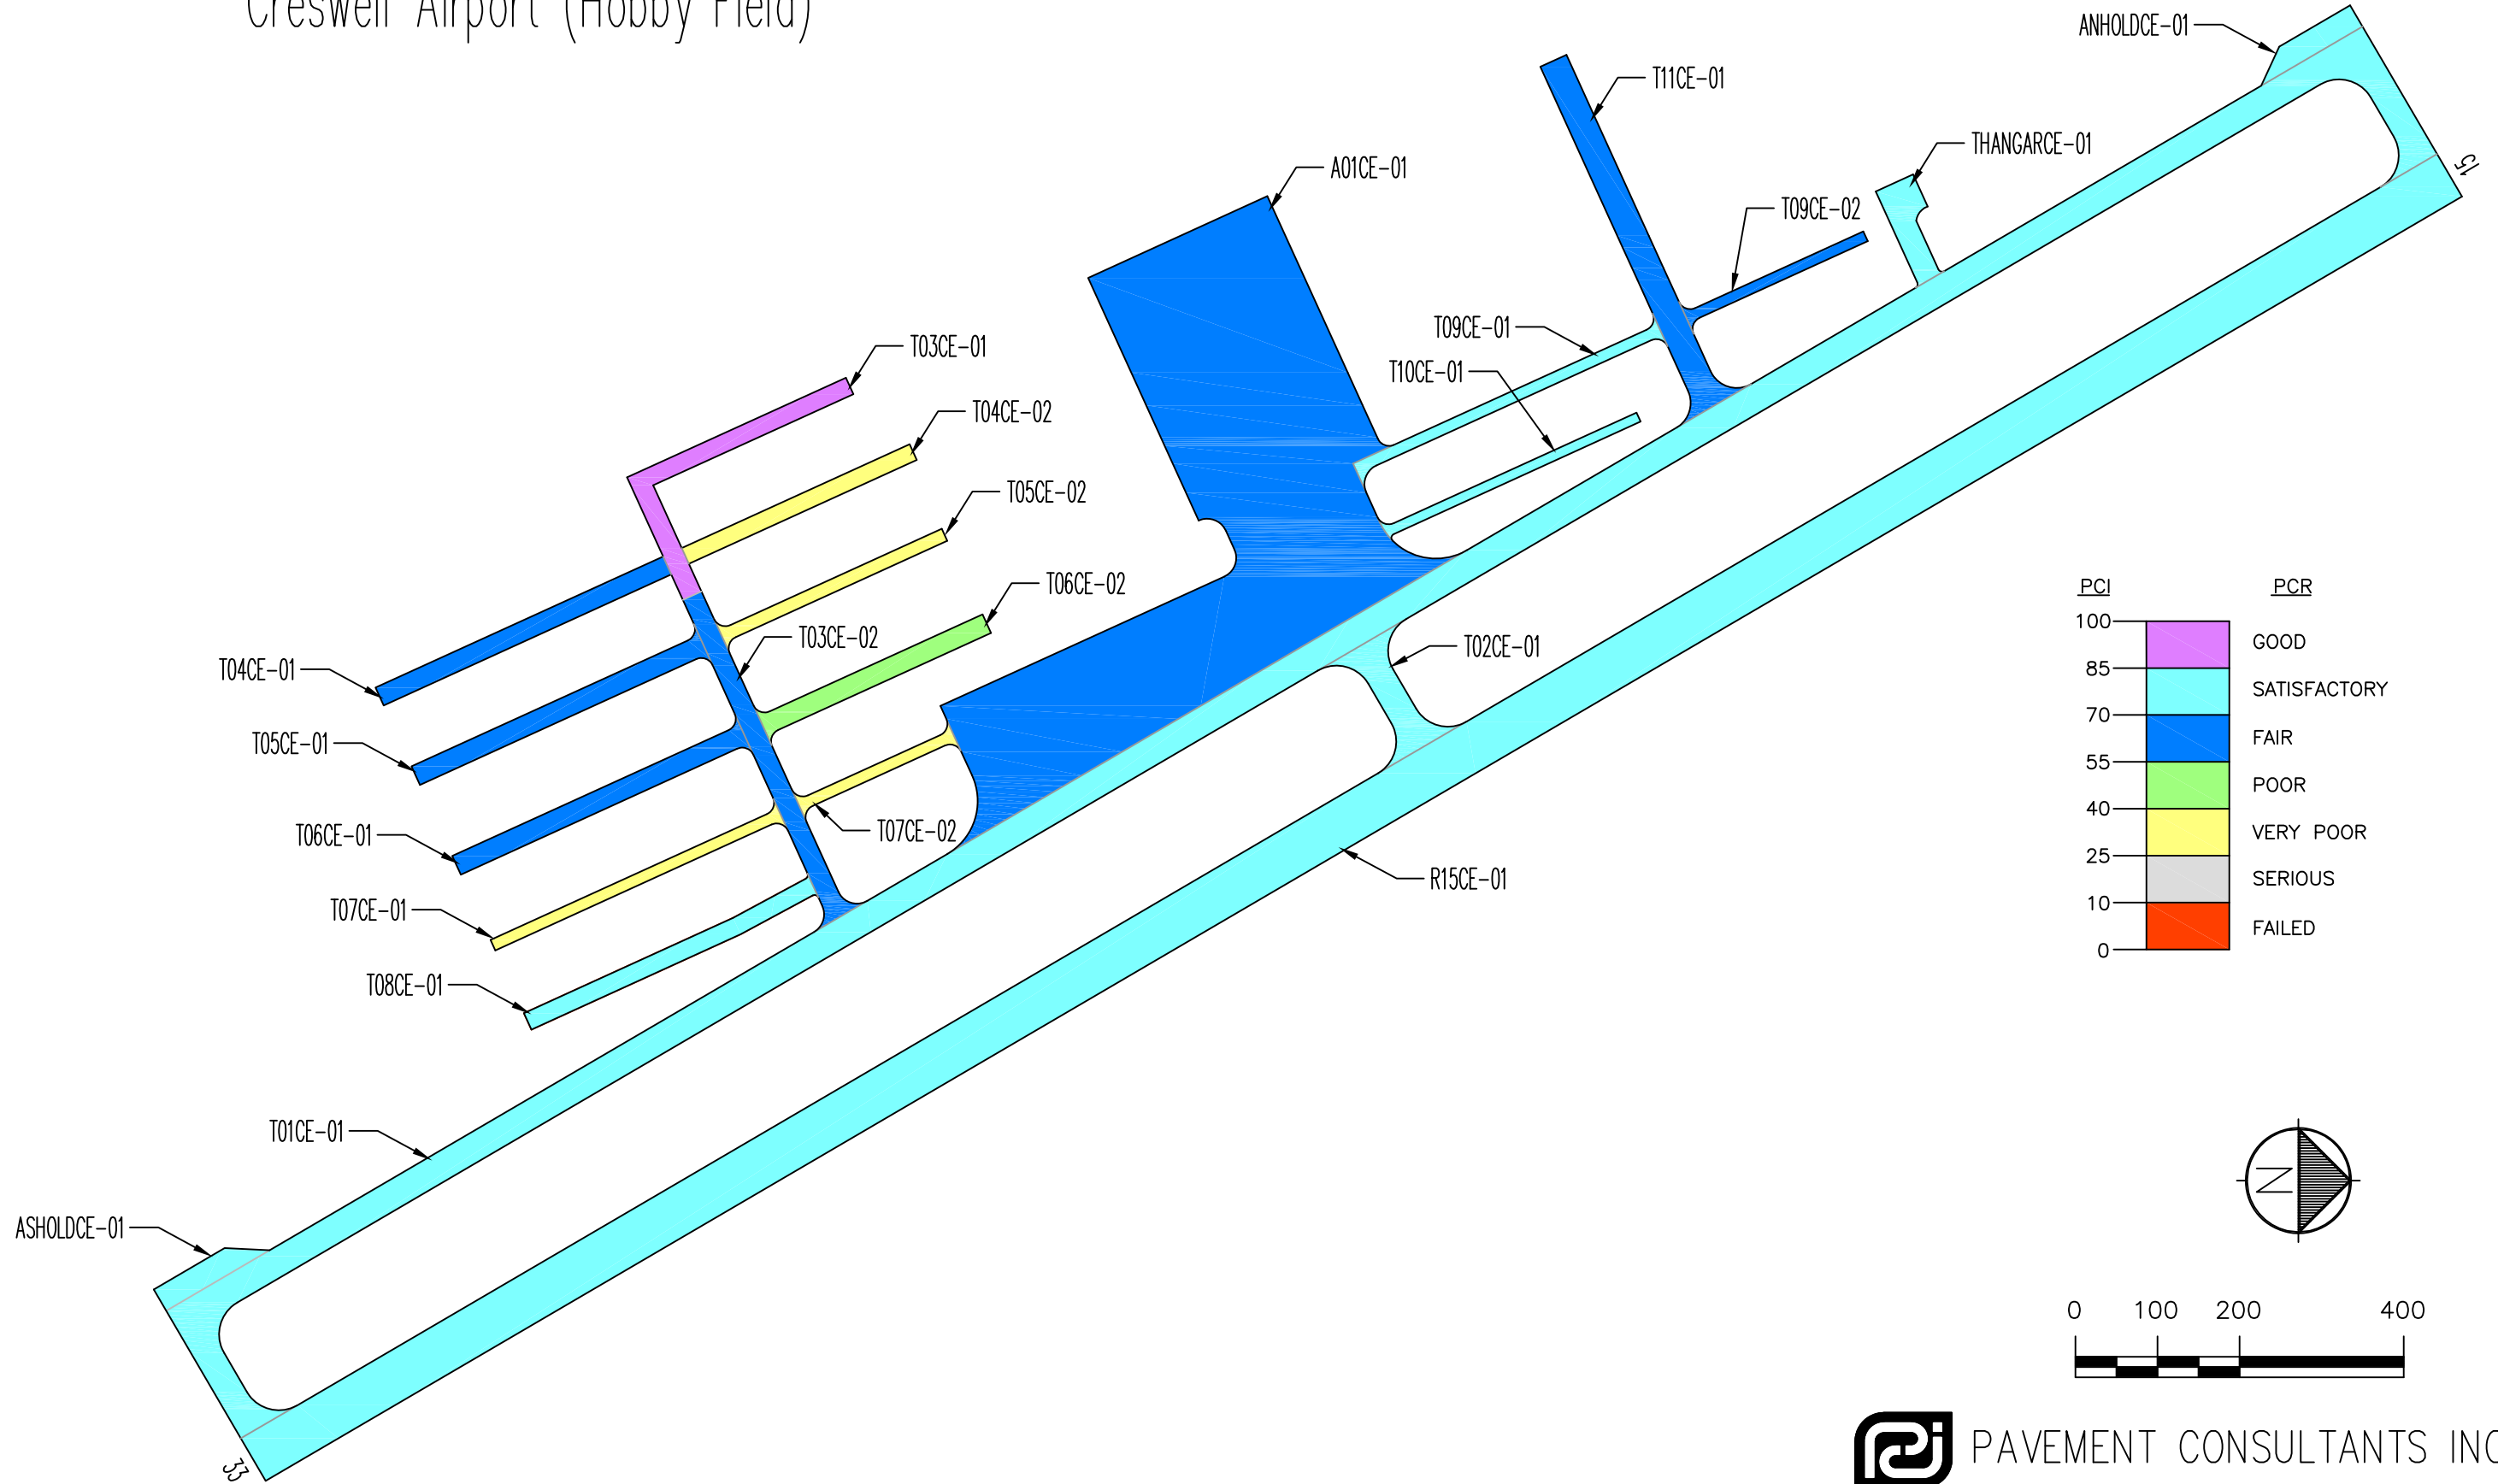
Figure CE-3. Pavement Condition in May 2019.
Creswell Airport (Hobby Field)

Section PCIs at Creswell Hobby Field range from a low of 32 (a PCR of “Very Poor”) to a high of 88 (a PCR of “Good”). The area-weighted average PCI for all airport pavements is 70, corresponding to an overall PCR of “Fair”. Figure CE-4 shows how much pavement area is associated with each Pavement Condition Rating category and also shows pavement condition distribution from the inspections conducted in 2013 and 2016.

The primary distresses observed during the inspection were: longitudinal and transverse cracking, weathering, alligator cracking, patching, depressions, raveling, and an isolated occurrence of block cracking.

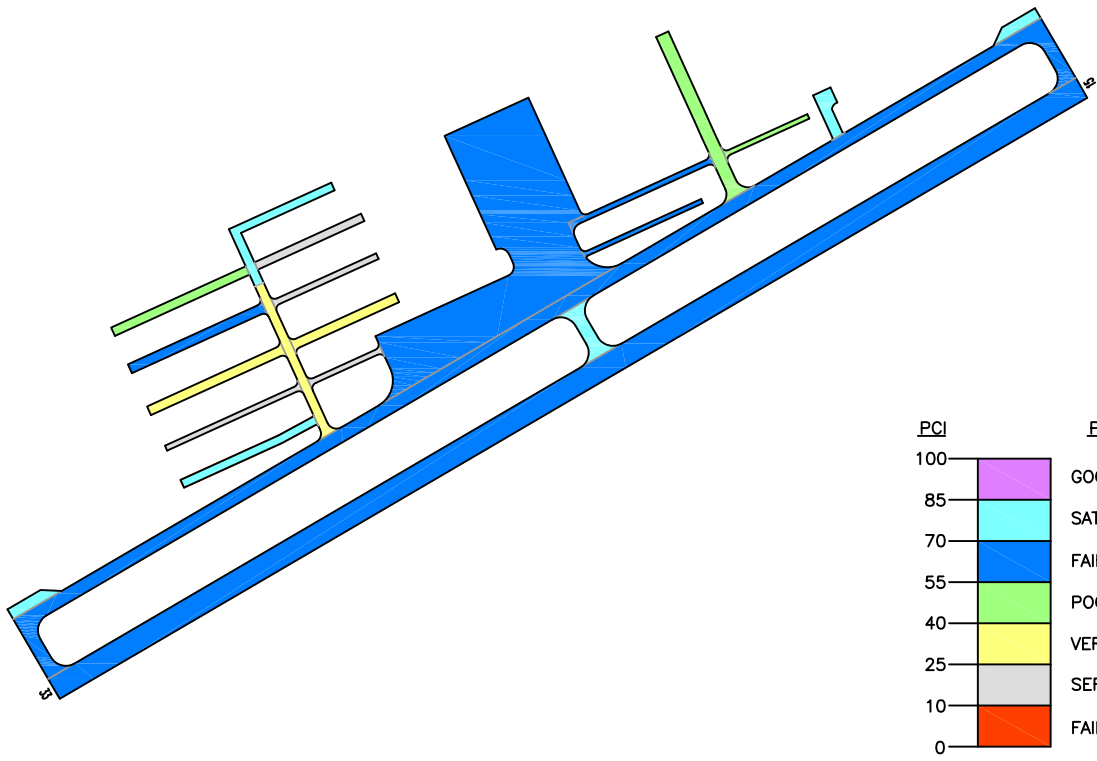
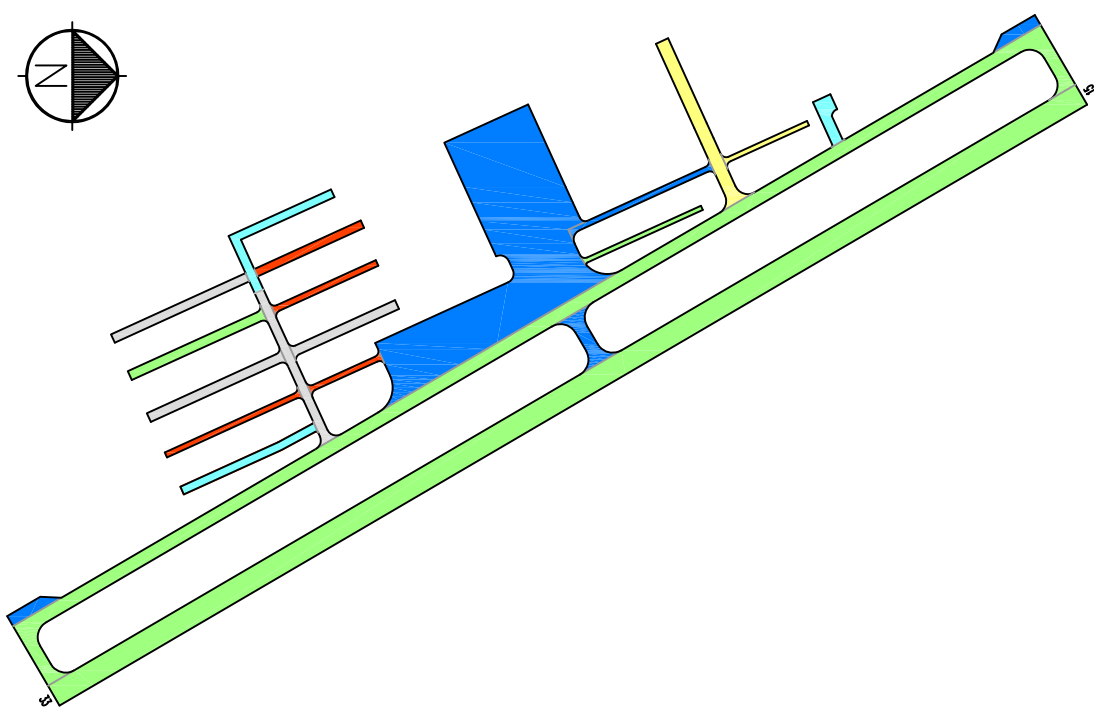
Figure CE-5. Future Pavement Condition.

A graphical representation of the projected PCIs listed in Table 1 is shown in Figure CE-5.
