# FLORENCE MUNICIPAL AIRPORT

Figure FL-1. Airport Layout, Dimensions and Pavement Cross-Sections.  
 Florence Municipal Airport

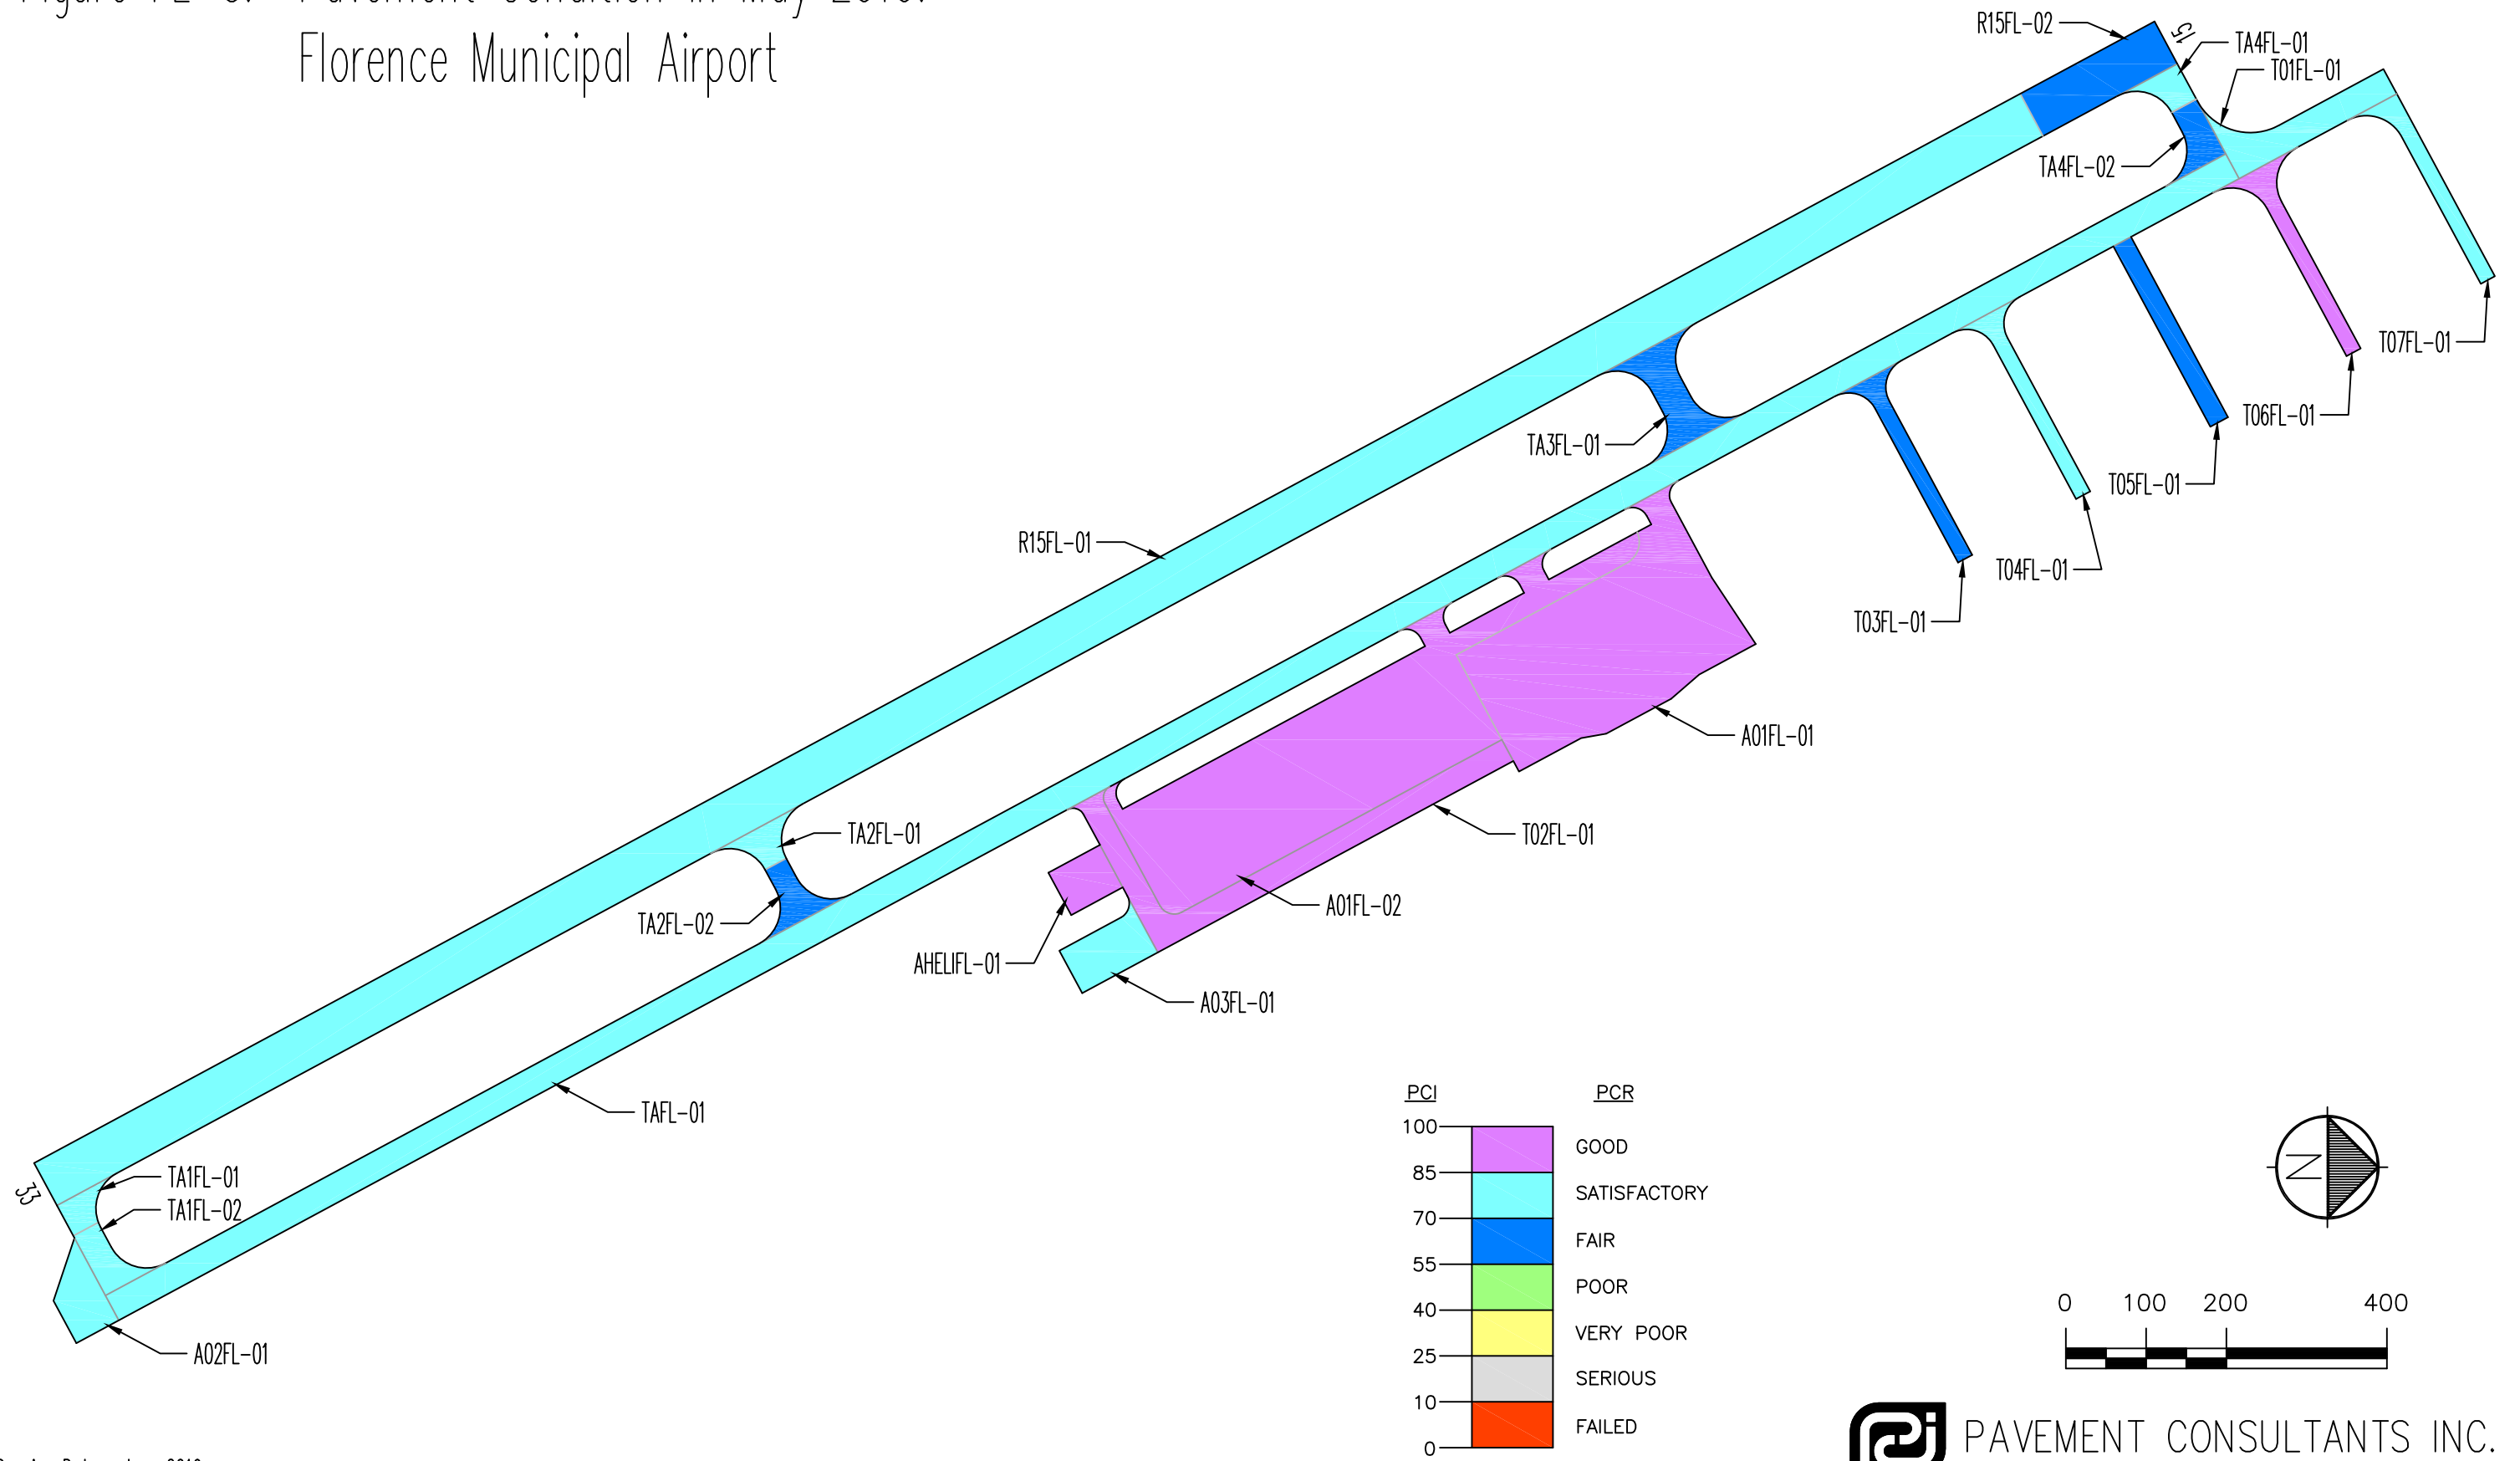
Figure FL-3. Pavement Condition in May 2019.  
 Florence Municipal Airport

Section PCIs at Florence Municipal Airport range from a low of 60 (a PCR of “Fair”) to a high of 100 (a PCR of “Good”). The area-weighted average PCI for all airport pavements is 82, corresponding to an overall PCR of “Satisfactory”. Figure FL-4 shows how much pavement area is associated with each Pavement Condition Rating category and also shows pavement condition distribution from the inspections conducted in 2013 and 2016.

The primary distresses observed during the inspection were: longitudinal and transverse cracking, weathering, depressions, and raveling with isolated occurrences of block cracking and patching.
