# GRANTS PASS AIRPORT

This report describes how your Pavement Maintenance Management Program (PMMP) was developed. Your Program was developed as part of the Oregon Continuous Aviation System Plan sponsored in part by the Oregon Department of Aviation and the Federal Aviation Administration (FAA). The information and data contained in this report ensures you comply with the requirements of FAA Grant Assurance Number 11 which states that any airport requesting federal funds for pavement improvement projects must have implemented a pavement maintenance management program.

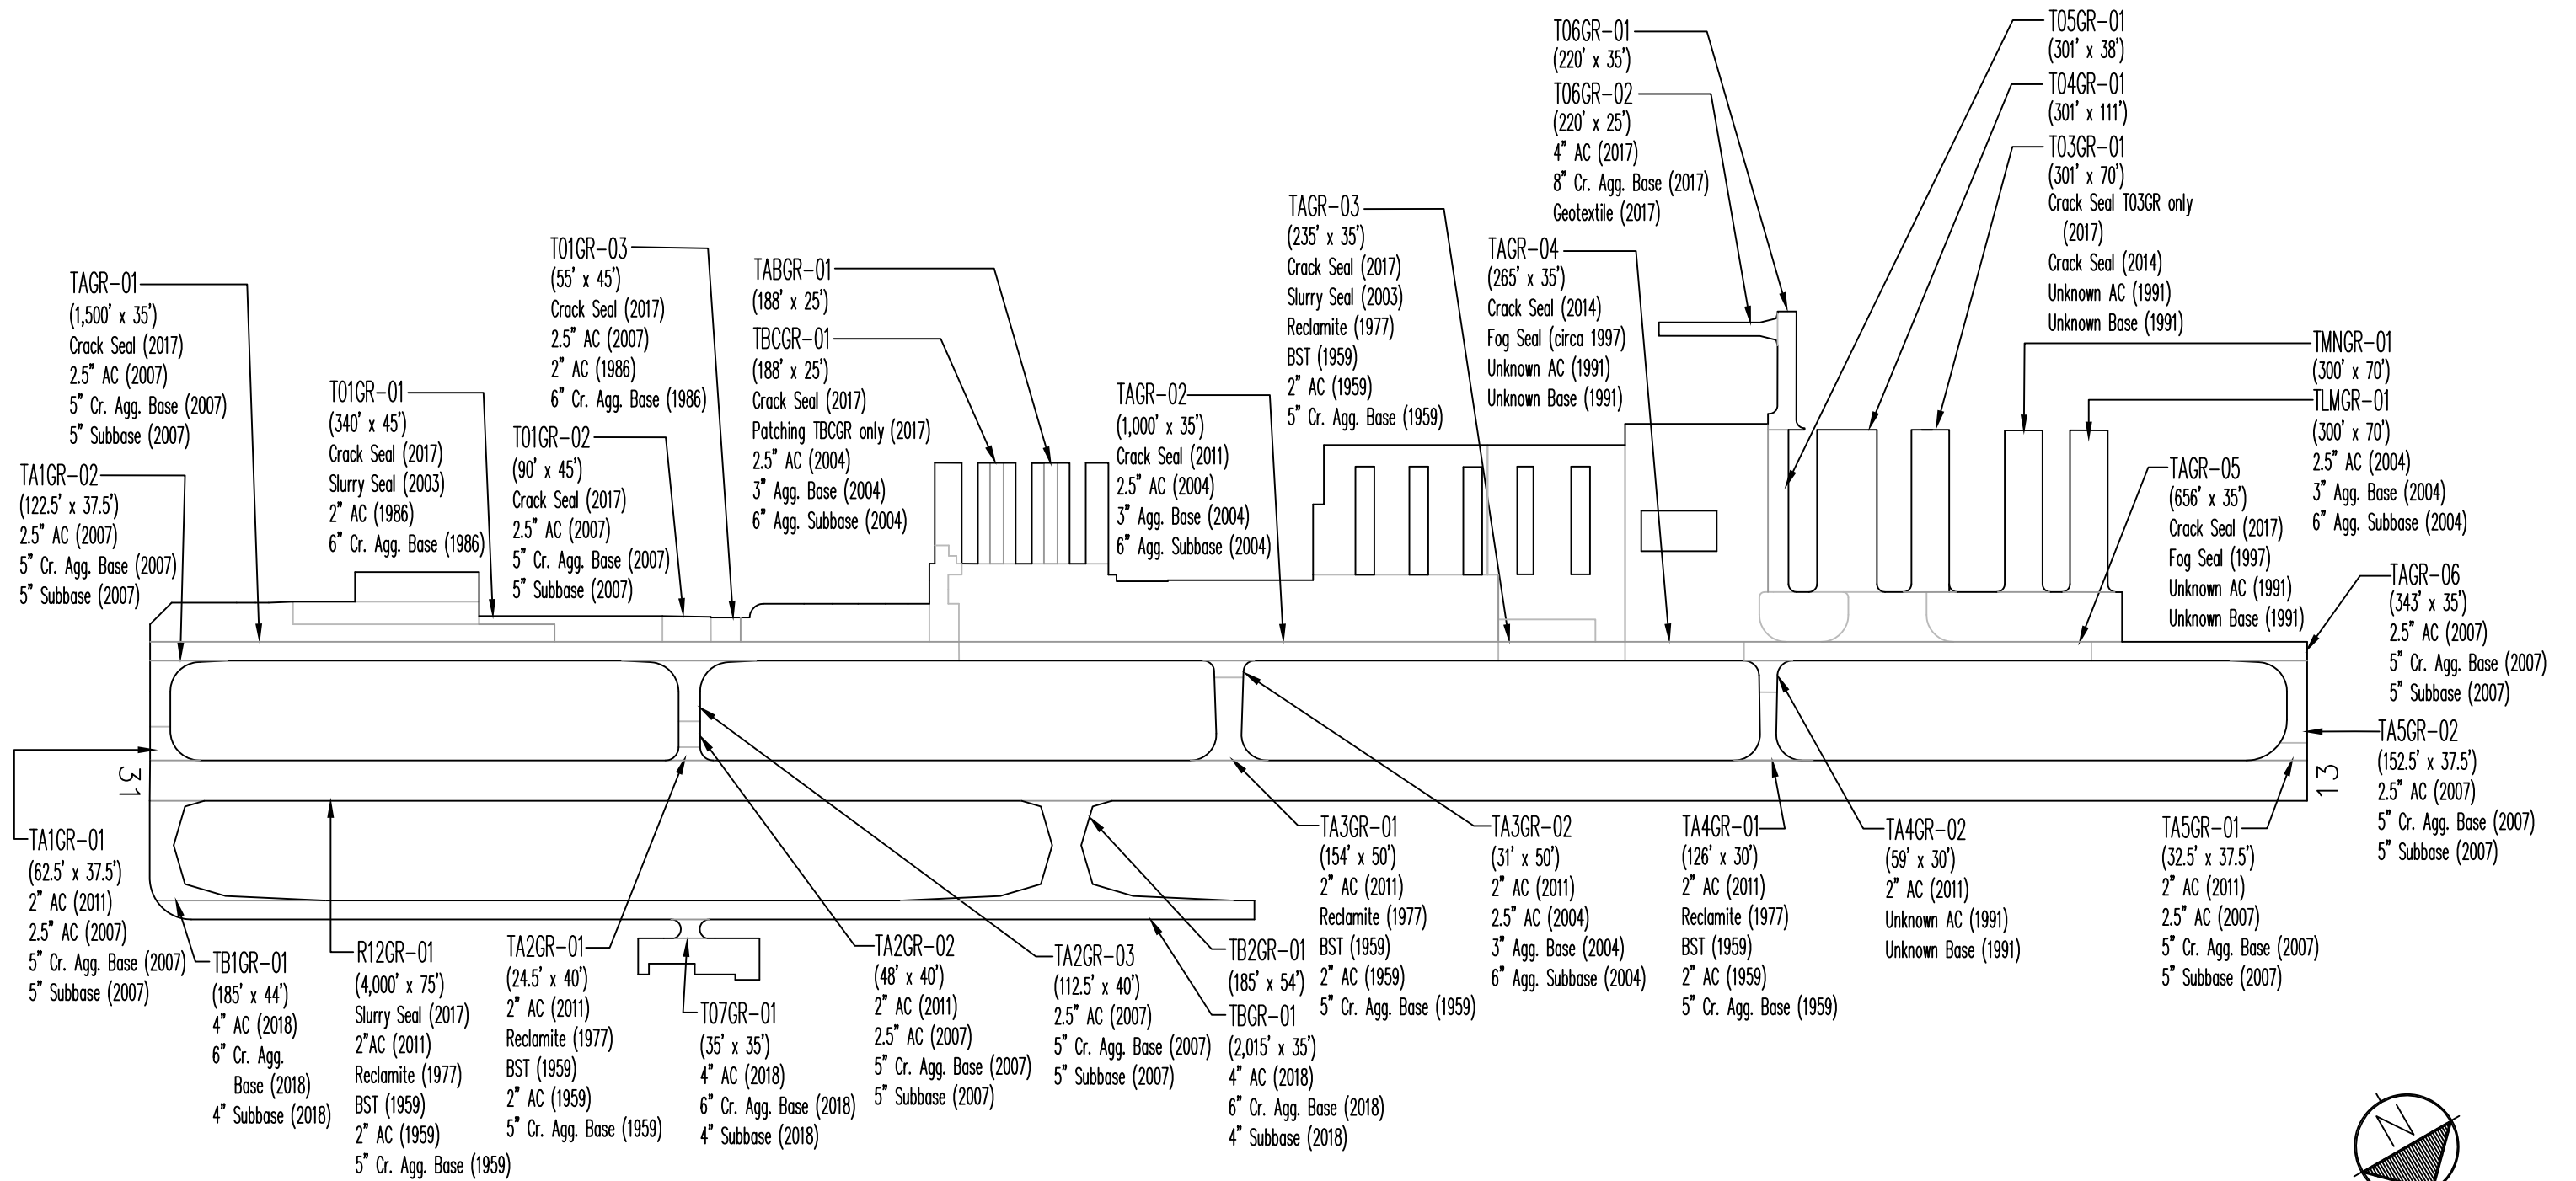
Figure GR-1A. Airport Layout, Dimensions and Pavement Cross-Sections – Runway and Taxiways.  
Grants Pass Airport

To determine how your pavements were constructed and their age, a records review was conducted. Figure GR-1 shows the records review results. This figure identifies pavement boundaries, dimensions, pavement layer types, thicknesses and dates of construction. The most recent construction date for each pavement can also be found in the Section Condition Report in Appendix 2. Figure GR-1 and the information contained in Appendices 1, 2 and 4 ensure that your airport complies with the “pavement inventory” requirement of FAA’s PMMP guidelines.

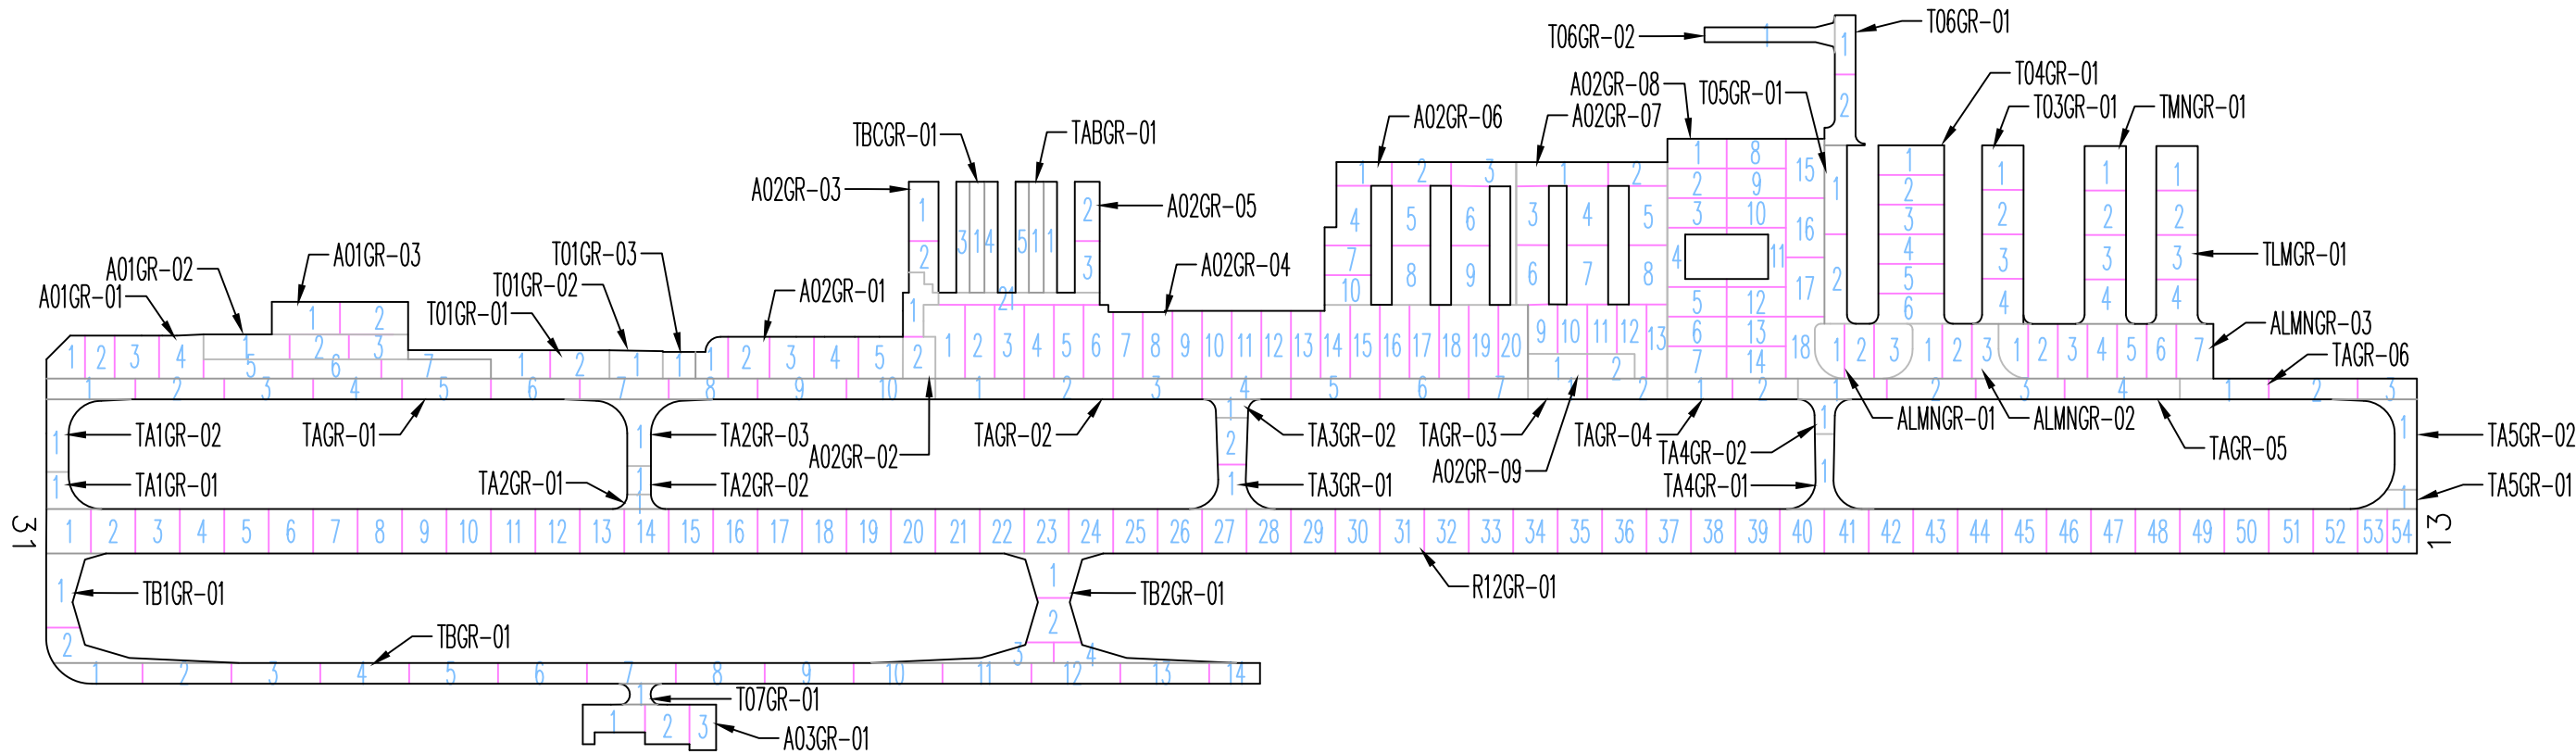
Figure GR-2. Pavement Branch, Section and Sample Unit Layout.  
Grants Pass Airport

The pavements at your airport were divided into branches, sections and sample units in accordance with the methodology outlined in the current edition of ASTM D5430, *Standard Test Method for Airport Condition Index Surveys*. The branches, sections and sample units established at your airport are shown in Figure GR-2. A Branch Condition Report showing all branches, their associated areas, and their area-weighted average condition is provided in Appendix 1. Additionally, the Appendix 2 Section Condition Report provides information used to define each branch and section in the PAVER database.

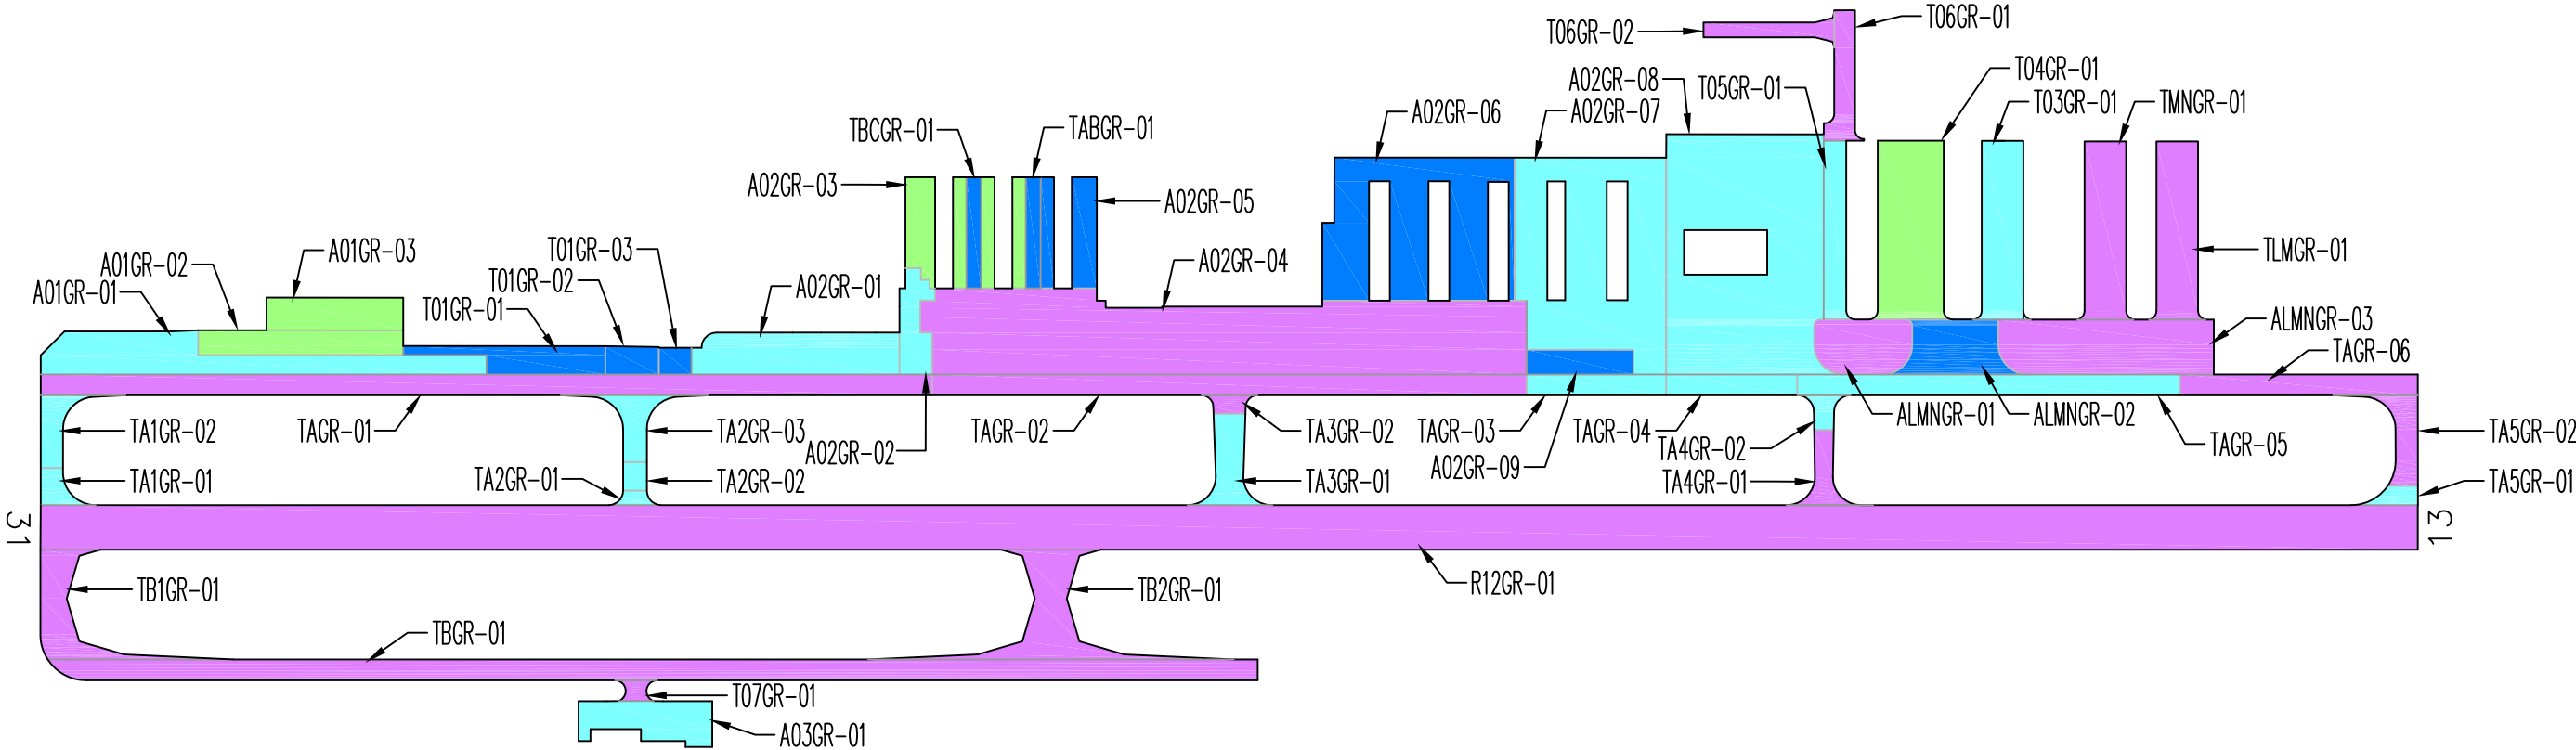
Figure GR-3. Pavement Condition in May 2019.  
Grants Pass Airport

The Branch Condition Report in Appendix 1 summarizes current pavement condition by branch while the Section Condition Report in Appendix 2 lists pavement condition by section. The current Pavement Condition Rating (PCR) is shown graphically in Figure GR-3.

Section PCIs at Grants Pass Airport range from a low of 50 (a PCR of “Poor”) to a high of 100 (a PCR of “Good”). The area-weighted average PCI for all airport pavements is 82, corresponding to an overall PCR of “Satisfactory”. Figure GR-4 shows how much pavement area is associated with each Pavement Condition Rating category and also shows pavement condition distribution from the inspections conducted in 2013 and 2016.

The primary distresses observed during the inspection were: longitudinal and transverse cracking, weathering, patching, block cracking, depressions, with an isolated occurrence of alligator cracking.

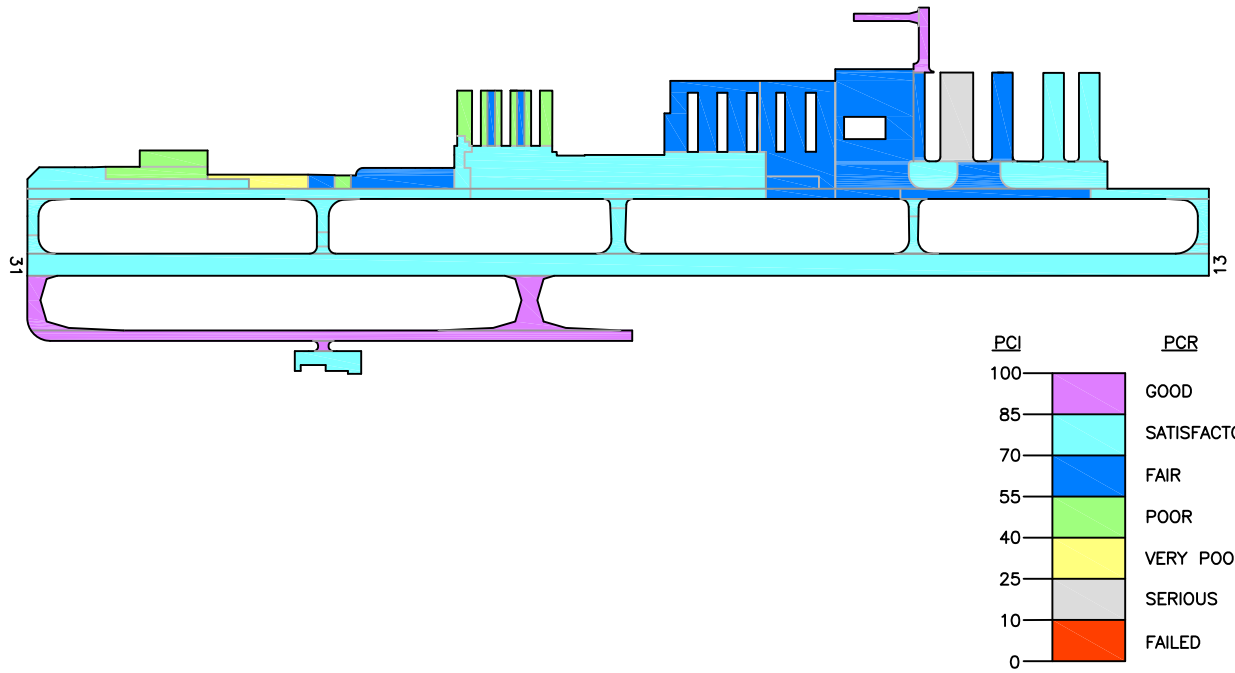
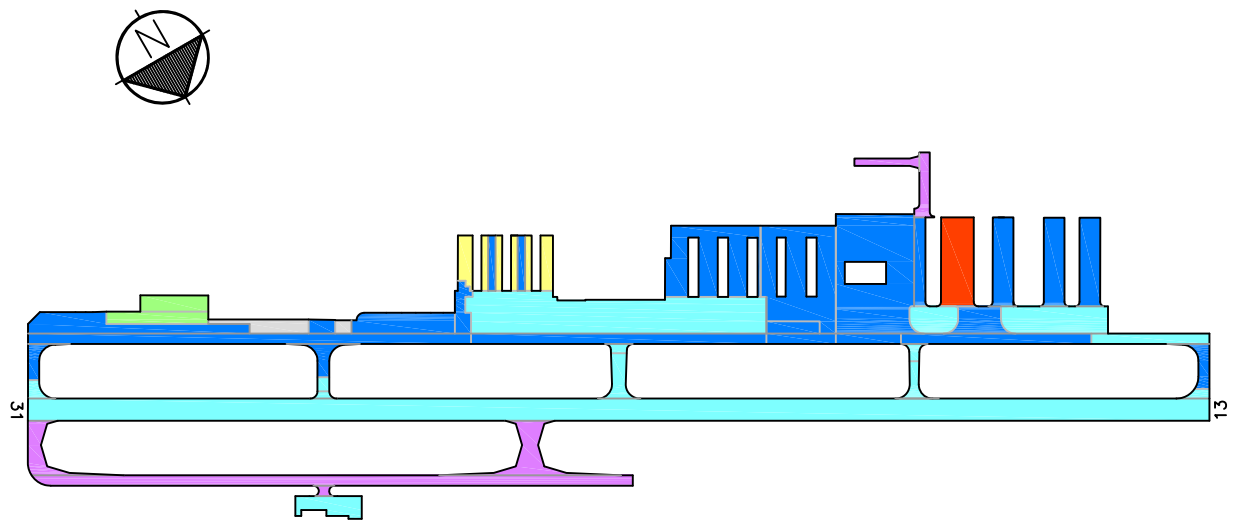
**Figure GR-5. Future Pavement Condition.**

A graphical representation of the projected PCIs listed in Table 1 is shown in Figure GR-5.
