ILLINOIS VALLEY AIRPORT

DATA COLLECTION

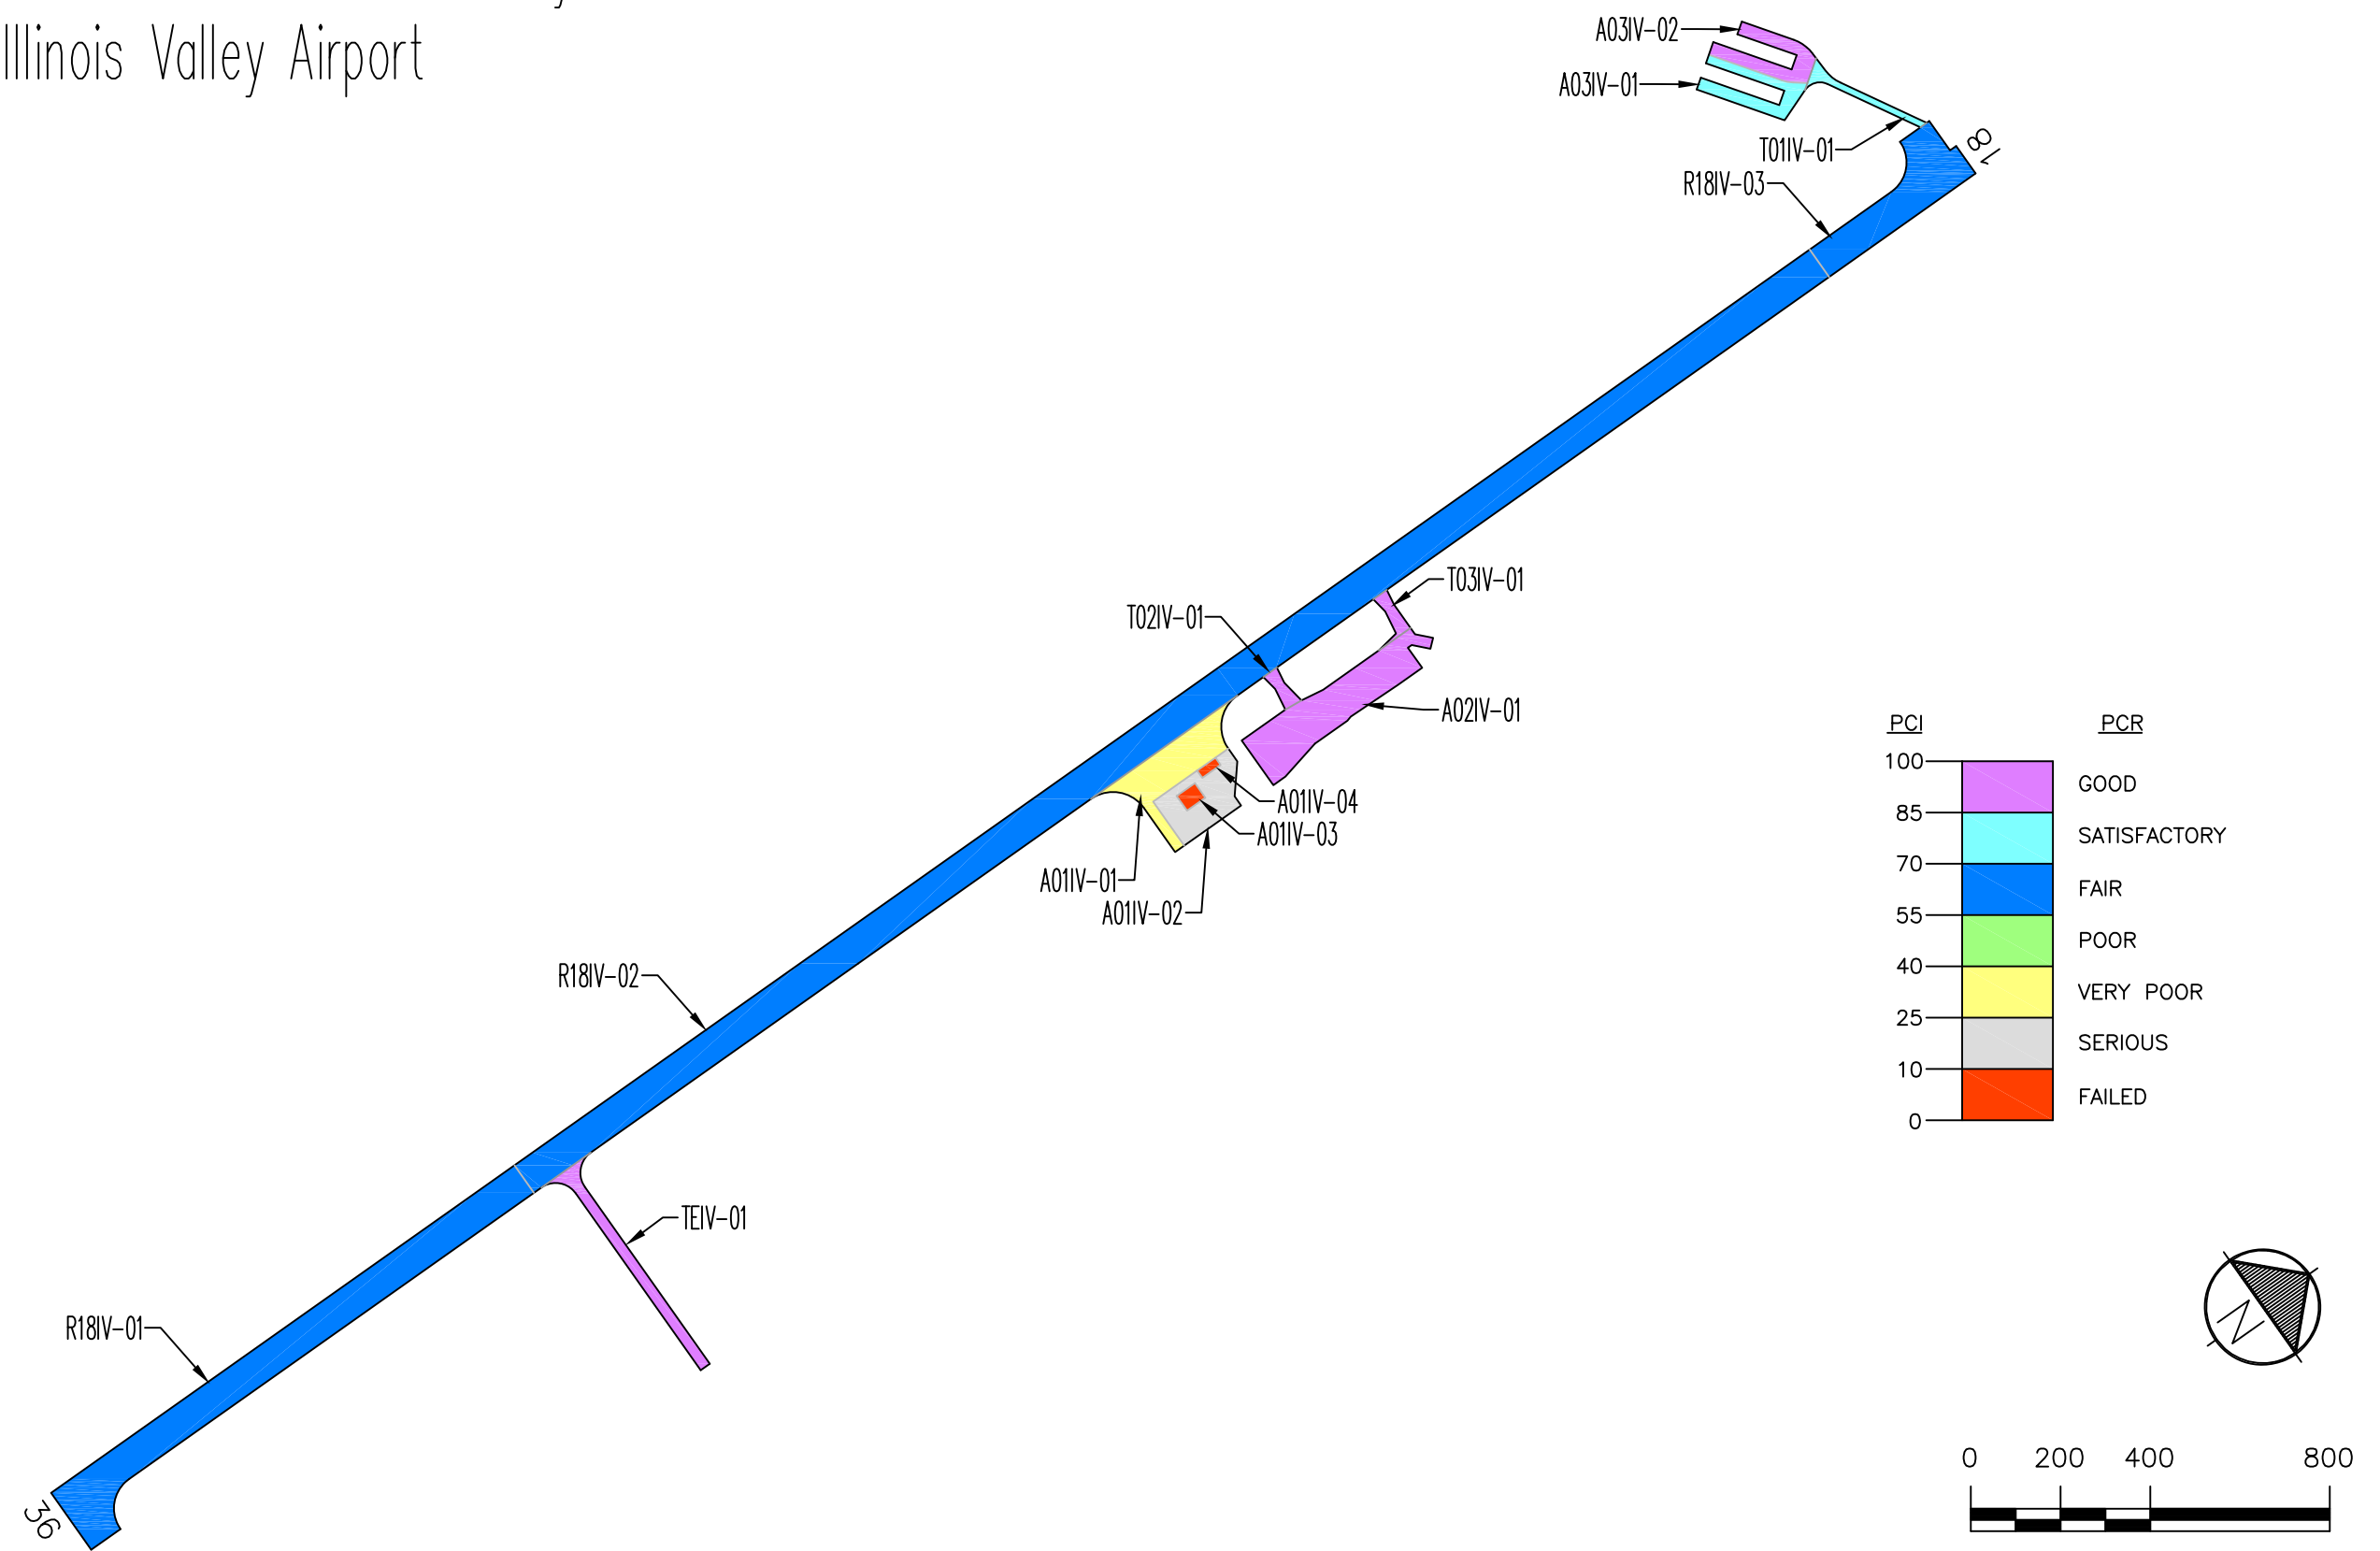
Figure IV-3. Pavement Condition in May 2019.
Illinois Valley Airport

The Branch Condition Report in Appendix 1 summarizes current pavement condition by branch while the Section Condition Report in Appendix 2 lists pavement condition by section. The current Pavement Condition Rating (PCR) is shown graphically in Figure IV-3.

Section PCIs at Illinois Valley Airport range from a low of 0 (a PCR of “Failed”) to a high of 100 (a PCR of “Good”). The area-weighted average PCI for all airport pavements is 64, corresponding to an overall PCR of “Fair”. Figure IV-4 shows how much pavement area is associated with each Pavement Condition Rating category and also shows pavement condition distribution from the inspections conducted in 2013 and 2016.

The primary distresses observed during the inspection were: longitudinal and transverse cracking, patching, block cracking, weathering, alligator cracking, shattered slabs, and isolated occurrences of raveling and depressions.

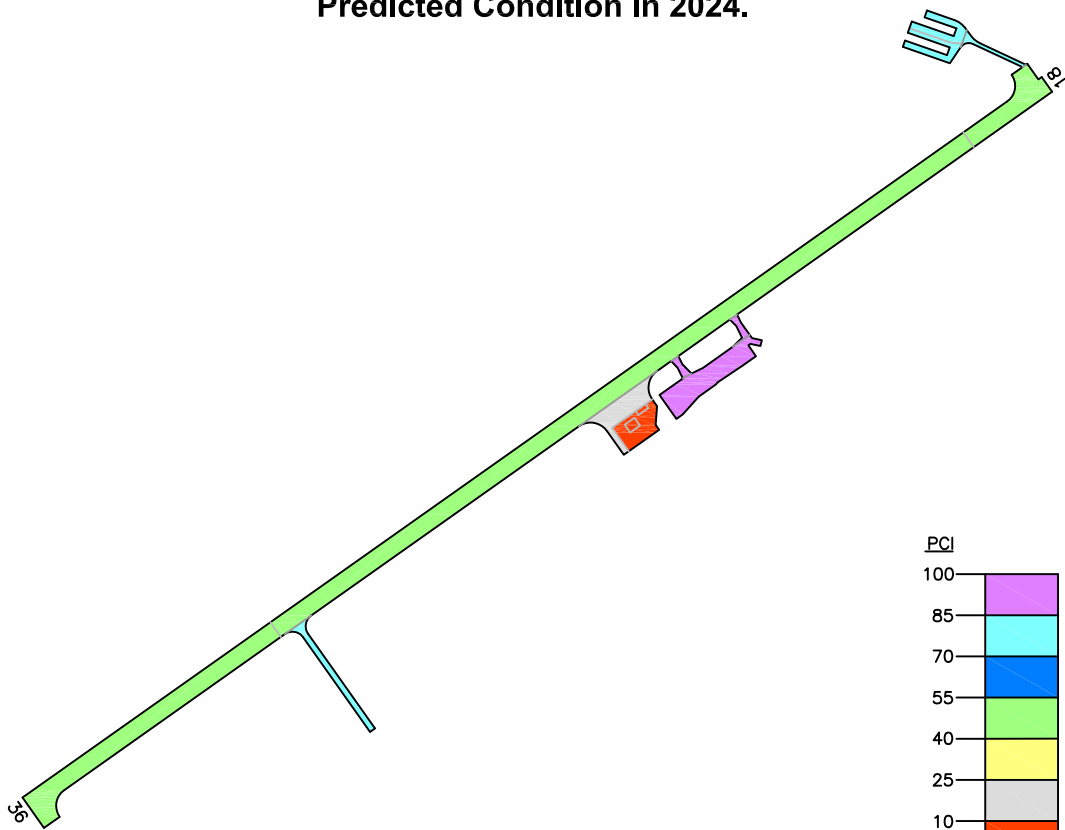
Predicted Condition in 2024.

A graphical representation of the projected PCIs listed in Table 1 is shown in Figure IV-5.
