# LAKE COUNTY AIRPORT

# Figure LA-1. Airport Layout, Dimensions and Pavement Cross-Sections. Lake County Airport

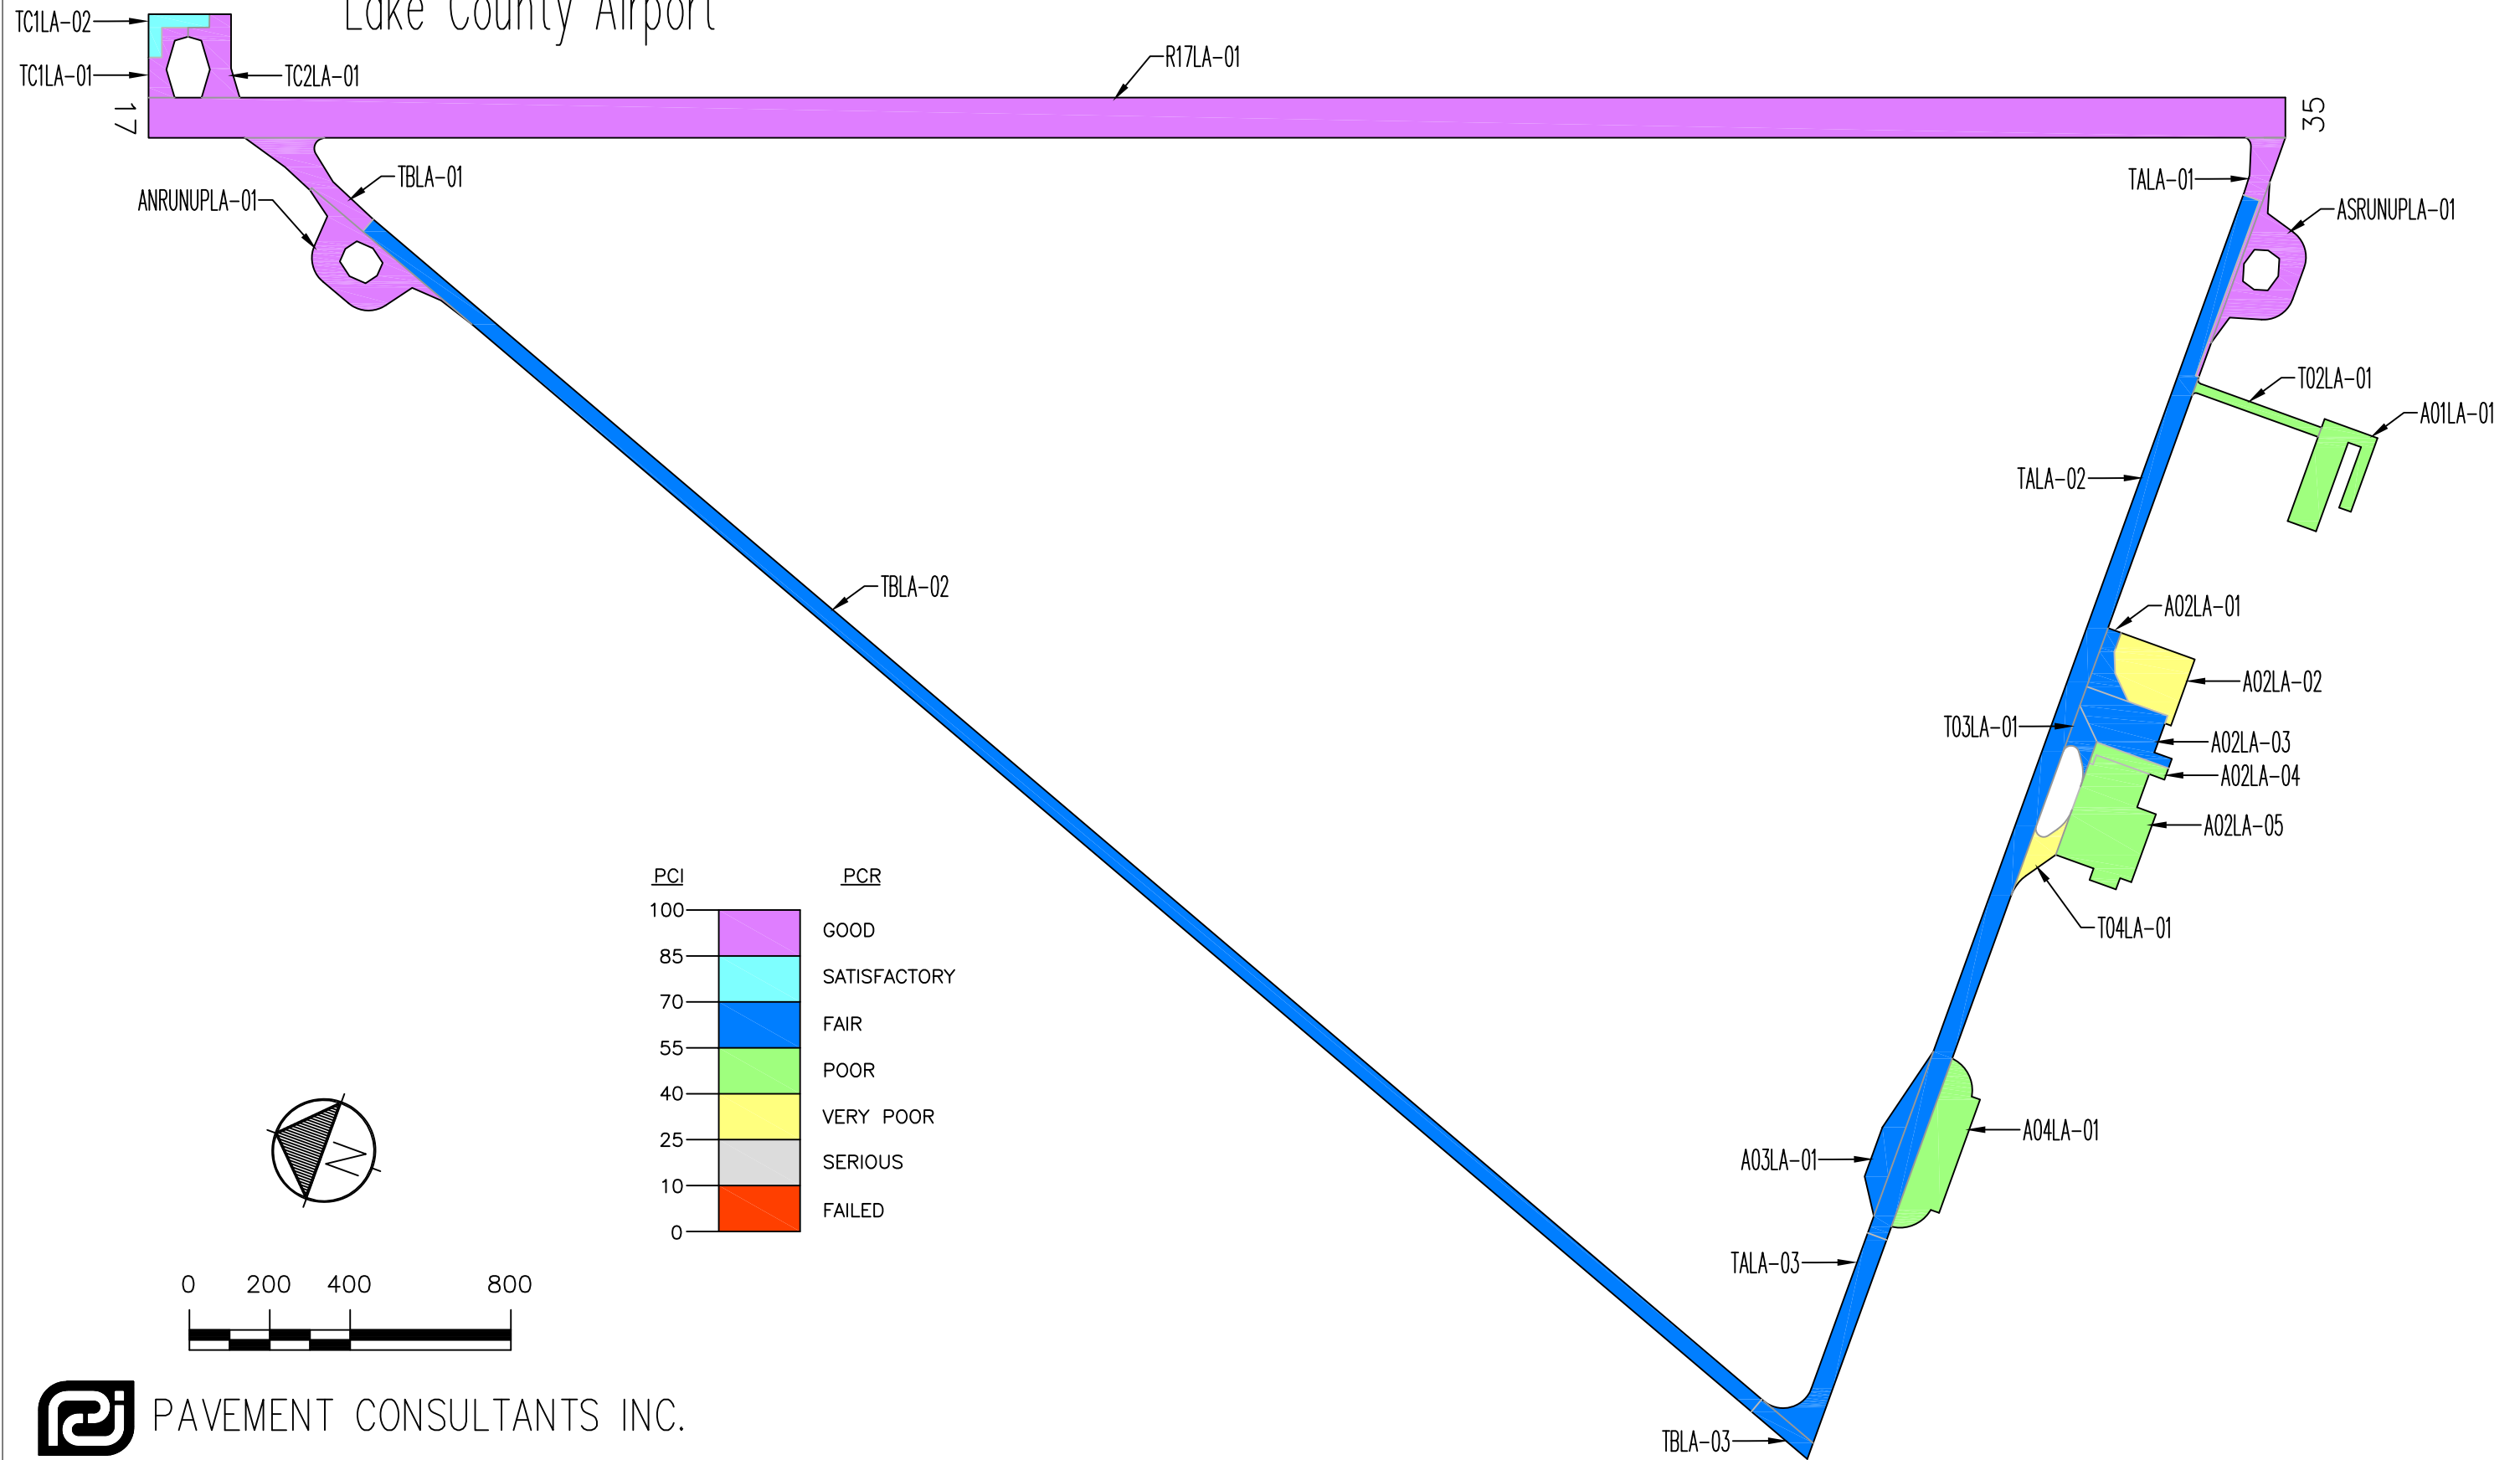
Figure LA-3. Pavement Condition in May 2019.  
Lake County Airport

Section PCIs at Lake County Airport range from a low of 30 (a PCR of “Very Poor”) to a high of 100 (a PCR of “Good”). The area-weighted average PCI for all airport pavements is 78, corresponding to an overall PCR of “Satisfactory”. Figure LA-4 shows how much pavement area is associated with each Pavement Condition Rating category and also shows pavement condition distribution from the inspections conducted in 2013 and 2016.

The primary distresses observed during the inspection were: block cracking, longitudinal and transverse cracking, weathering, patching, raveling, depressions, and alligator cracking.

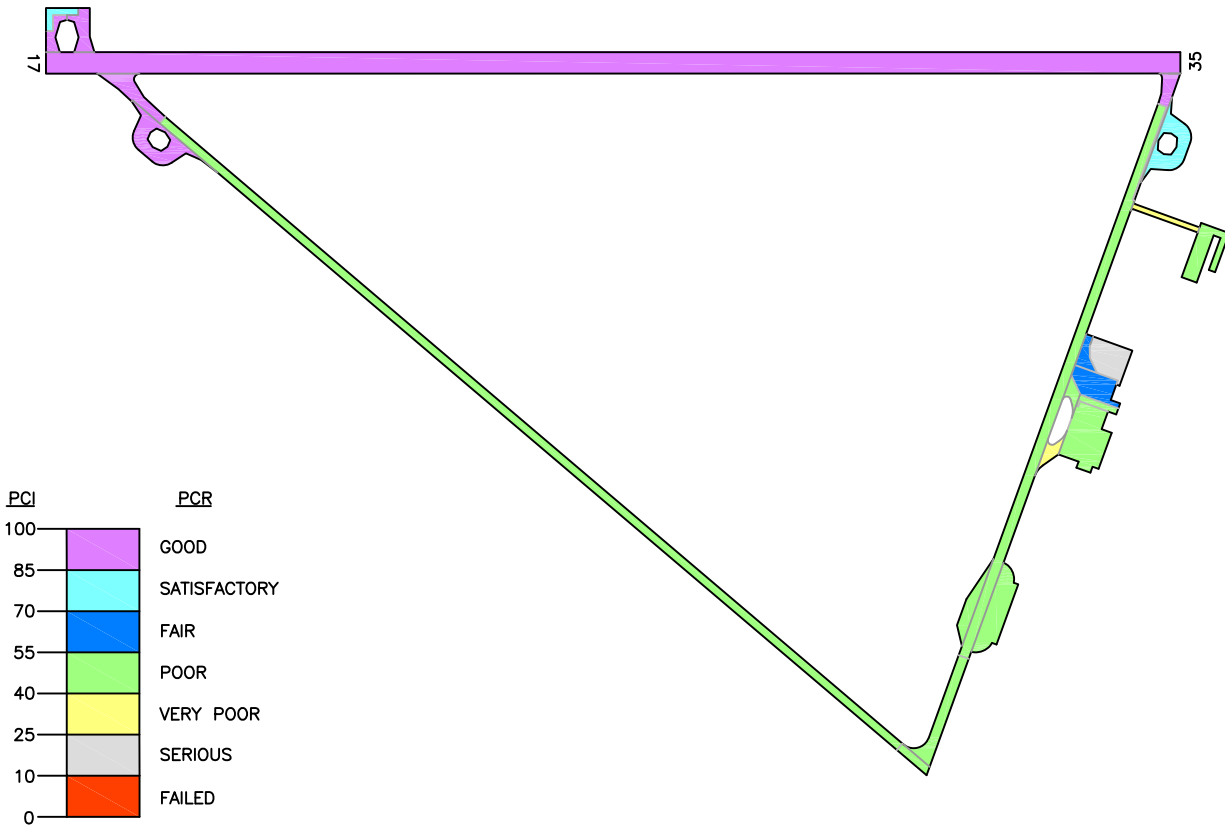
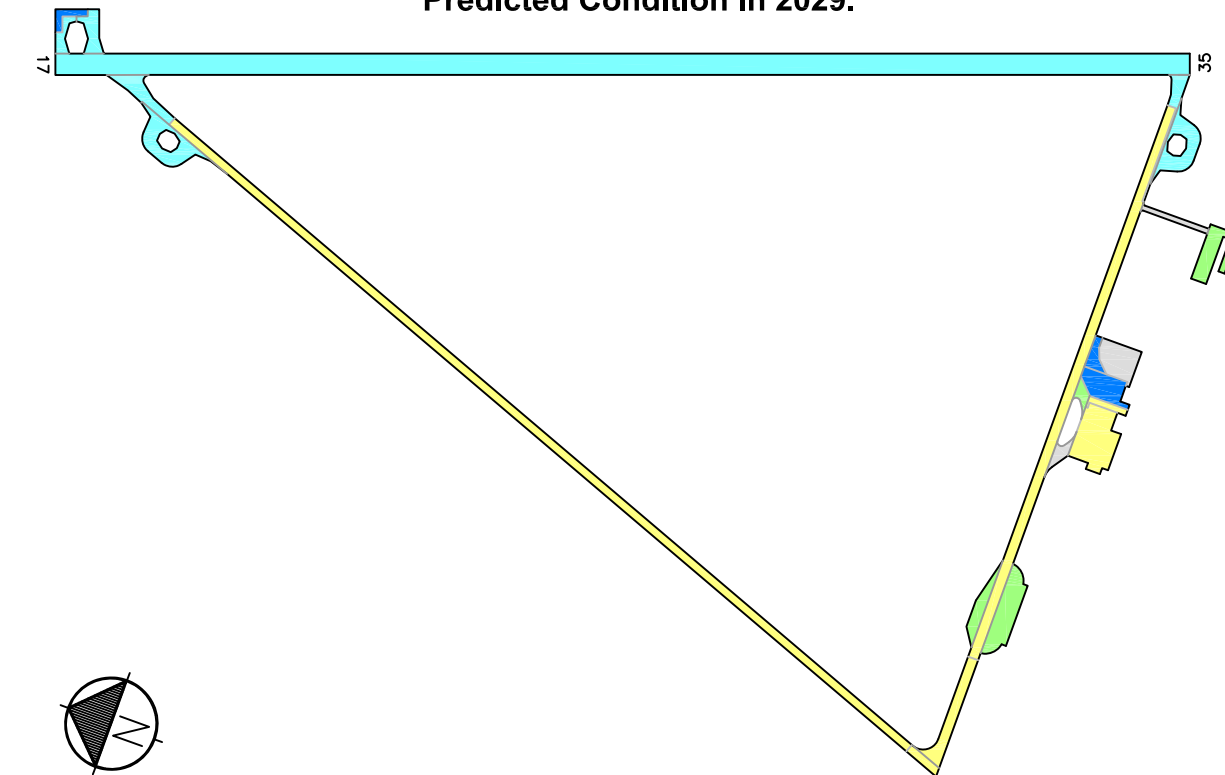
**Figure LA-5. Future Pavement Condition.**

A graphical representation of the projected PCIs listed in Table 1 is shown in Figure LA-5.
