PROSPECT STATE AIRPORT

This report describes how your Pavement Maintenance Management Program (PMMP) was developed. Your Program was developed as part of the Oregon Continuous Aviation System Plan sponsored in part by the Oregon Department of Aviation and the Federal Aviation Administration (FAA). The information and data contained in this report ensures you comply with the requirements of FAA Grant Assurance Number 11 which states that any airport requesting federal funds for pavement improvement projects must have implemented a pavement maintenance management program.

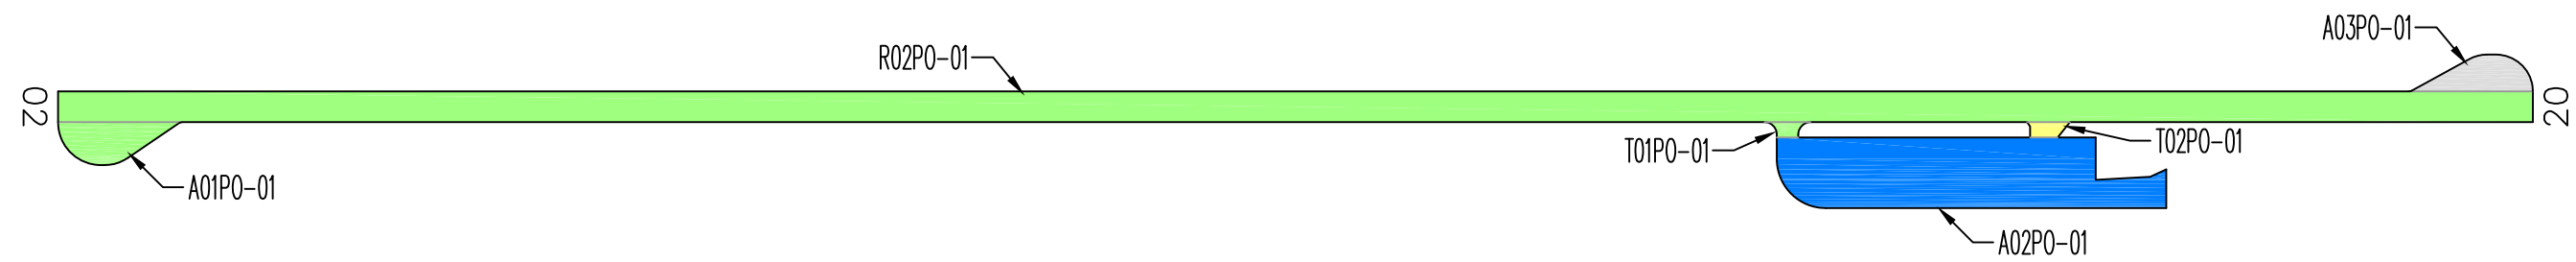
Figure PO-3. Pavement Condition in May 2019.
Prospect State Airport

Section PCIs at Prospect State Airport range from a low of 23 (a PCR of “Serious”) to a high of 57 (a PCR of “Fair”). The area-weighted average PCI for all airport pavements is 48, corresponding to an overall PCR of “Poor”. Figure PO-4 shows how much pavement area is associated with each Pavement Condition Rating category and also shows pavement condition distribution from the inspections conducted in 2013 and 2016.

The primary distresses observed during the inspection were: longitudinal and transverse cracking, alligator cracking, block cracking, patching and an isolated occurrence of raveling.
