ROSEBURG REGIONAL AIRPORT

Figure RS-1. Airport Layout, Dimensions and Pavement Cross-Sections.
Roseburg Regional Airport

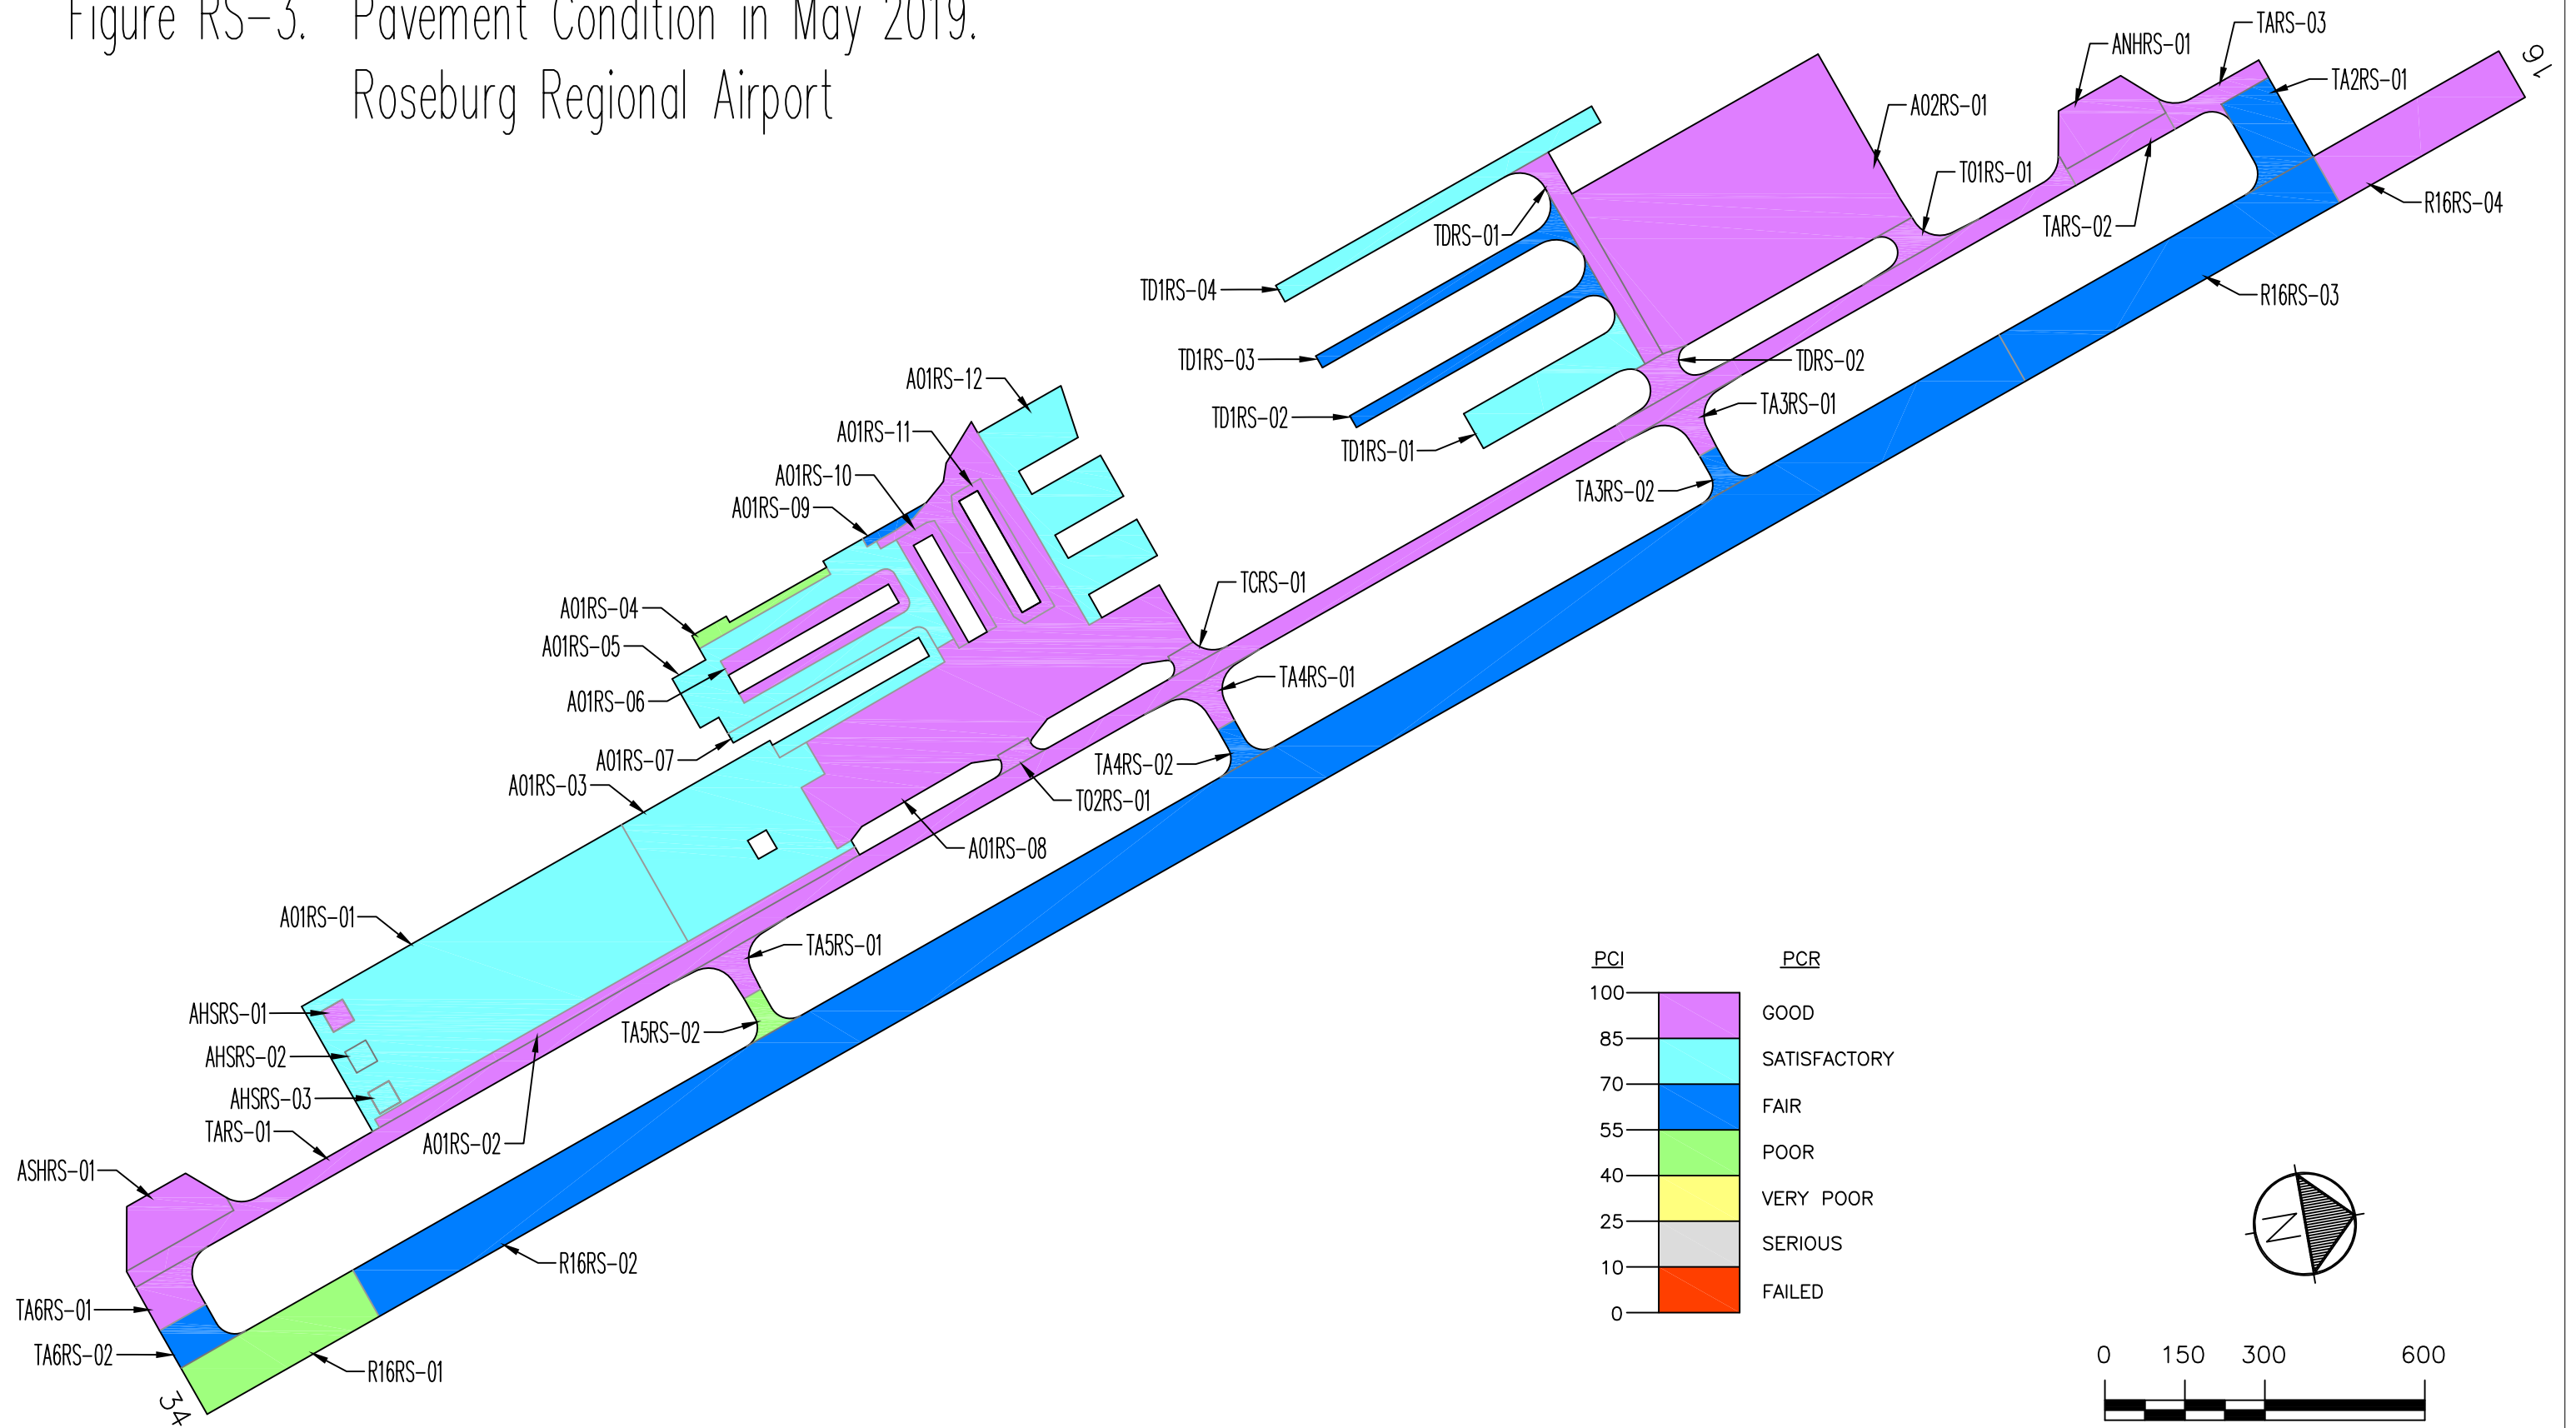
Figure RS-3. Pavement Condition in May 2019.
Roseburg Regional Airport

Section PCIs at Roseburg Regional Airport range from a low of 54 (a PCR of “Poor”) to a high of 100 (a PCR of “Good”). The area-weighted average PCI for all airport pavements is 80, corresponding to an overall PCR of “Satisfactory”. Figure RS-4 shows how much pavement area is associated with each Pavement Condition Rating category and also shows pavement condition distribution from the inspections conducted in 2013 and 2016.

The primary distresses observed during the inspection were: longitudinal and transverse cracking, weathering, block cracking, raveling, patching, joint seal damage, joint and corner spalls, and linear cracking.

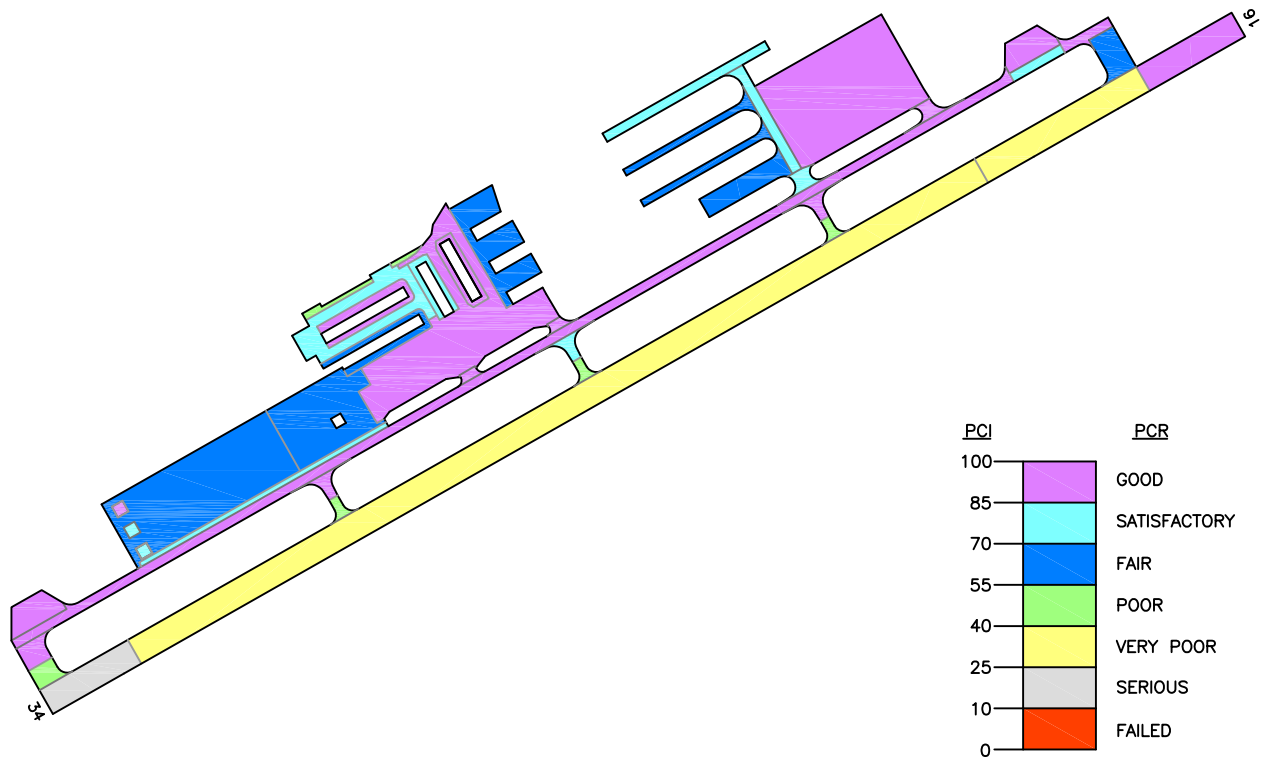
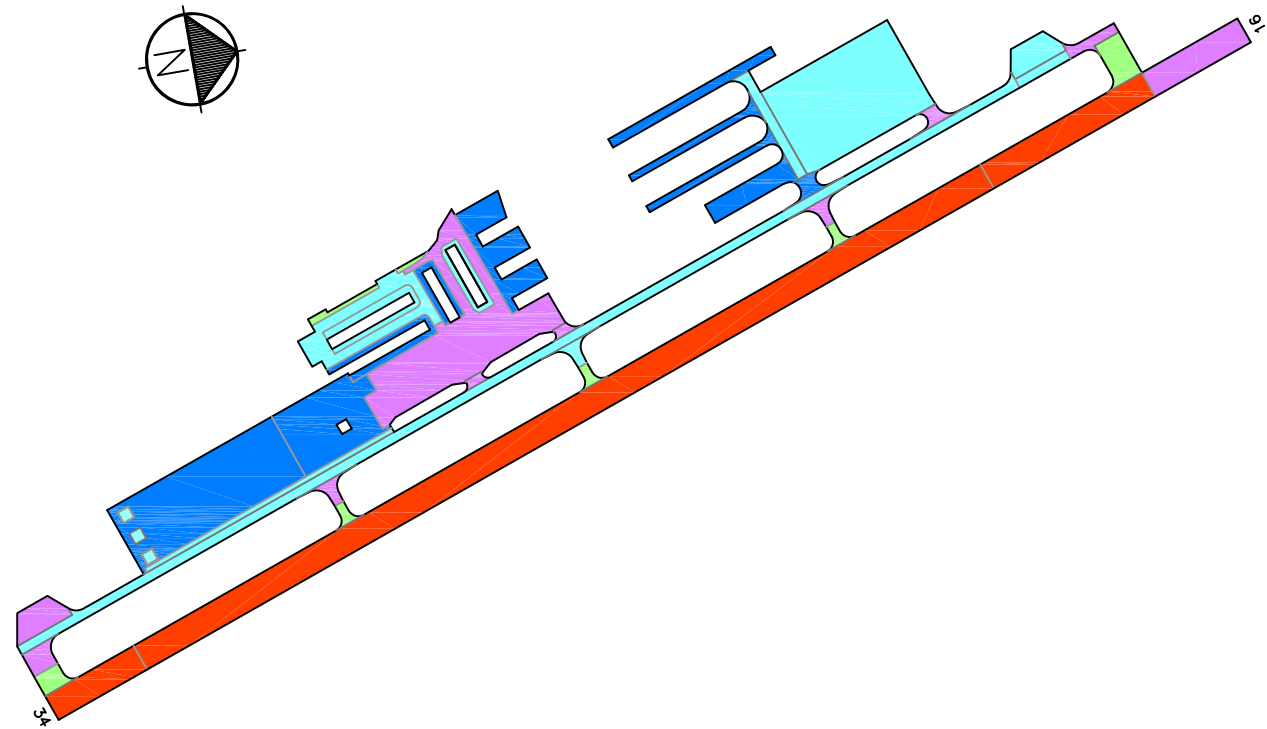
Figure RS-5. Future Pavement Condition.

A graphical representation of the projected PCIs listed in Table 1 is shown in Figure RS-5.
