## **PHASE I ENVIRONMENTAL SITE ASSESSMENT REPORT**

**Oregon State Hospital – North Campus  
2575 Bittern St. NE, 2575-2600 Center St. NE  
Salem, OR 97301**

May 14, 2013  
185750103

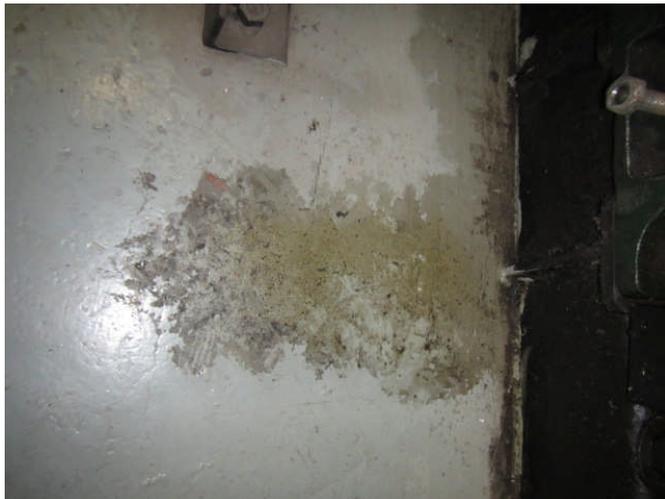
**PHOTO No. 60**

- (4.) Elevator equipment rooms in the basements of Breitenbush Hall and the Dome Building appear to have oil staining on floor areas outside of equipment containment structures. Based on the age of the buildings, it is possible that releases to soil and/or groundwater beneath these areas may have occurred. Impacts, if present, could be encountered if demolition of subsurface structures and/or excavation activities were conducted in conjunction with redevelopment of the Site.

**Basement – East Freight Elevator Room, Oil Staining**

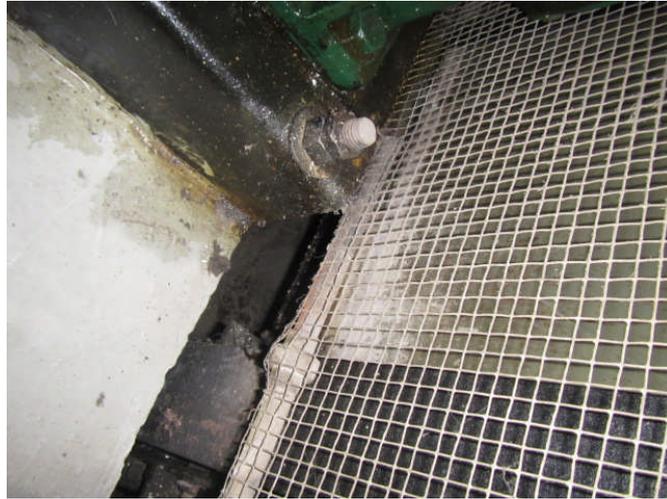
**PHOTO No. 61**

**Basement – East Freight Elevator Room, Oil Staining**

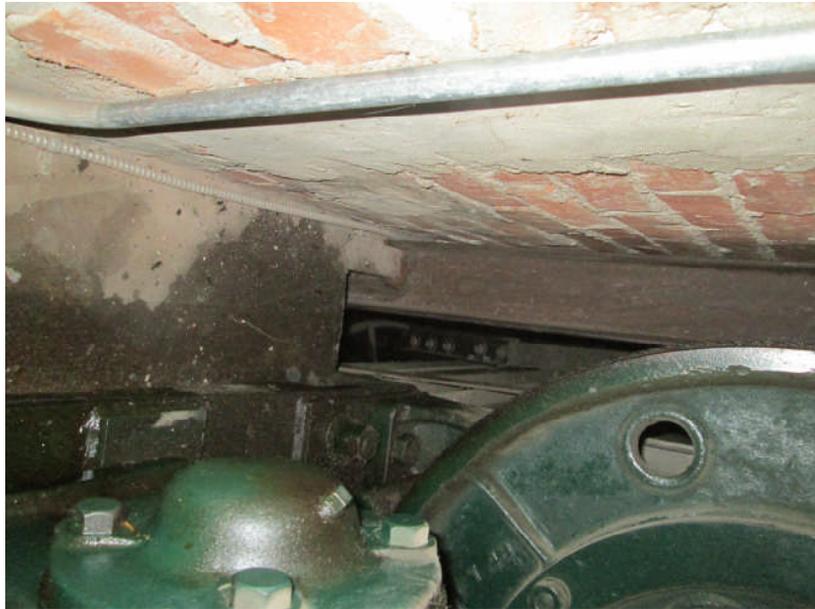
**PHOTO No. 3, February 19, 2013**

**Basement – Staining on Floor of Elevator Room**

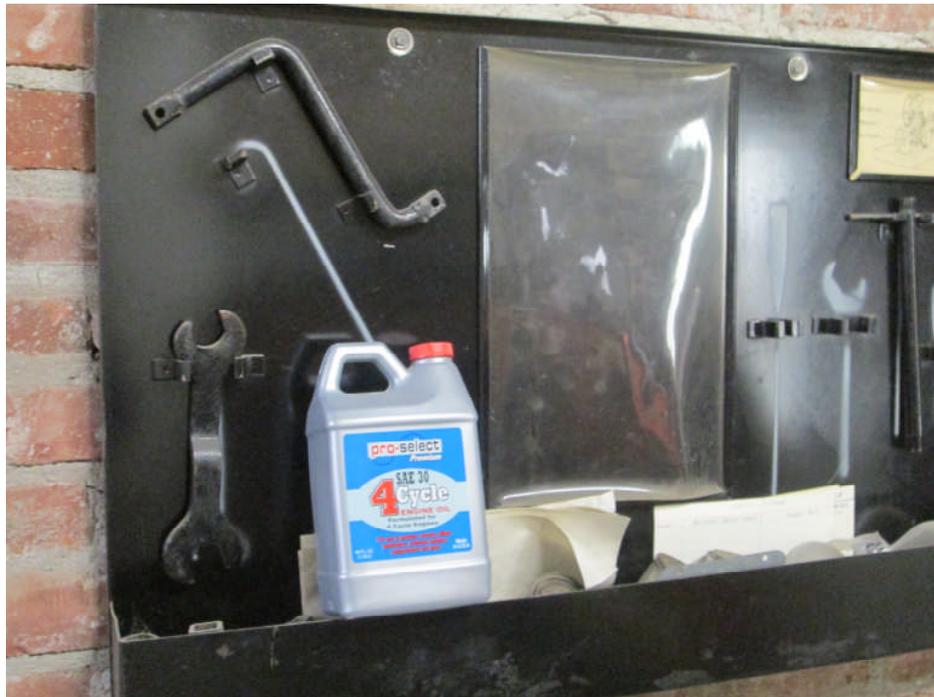
**PHOTO No. 4**

**Basement – Oil in Storage Area**

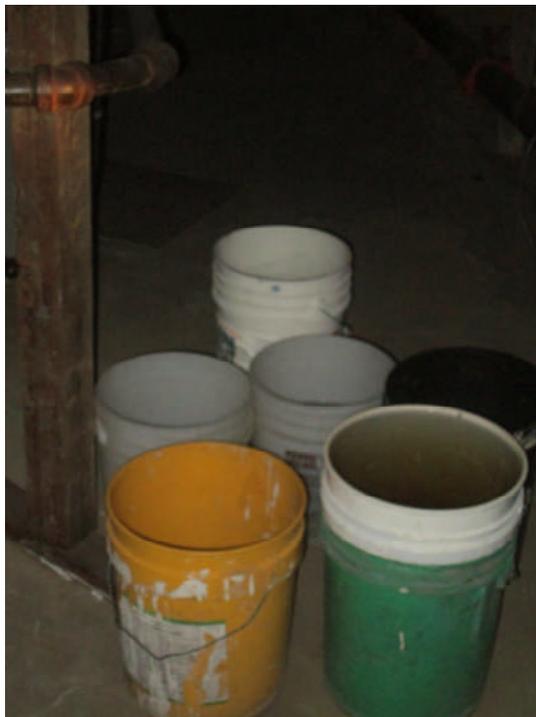
**PHOTO No. 26**

- Roof leaks are common and occur in buildings occupied by patients. Although mold and mildew were described as being an issue within the buildings at the OSH-SC, they were not described for the buildings at the Site;

Buckets in Attic to Contain Roof Leaks

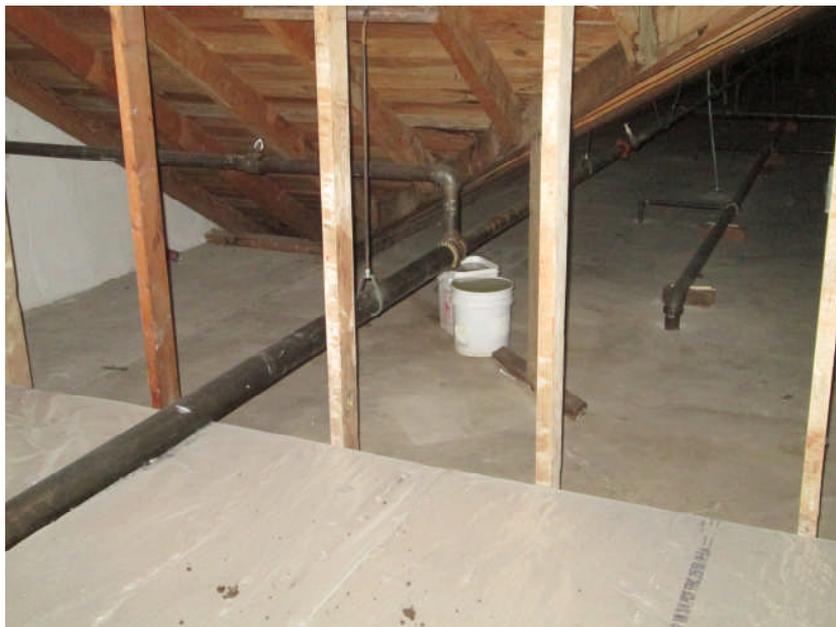
**PHOTO No. 30**

**Buckets in Attic to Contain Leaks**

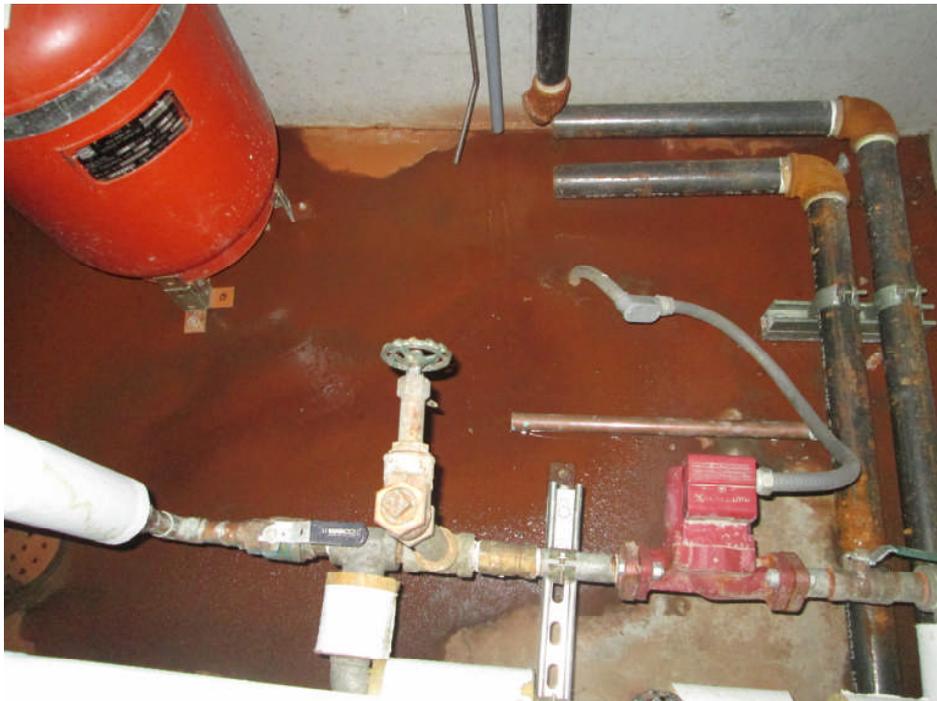
**PHOTO No. 46**

Basement – Mechanical Room, Staining Etc. on Floor
