State of Oregon  
Department of  
Environmental  
Quality

DEQ Solid Waste Program

**LANDFILL INSPECTION CHECKLIST**

<b>FACILITY:</b>	Riverbend Landfill		
<b>COUNTY:</b>	Yamhill	<b>PERMIT NO:</b>	345
<b>INSPECTOR(S):</b>	Bob Schwarz	<b>INSPECTION DATE:</b>	August 10, 2016
	<b>Start time:</b>	9 am	<b>End time:</b> Noon
<b>Site Weather Conditions:</b> partly sunny, 70s F			
<b>Facility Representatives:</b>	Jim Chabot, Jeff O'Leary, Nick Godfrey		
<b>Inspection type:</b>	Announced		
<b>Facility Type:</b>	MSW Landfill		
<b><u>INSPECTION SUMMARY:</u></b>			
<b>Inspection summary:</b>			
<p><b>Leachate seep.</b> Leachate seeps have been observed at three locations along the west and south sides. To address this prior to the fall rains, WM has constructed French drains in the soil cover in this area, to promote downward migration of this liquid. One of these drains is not draining quickly, so WM has installed a sump from which the liquid is piped to one of the main leachate sump riser pipes.</p>			
<p><b>Birds.</b> The number of birds has increased from what was observed during the previous site inspection, conducted on May 18, 2016. The birds observed are primarily starlings. Gulls wer

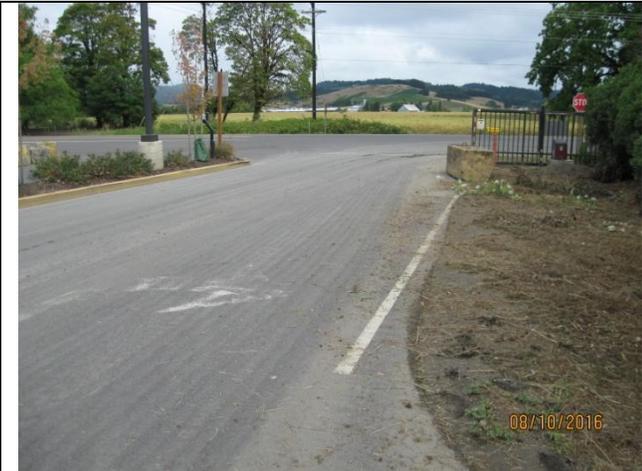
View of access road leading to Highway 18 (debris on road is mainly cut grass; landscapers were working at the time).

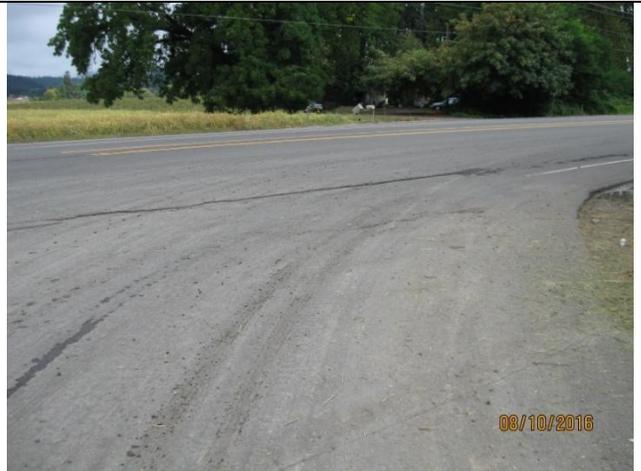
<p><b>Trackout.</b> Some mud was observed on the paved road within the facility, near the site entrance. Some mud was also observed on the Highway 18 acceleration lane heading north from the site. I did not observe a road sweeper operating onsite, or on the acceleration lane, and suggested that more frequent sweeping be done. WM staff noted that they are in the process of modifying the wheel wash facility that sits along the road leading down from the top of the landfill. It was not operating during my visit. They plan to lower the structure's two sediment tanks to allow more volume for settling of sediment. This will presumably increase the wheel wash's efficiency.</p>			
<p><b>Odors.</b> I did not notice odors from the landfill while driving around outside the property. Odors were also less within the property during my site inspection. Some odors were observed near the leachate pond.</p>

Merger of access road with Highway 18. Some dirt and stones were observed in addition to cut grass. Road sweepers were not operating during my site visit.

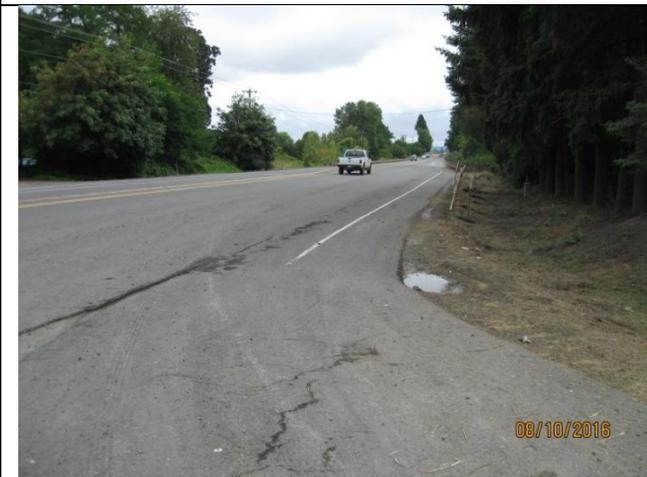
Highway 18, looking north from site access road. Some soil and stones were observed on acceleration lane.

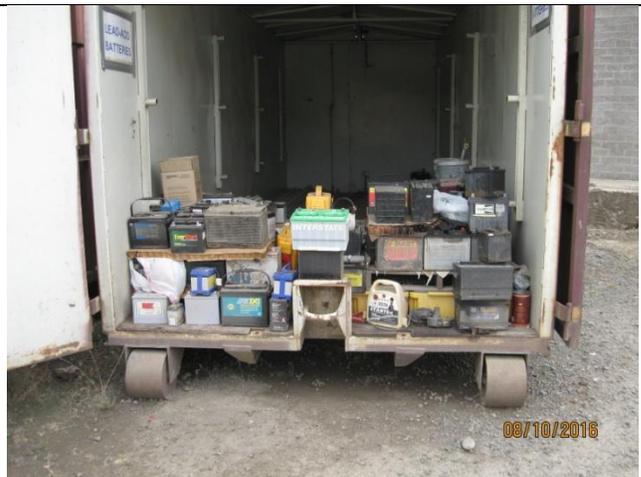
Trailer for recycled batteries

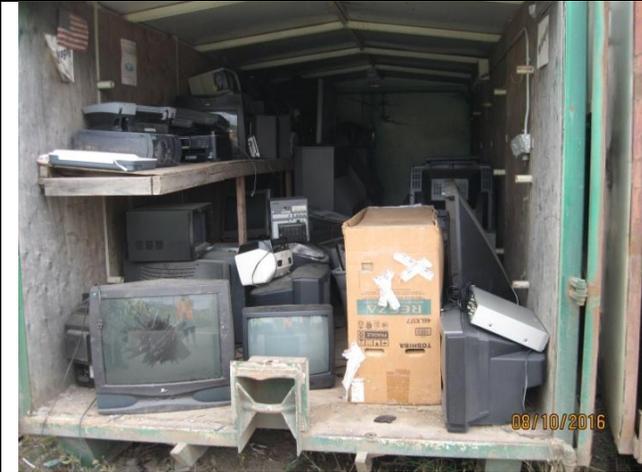
Trailer for recycling electronics.

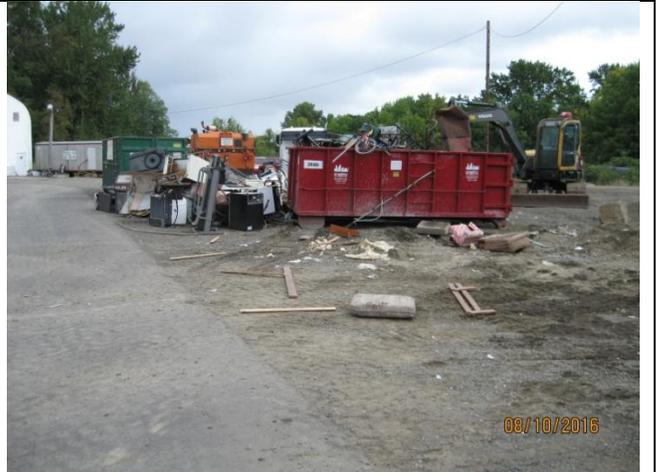
Recycled scrap metal. Site staff noted that recyclers do not always pick up material quickly enough to address the quantity of materials brought to the site. Debris was observed next to this trailer.

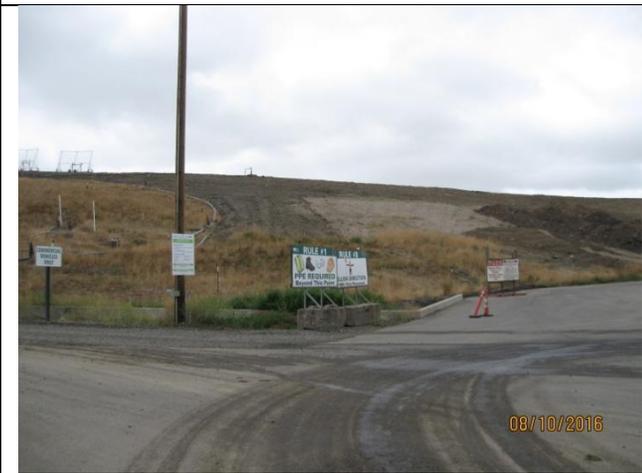
Northwest corner of landfill, where additional cover soil was recently placed.

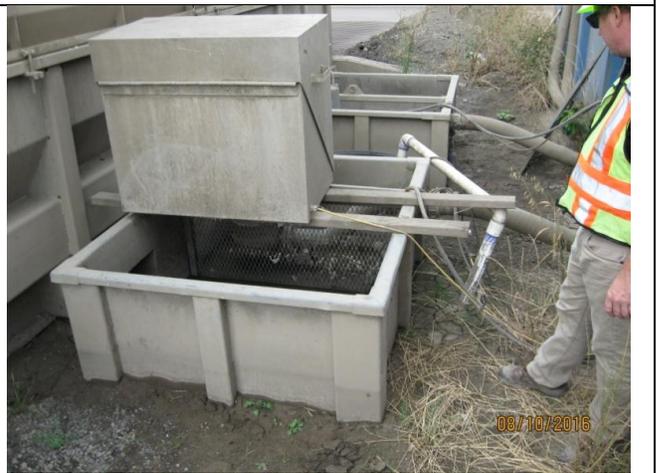
Sediment holding bins for storing sediment from wheel wash water. Waste Management plans to lower these tanks in the next few weeks to provide greater sediment storage volume, to improve the efficiency of the wheel wash.

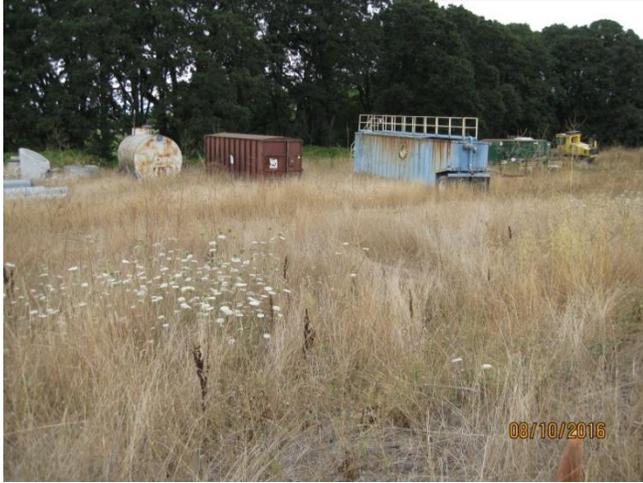
Surplus tanks, along north side of landfill. Waste Management plans to remove these from the site.

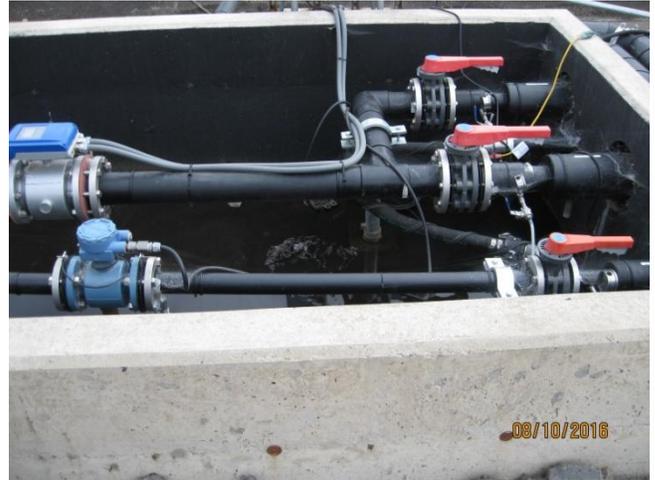
flexible hose was connected from the air pressure relief valve to the containment area, because leachate was escaping from this pipe. WM had said in May that this would be repaired. This has not yet been done. The leachate is contained within the concrete structure and piped from there to the leachate pond. However, relief valve should be repaired to address this issue.

Leachate control valves for Module 9 leachate management system. Small amounts of leachate in the air relief valve are directed to this concrete containment pad, and then piped to the leachate pond.

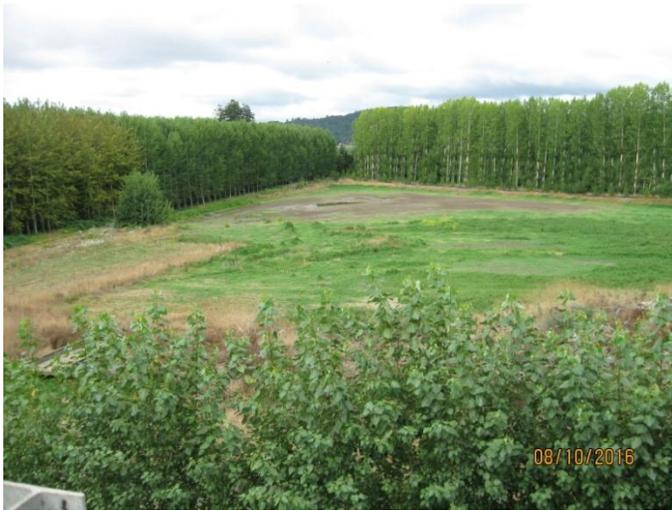
View of stormwater detention basin No. 2, in location of former north poplar field. Photo taken from top of MSE berm, looking west.
