State of Oregon  
Department of  
Environmental  
Quality

**LANDFILL INSPECTION CHECKLIST**

<b>FACILITY:</b>	Riverbend Landfill		
<b>COUNTY:</b>	Yamhill	<b>PERMIT NO:</b>	345
<b>INSPECTOR(S):</b>	Bob Schwarz	<b>INSPECTION DATE:</b>	Nov. 30, 2016
	<b>Start time:</b>	9:30 am	<b>End time:</b> Noon
<b>Site Weather Conditions:</b> rain, 40s F			
<b>Facility Representatives:</b>	Nick Godfrey		
<b>Inspection type:</b>	Unannounced		
<b>Facility Type:</b>	MSW Landfill		
<b><u>INSPECTION SUMMARY:</u></b>			
<b>Inspection summary:</b>			
<p><b>Leachate seeps.</b> Conditions were quite wet due to recent and ongoing heavy rains. Landfill staff have installed several gravel trenches at locations of leachate seeps to direct this liquid back into the landfill. These appear to be working effectively.</p>			
<p><b>Birds.</b> A significant number of birds (mostly gulls and starlings) were observed.</p>			
<p><b>Road conditions.</b> I did not observe significant mud on roads on the landfill property or on Highway 18. A road sweeper was working on site roads during my inspection. As noted in the photos below, the wheel wash is spraying muddy water. The landfill manager stated that this problem is cau

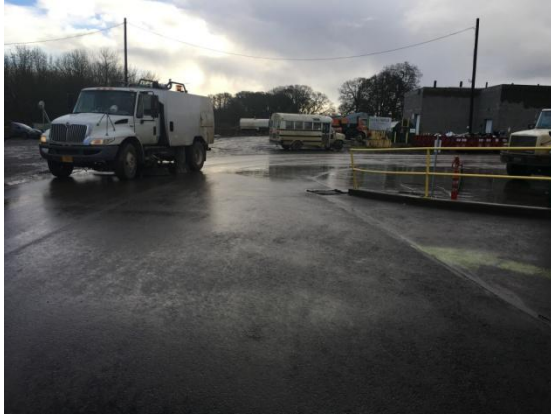
Photo showing onsite road conditions. No significant mud was observed on either onsite road or Hwy 18.

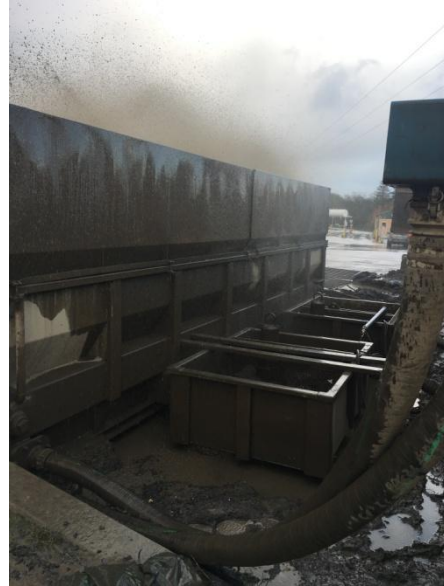
Muddy water at wheel wash. Landfill manager stated that this problem is caused by water/sediment reservoirs that are too small and pumps that are too powerful, and therefore stir up sediment in reservoirs. They are working on replacing this wheel wash. A date for replacement has not been determined.

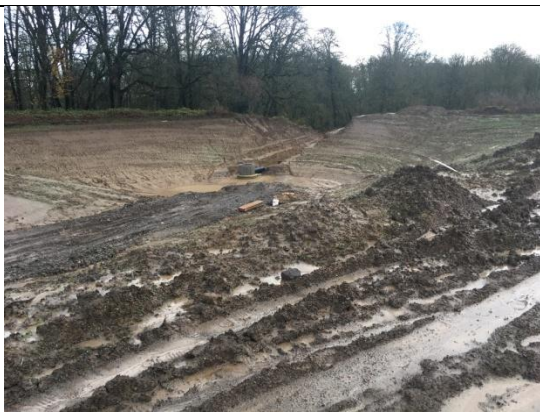
North stormwater pond under construction. Sediment fence was in good condition.

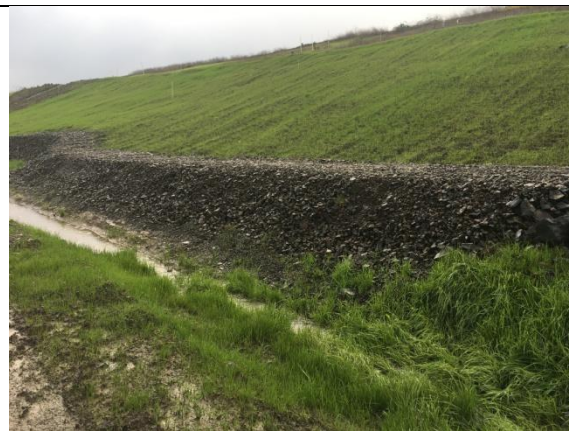
Repair area where outside of north berm had some soil sloughing. This area is in good condition.

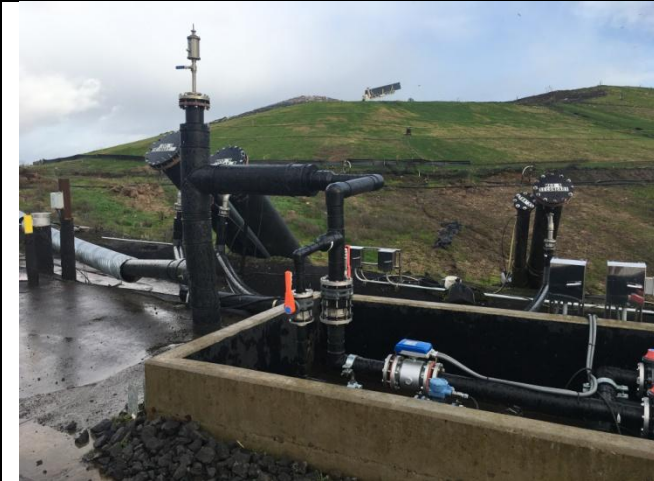
Concrete containment area for controls for Module 9 leachate management system. Previous inspection report noted hose running from the air relief valve (on vertical pipe) to the concrete containment area because leachate was getting into this air line. This problem has been corrected.

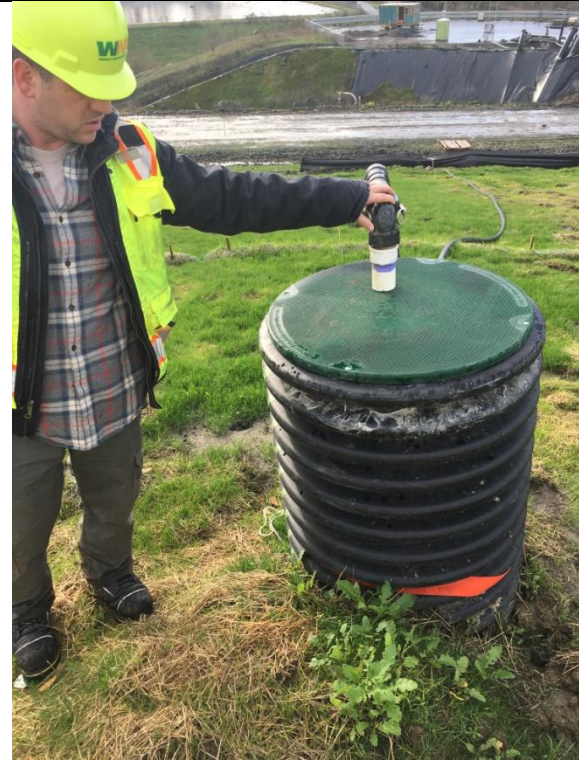
Access point for French drain, one of several installed on the sideslope to address leachate seeps.
