NPDES Industrial Stormwater Inspection Worksheet

Facility Information	
Name of Facility	Riverbend Landfill Co.
Address of Location	13469 SW Highway 18
	McMinnville, Yamhill County
Receiving Waterbody	unnamed

Site Information	
Industrial Activity	Operation of a solid waste landfill
SIC Code	4653
Secondary SIC Code	N/A
Facility Description	Riverbend Landfill Co. operates a municipal solid waste landfill.

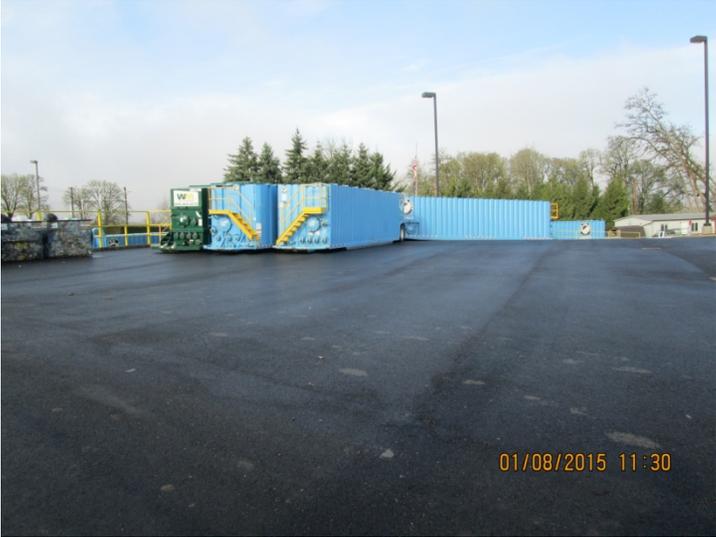
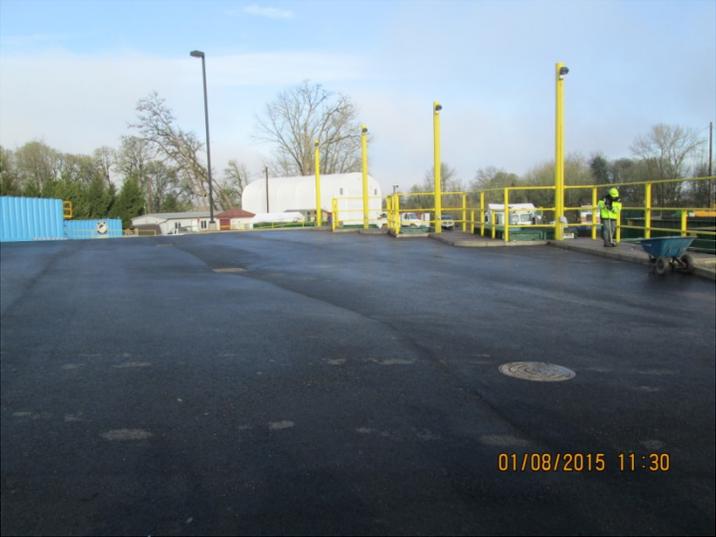
<p>Photo # 1 Description, location, comments: Residential waste and recycling drop off area.</p>		<p>Photo # 2 Description, location, comments: Residential waste and recycling drop off area.</p>

- Residential waste and recycling drop off area
- Outfall associated with new area, Outfall 1b
- Settling pond constructed at the entrance
- Detention pond/bioswale located near Outfall 2
- Where the active face of the landfill is located
- Landfill haul road
- Illustration on the Site Plan of how contaminated stormwater is being managed
- Description in the text of the SWPCP of how contaminated stormwater is being managed

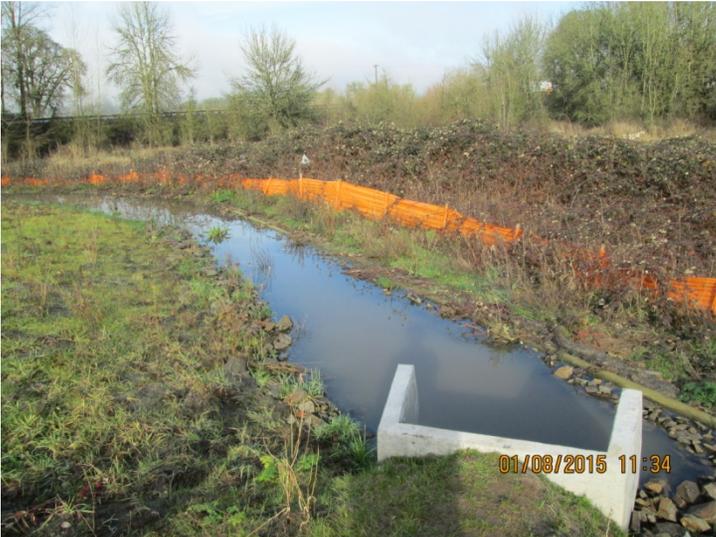
<p>Photo # 3 Description, location, comments: Outfall 1b, looking to the northwest. Outfall is the low point in the center of the photo.</p>		<p>Photo # 4 Description, location, comments: Settling basin, located just upstream from Outfall 1b.</p>

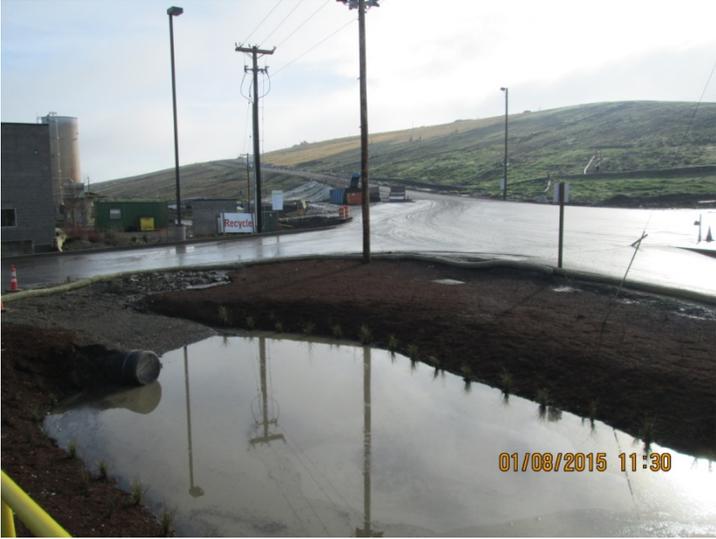
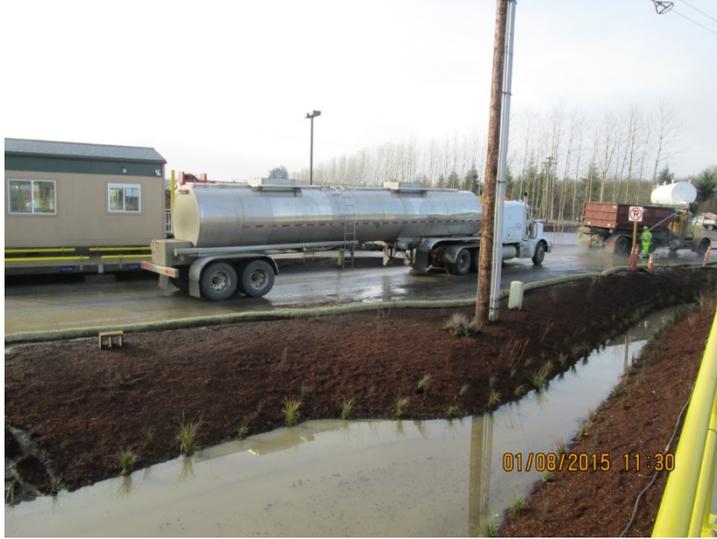
<p>Photo # 5 Description, location, comments: Settling basin near entrance (north side of entrance road). Discharge point is capped at this time.</p>		<p>Photo # 6 Description, location, comments: Settling basin shown in Photo 5.</p>

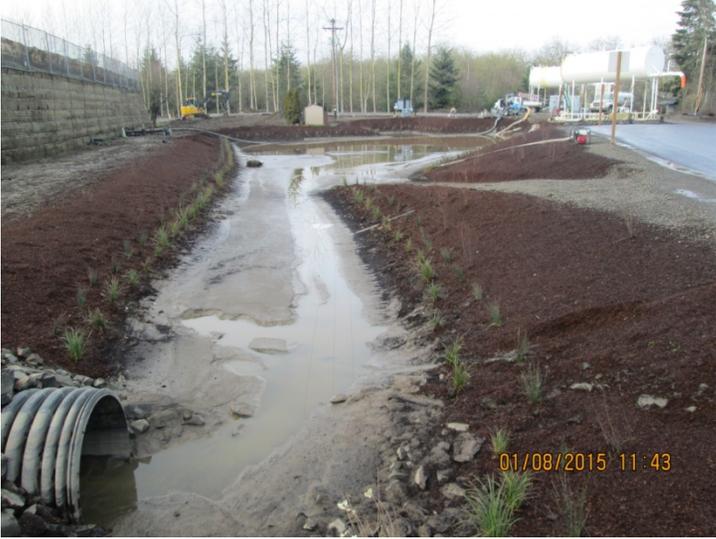
<p>Photo # 7 Description, location, comments: Settling basin near entrance (south side of entrance road). Discharge point is capped at this time.</p>		<p>Photo # 8 Description, location, comments: Just east of settling basin in Photo 7, looking towards haul road.</p>

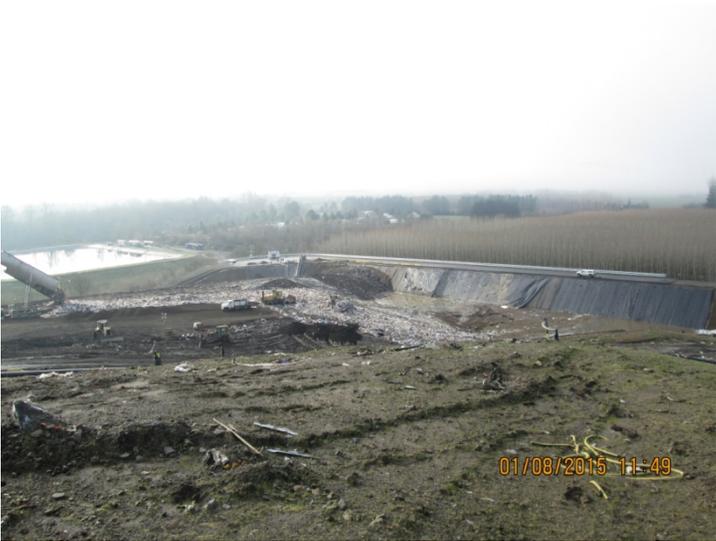
Photo #	9		Description, location, comments: Active face of landfill, looking southwest.		
Photo #	10		Description, location, comments: Poplar farm that was recently harvested, looking west.

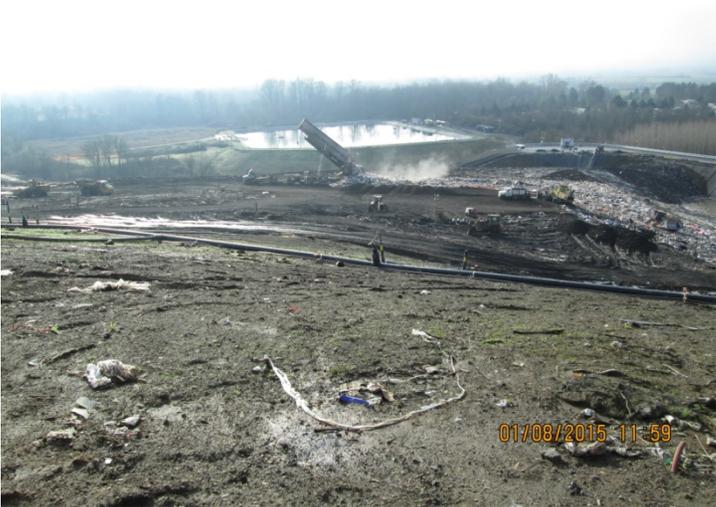
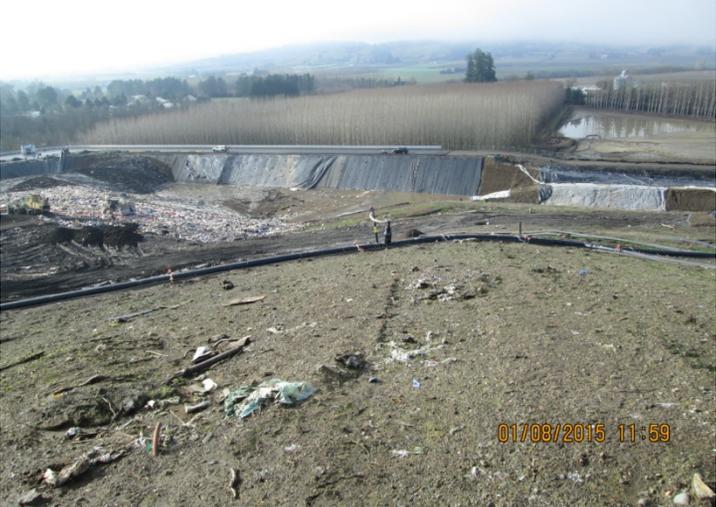
Photo #	11		Description, location, comments: Active face of landfill, looking south.		
Photo #	12		Description, location, comments: Active face of landfill, looking west.

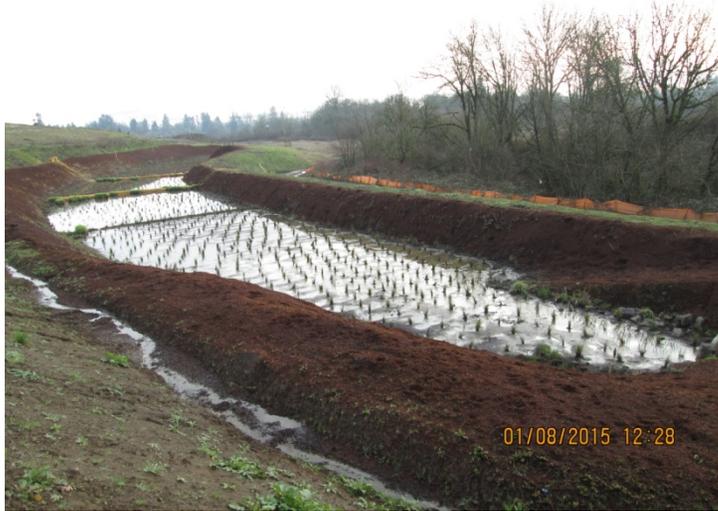
Photo # 13
Description, location, comments: Detention pond/bioswale before Outfall 2.

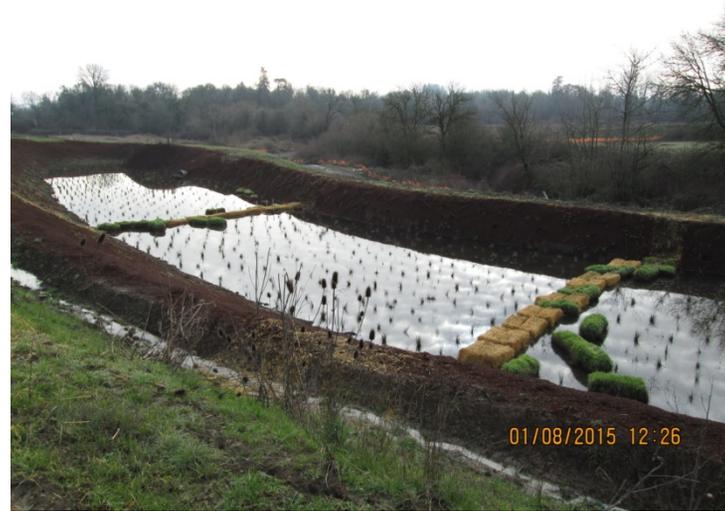
Photo # 14
Description, location, comments: Detention pond/bioswale before Outfall 2.

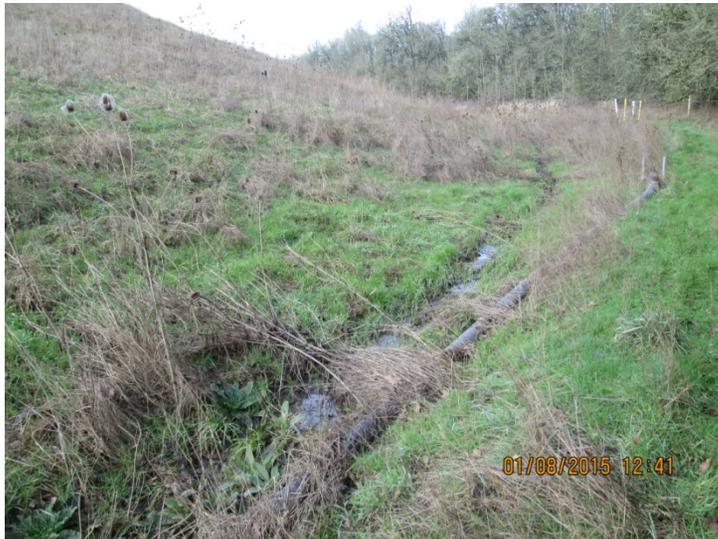
Photo # 15
Description, location, comments: Vegetated area just before pipe discharge at Outfall 4.

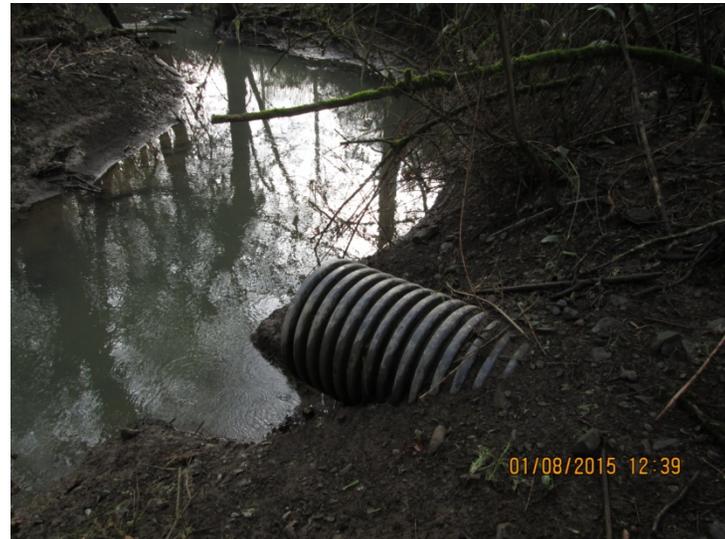
Stormwater Runoff		
Was stormwater discharging from the site?	Yes <input checked="" type="checkbox"/> No <input type="checkbox"/> N/A <input type="checkbox"/>	Outfall 4 was discharging.
Do the stormwater outfalls on site correspond with those listed in the SWPCP	Yes <input checked="" type="checkbox"/> No <input type="checkbox"/> N/A <input type="checkbox"/>

Photo # 16
Description, location, comments: Outfall 4 into unnamed creek.
