State of Oregon
Department of
Environmental
Quality

Subject: Investigation of Riverbend Landfill leachate spill of Feb. 9-10, 2014

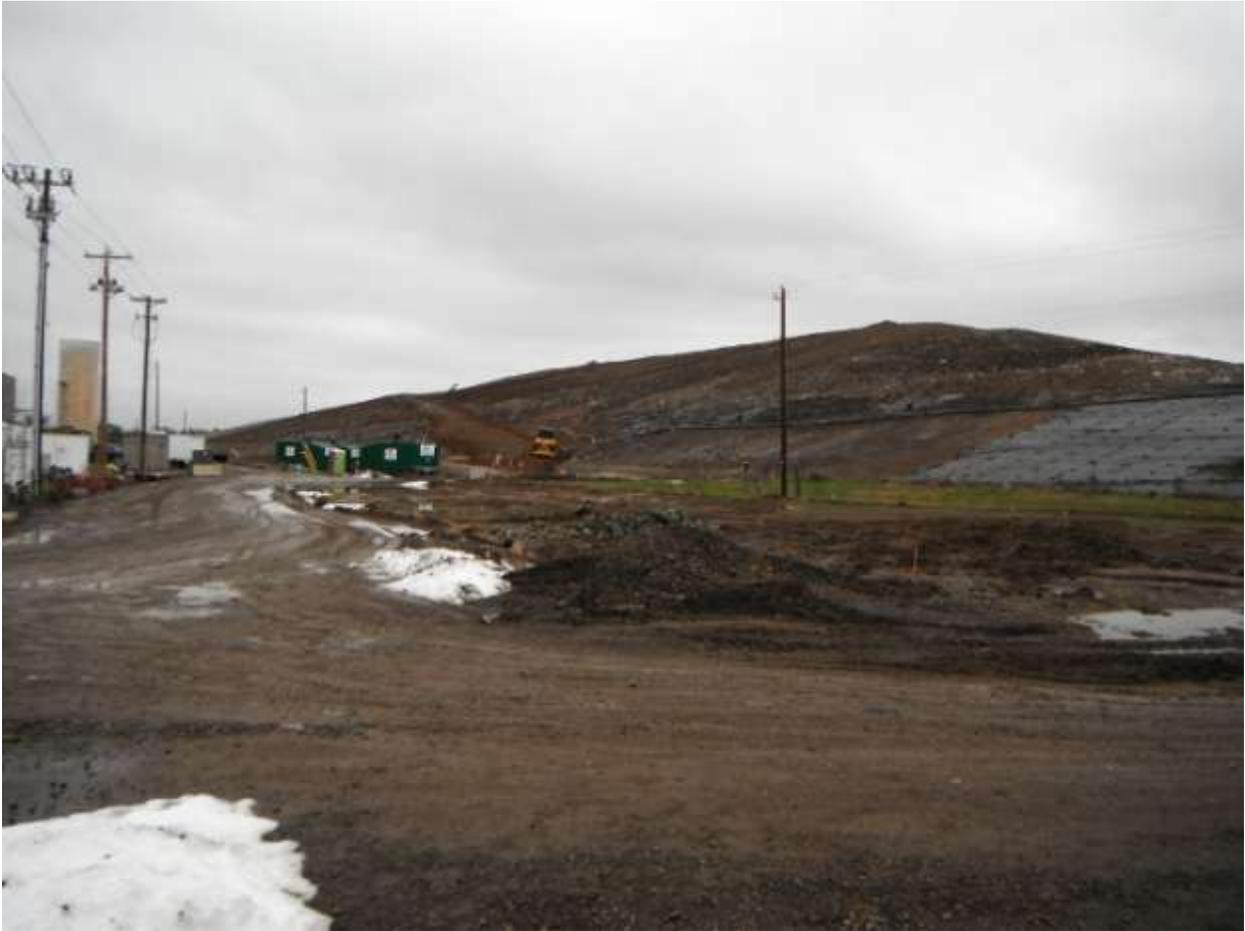
Photo # 1: View of Module 8 looking southeast from the administrative office area. Spill occurred near the green leachate storage tanks in the distance. Plastic tarps have been removed from this area in the last year to allow for construction of the north access road and relocation of waste to accommodate design slopes associated with the MSE berm.

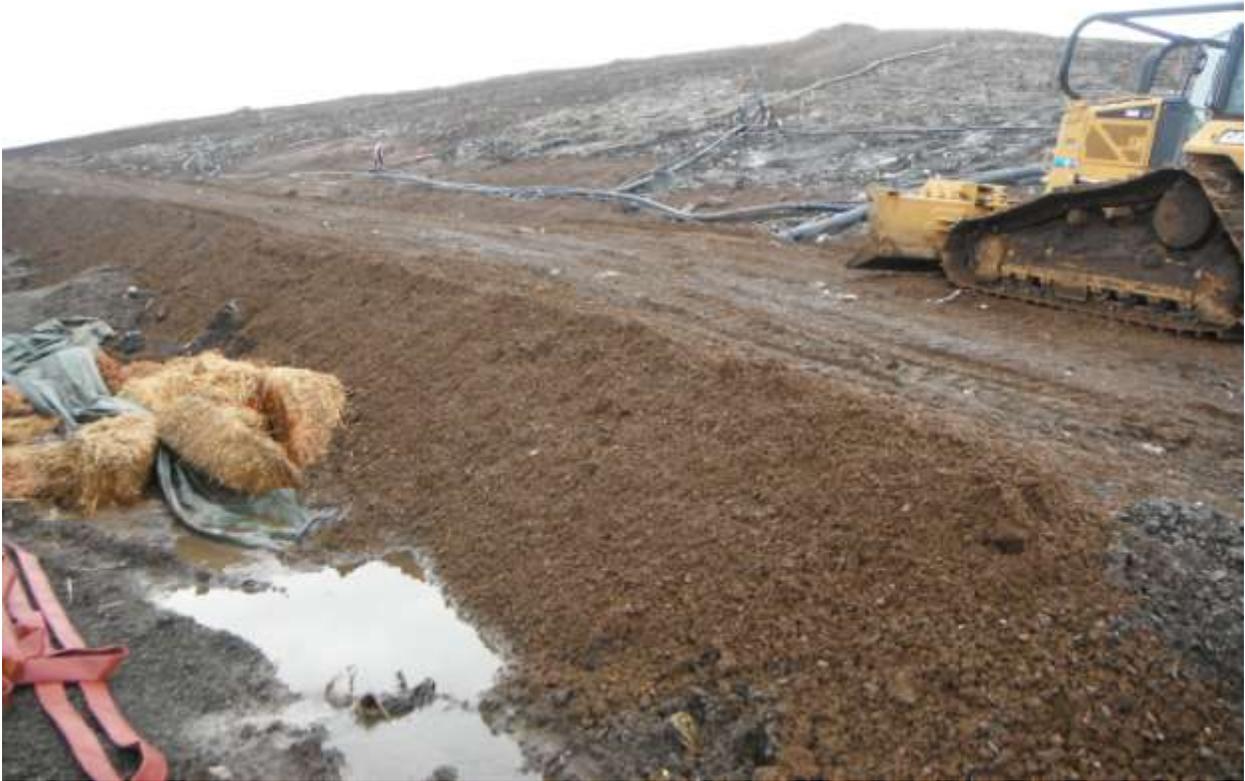
Photo #2: Construction of new access road through part of Module 8, located directly up-slope of the leachate seep area.

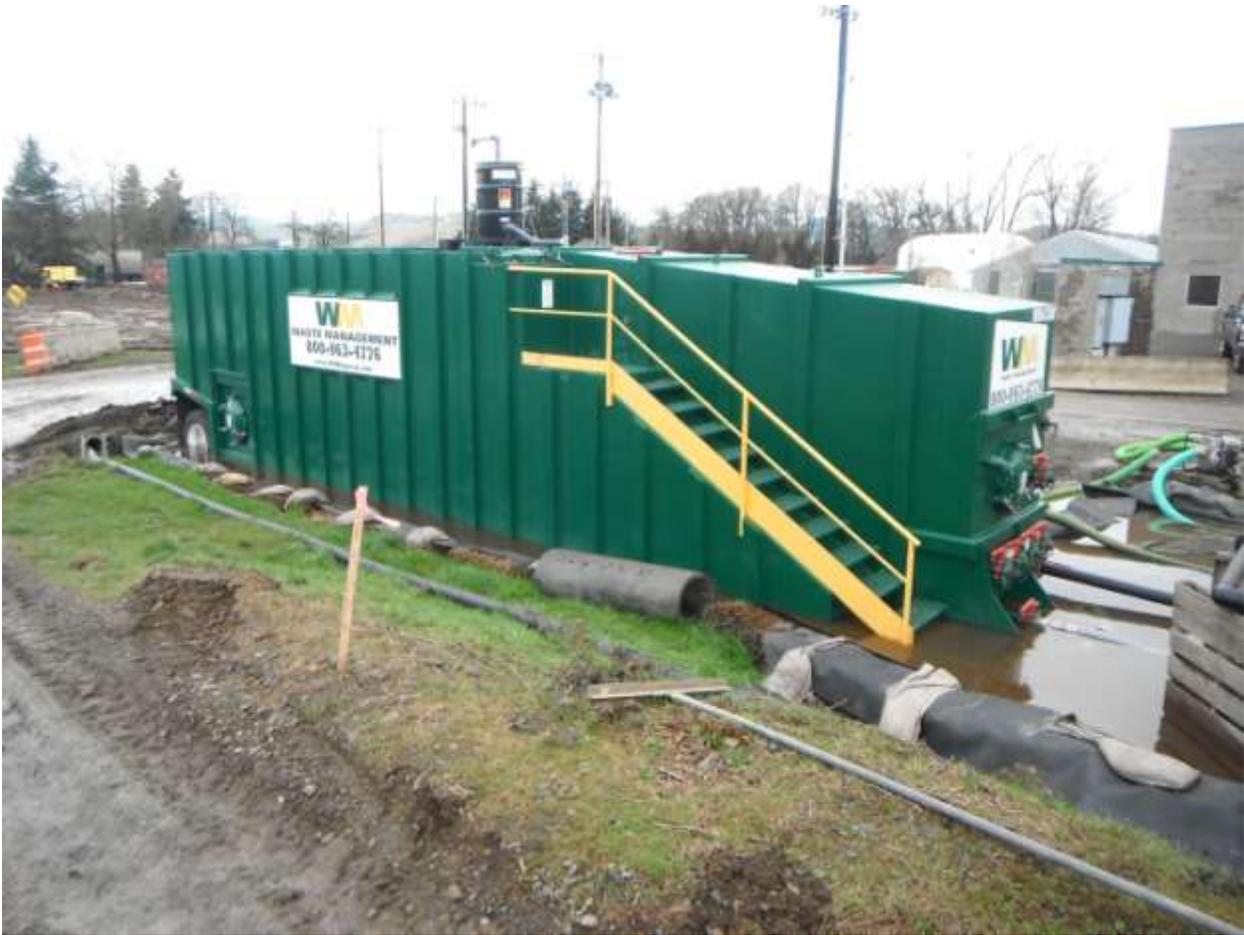
Photo # 3: Leachate holding tank (one of three 21,000 gallon tanks)

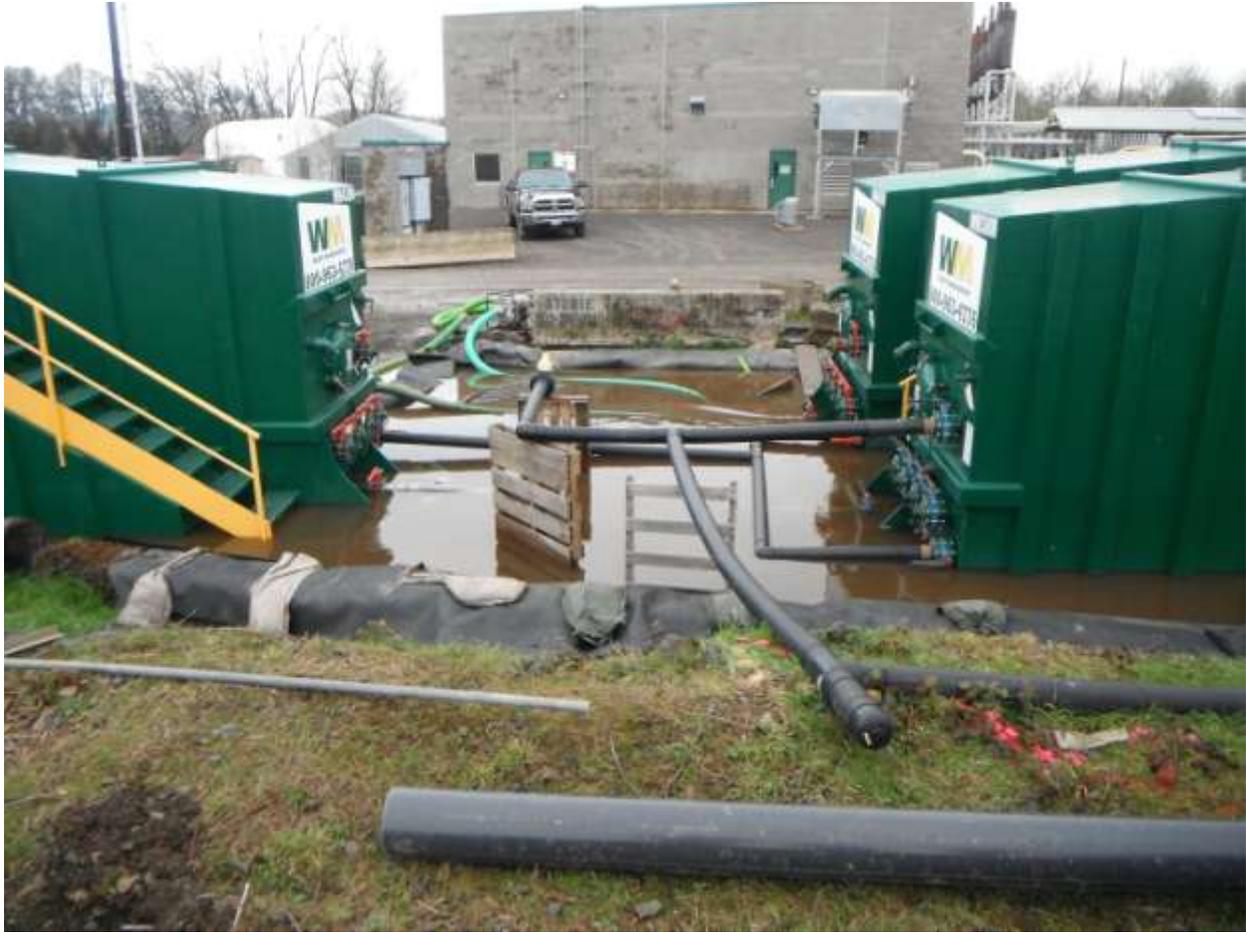
Photo # 4: Three leachate holding tanks with combined capacity of 63,000 gallons.

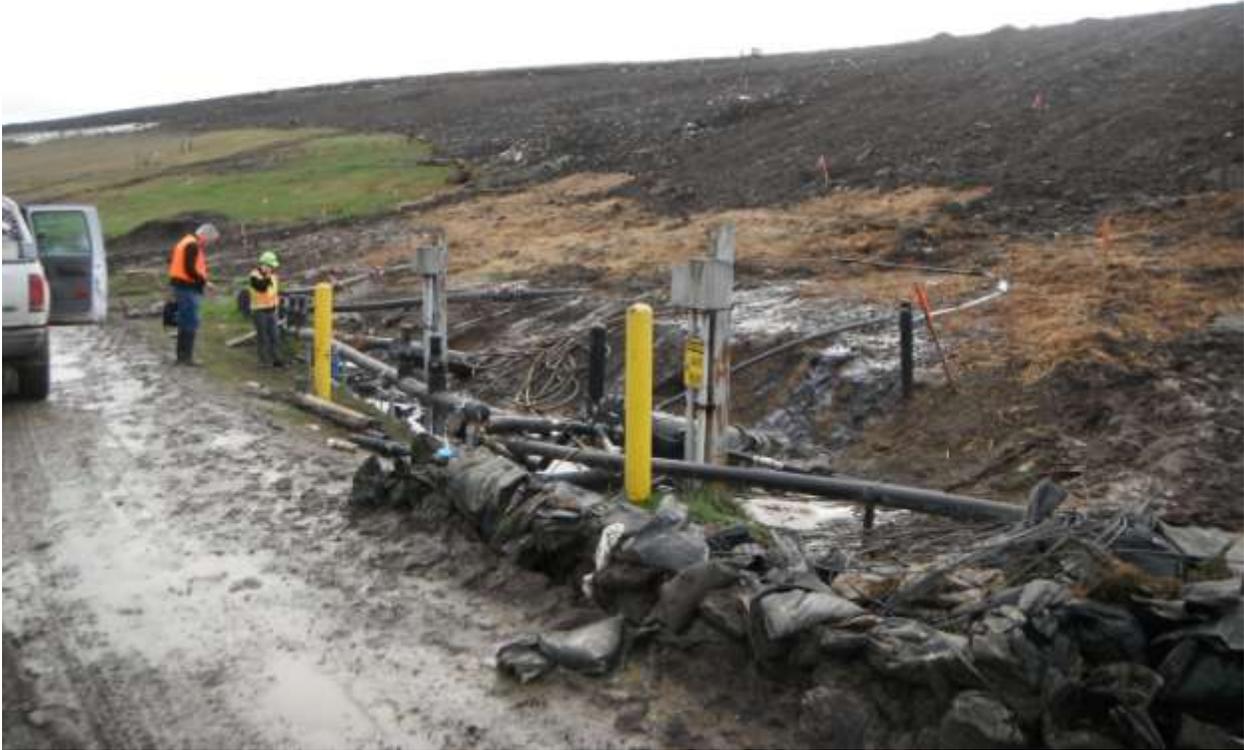
At the time of DEQ's site visit leachate seeps in the spill source area had an estimated flow rate of about 5 gallons per minute. Leading up to and during the spill the seep flow rate may have been higher because the gas well pump-out system had been turned off in response to the adverse weather and road conditions. WM restored the operation of the leachate pump-out system on Monday, February 10th. Attached Photos # 3 and 4 show the leachate holding tanks; Photos # 5, 6, and 7 show the leachate seepage area, the source of the leachate spill. The leachate seep area and ponded leachate were anaerobic and extremely odorous.

Photo # 5: Module 8 leachate seep area (to the right of the yellow bollards) – source of the leachate spill.

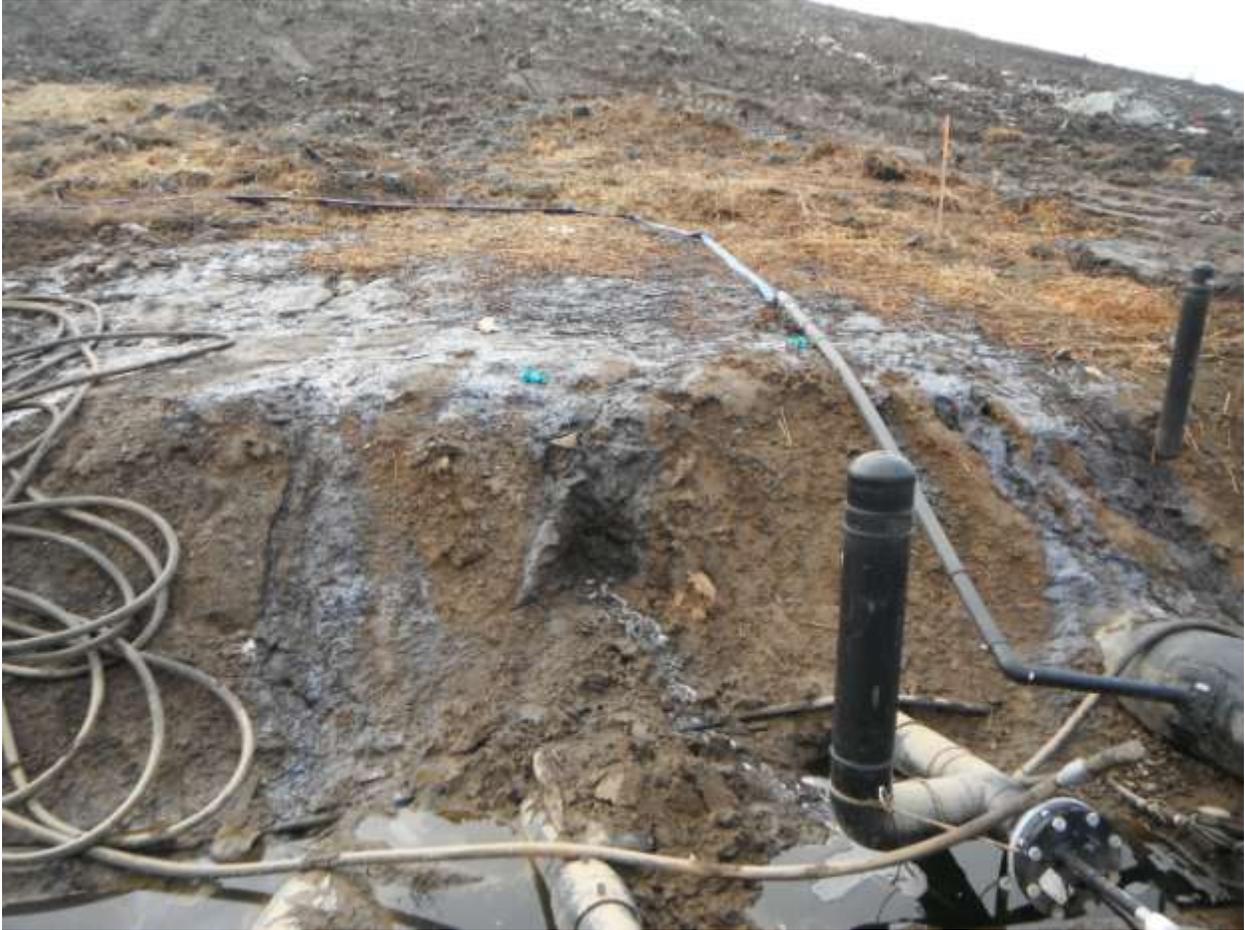
Photo # 6: Leachate seeps and ponded leachate – source of the leachate spill.

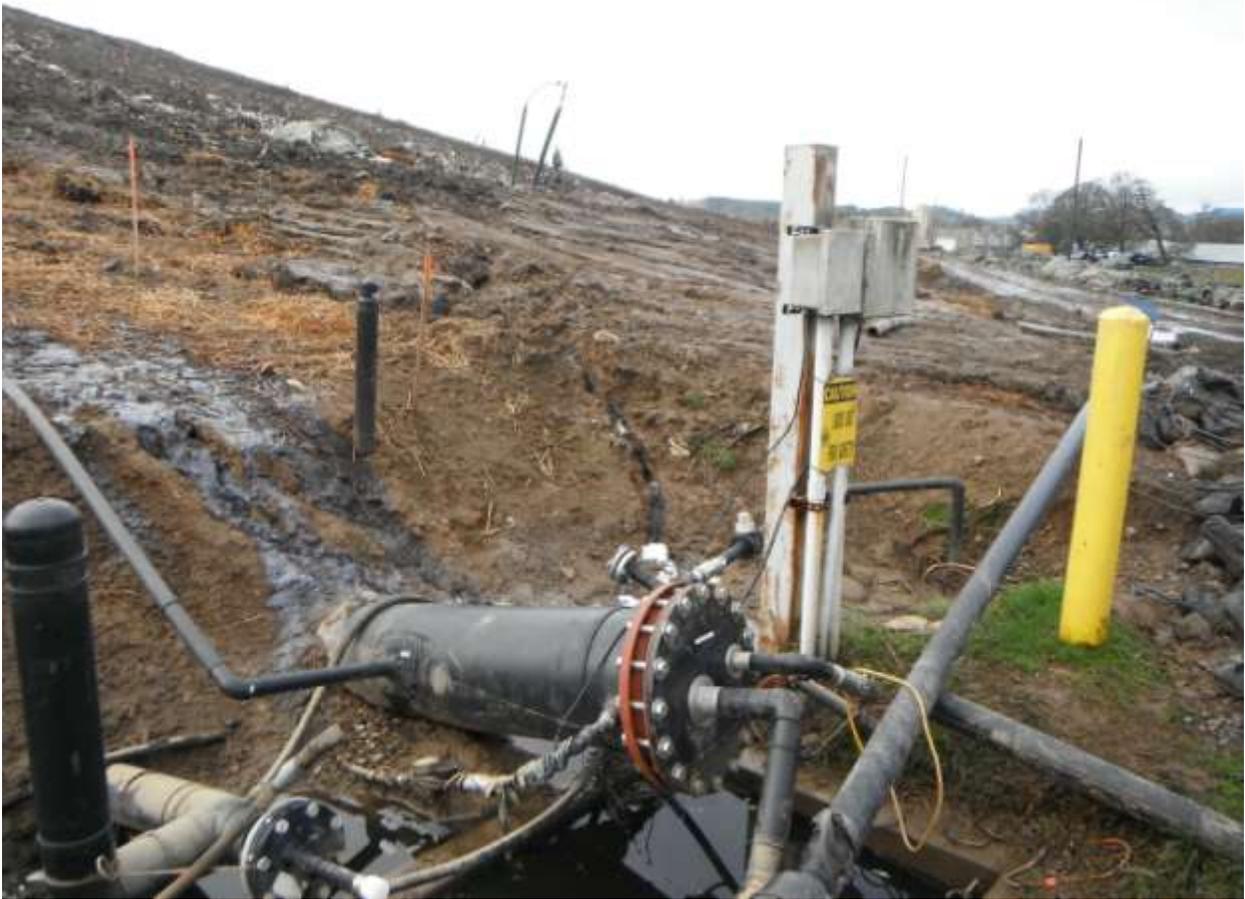
Photo # 7: Leachate seeps around Module 8 sloped riser for main leachate collection system. Ponded leachate in the foreground.

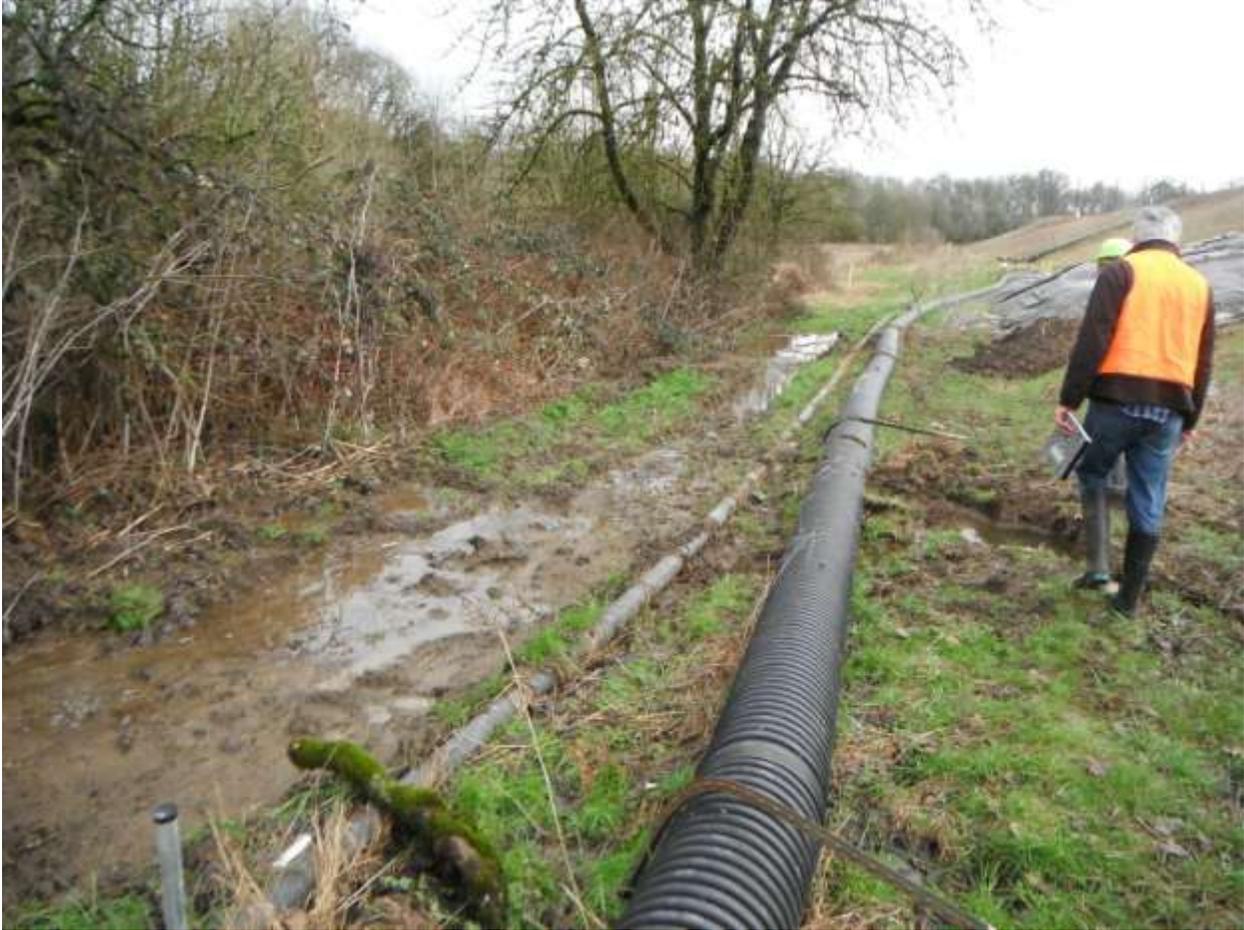
Photo # 8: Toe of Module 8 landfill berm where spill occurred

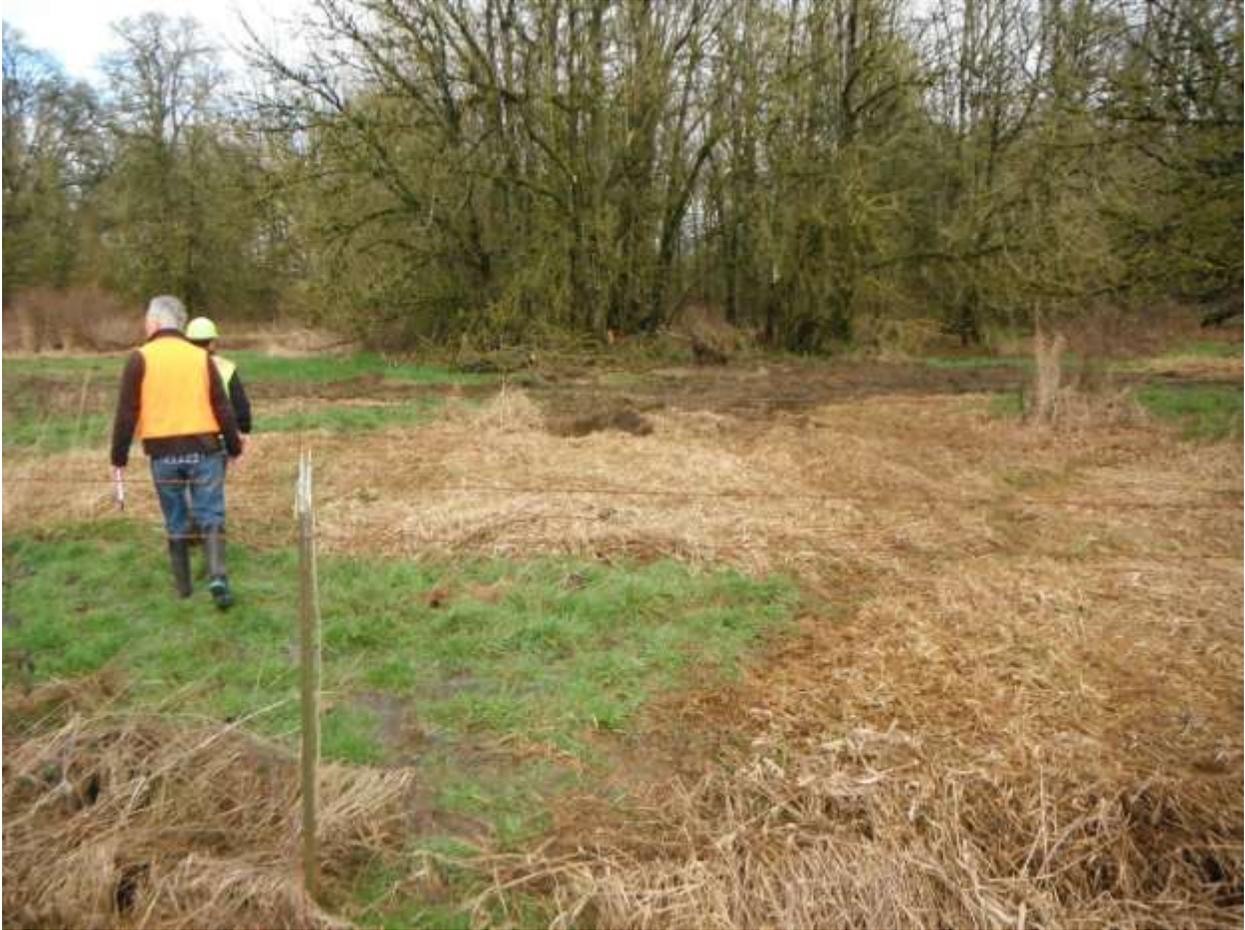
Photo # 9: Heading north-northeast along the leachate spill flow path (the natural drainage route) toward McPhillips Creek.

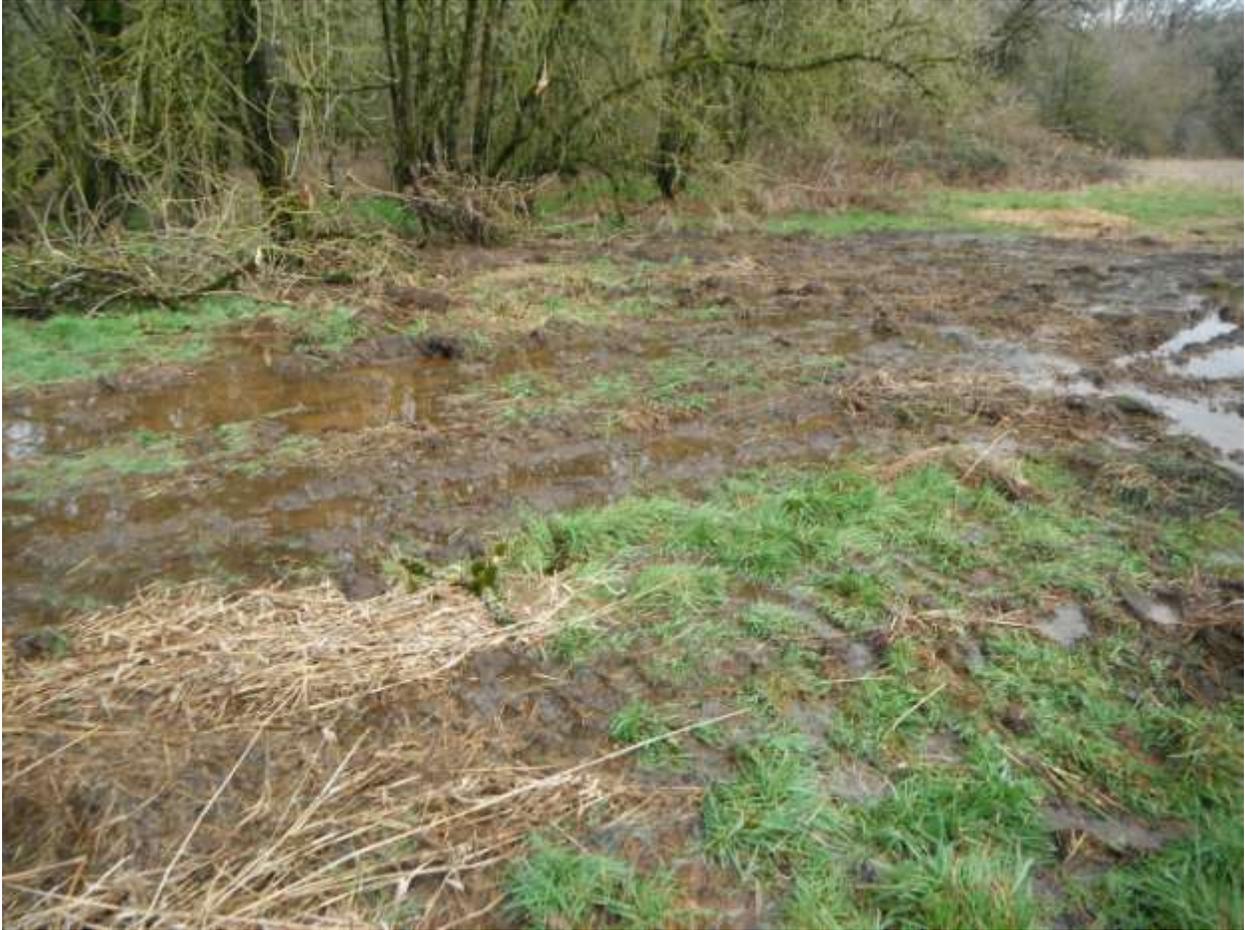
Photo # 10: Wet area along spill flow path, approximately 200 feet northeast of the landfill perimeter. No visible signs of leachate noted in this area.

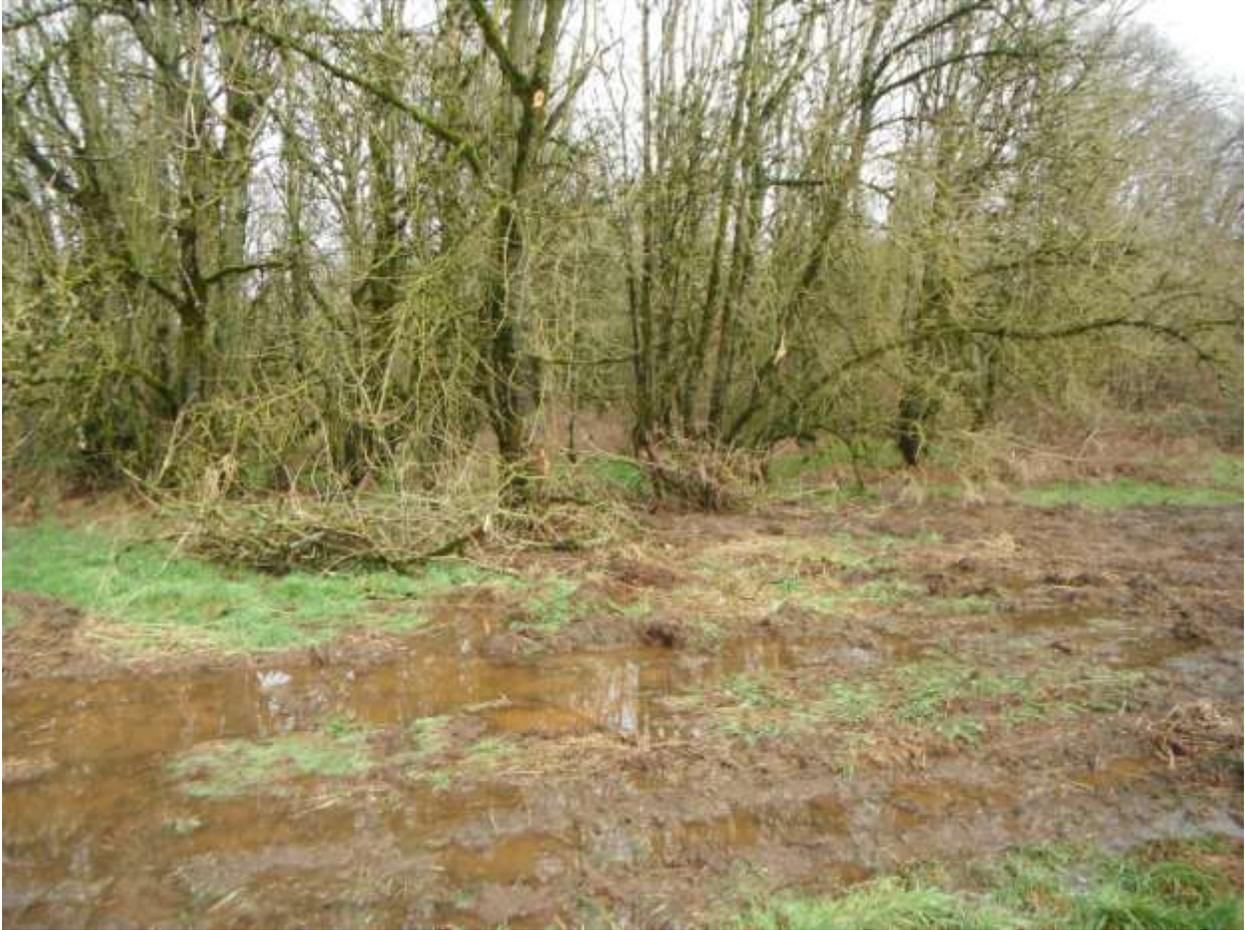
Photo # 11: Additional view of standing water approximately 200-feet north-northeast of the landfill.

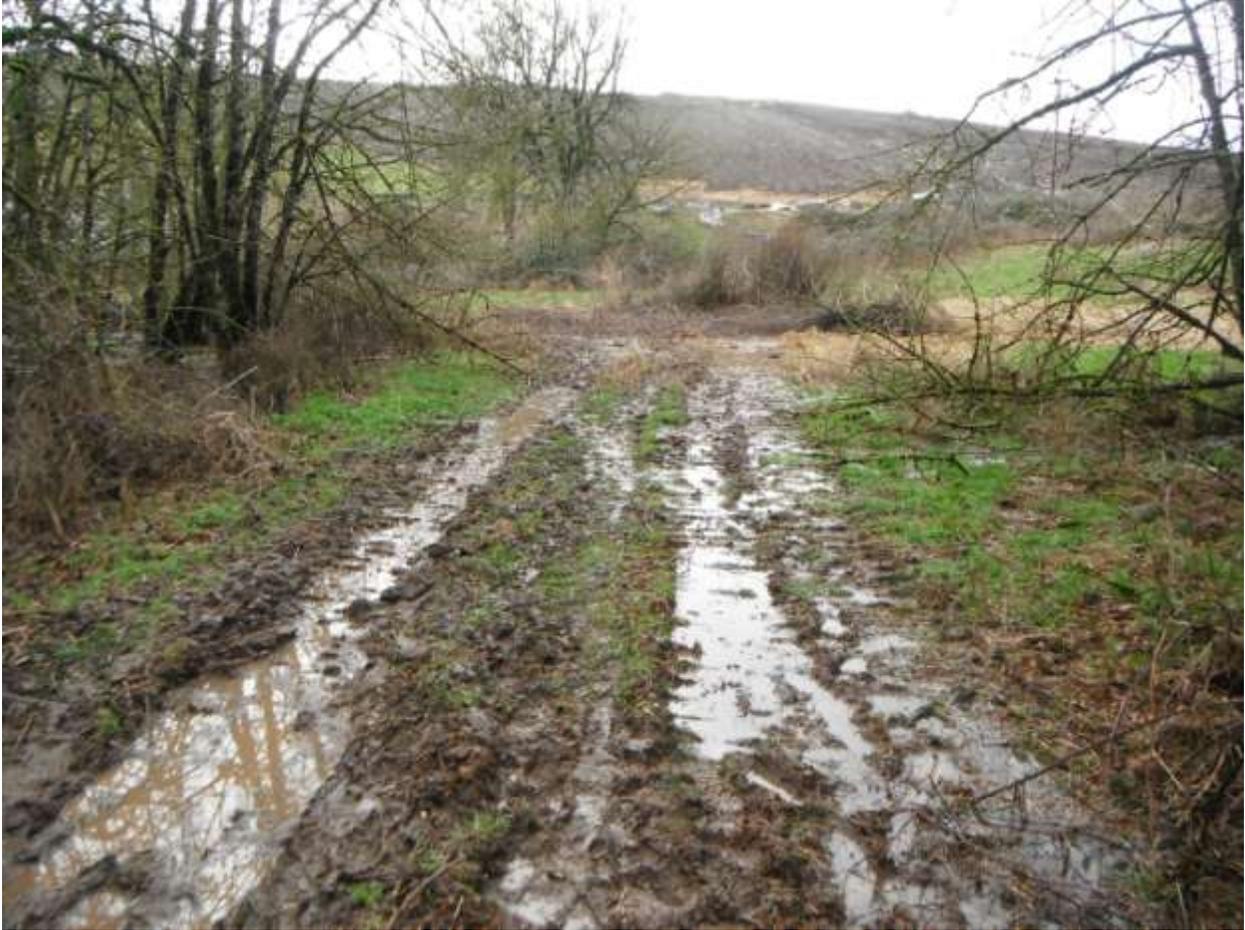
Photo # 12: View of landfill looking southwest and standing water along the spill flow path.

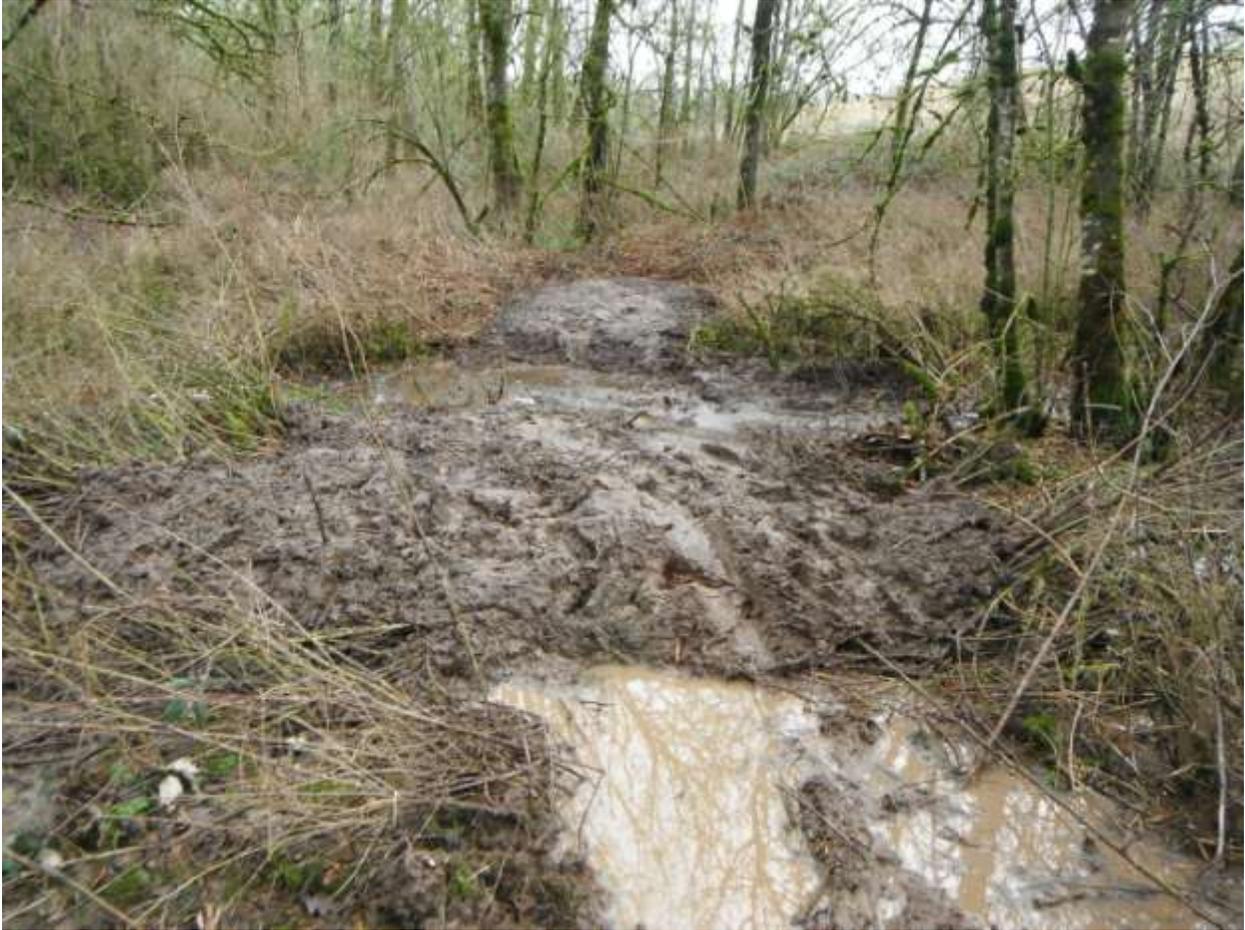
Photo # 13: Bermed sump area constructed by WM to contain and collect leachate upstream of McPhillips Creek. Muddy water present but no visible or olfactory evidence of leachate noted.

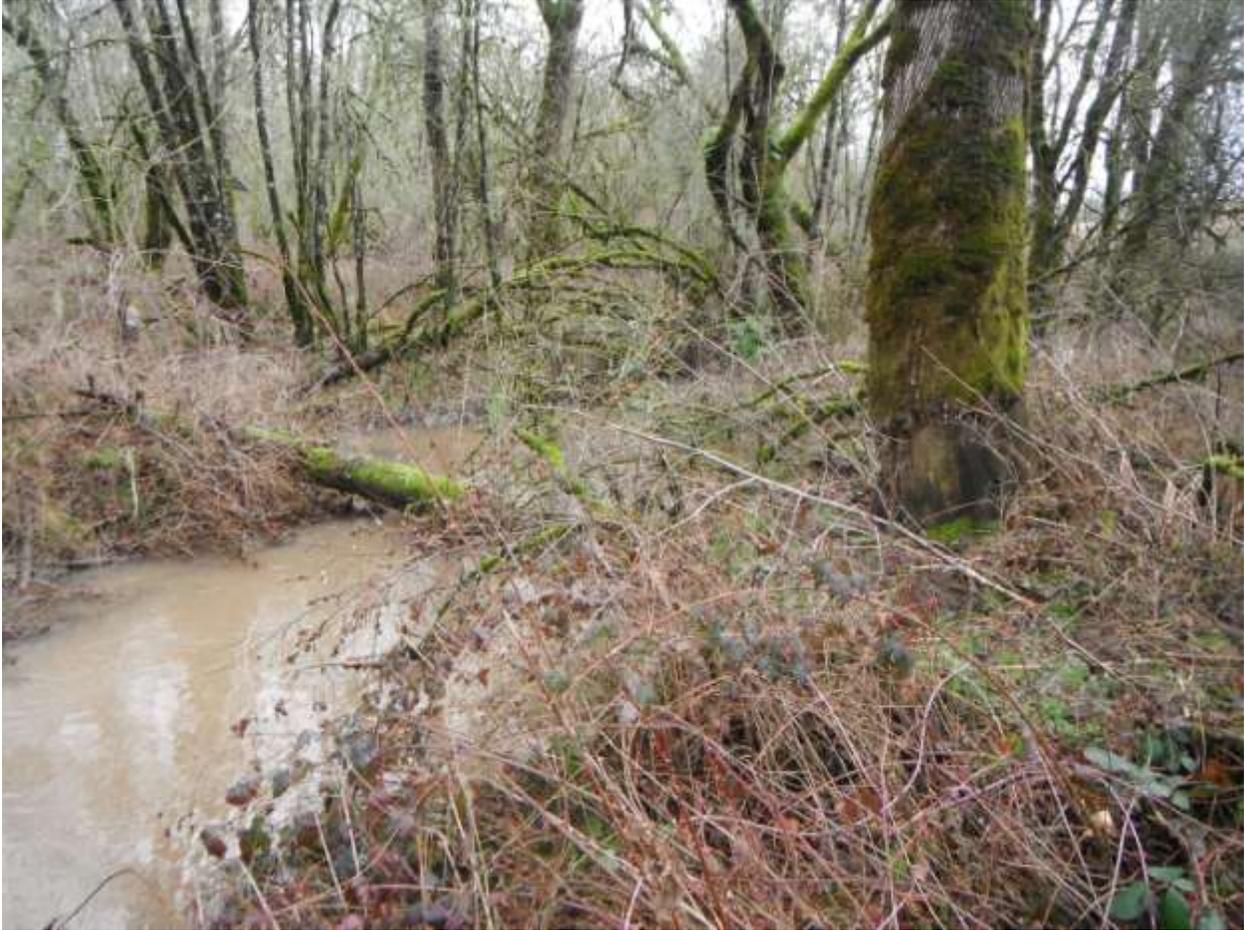
Photo # 14: McPhillips Creek at Leachate discharge location.

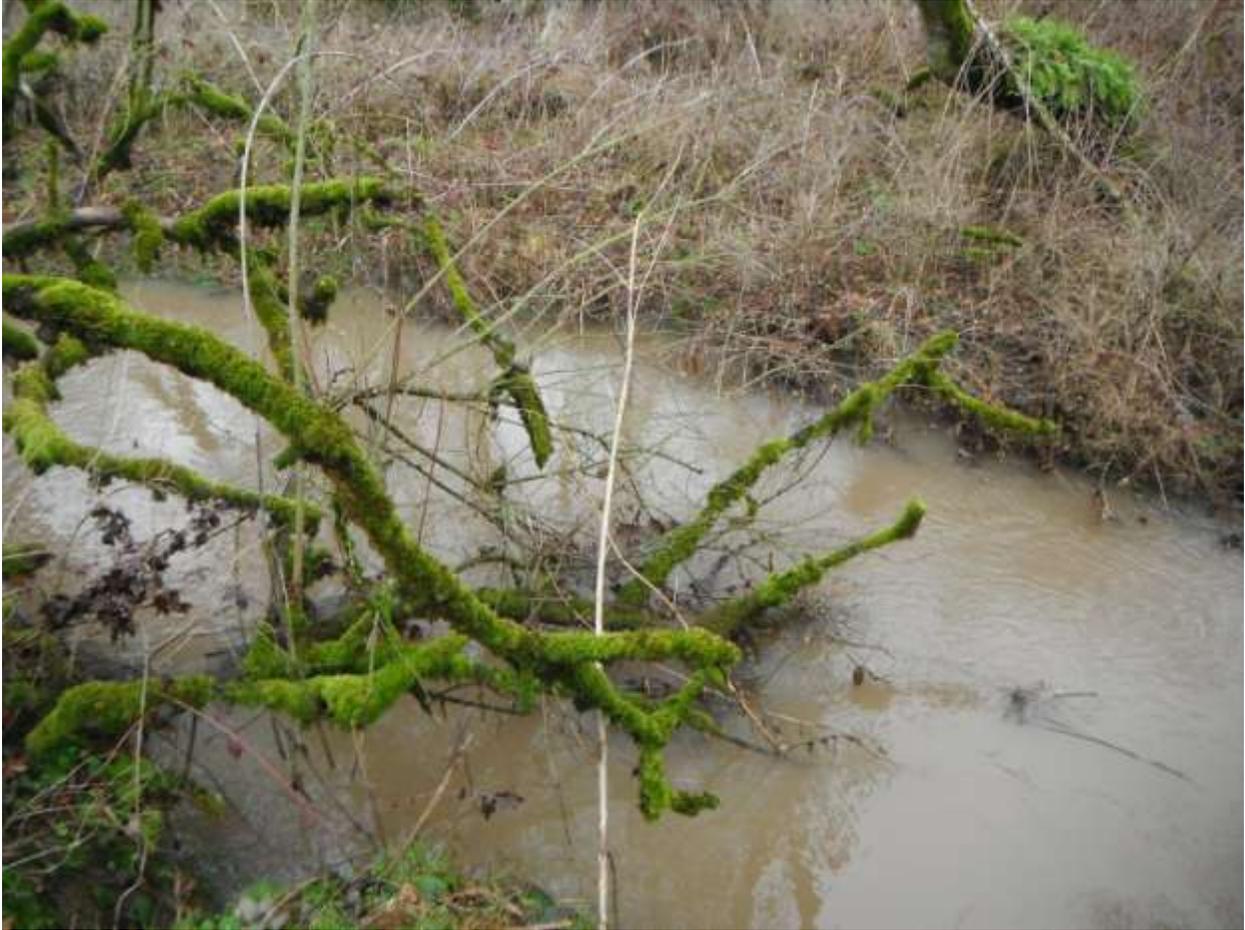
Photo # 15: McPhillips Creek, just downstream of leachate discharge point.

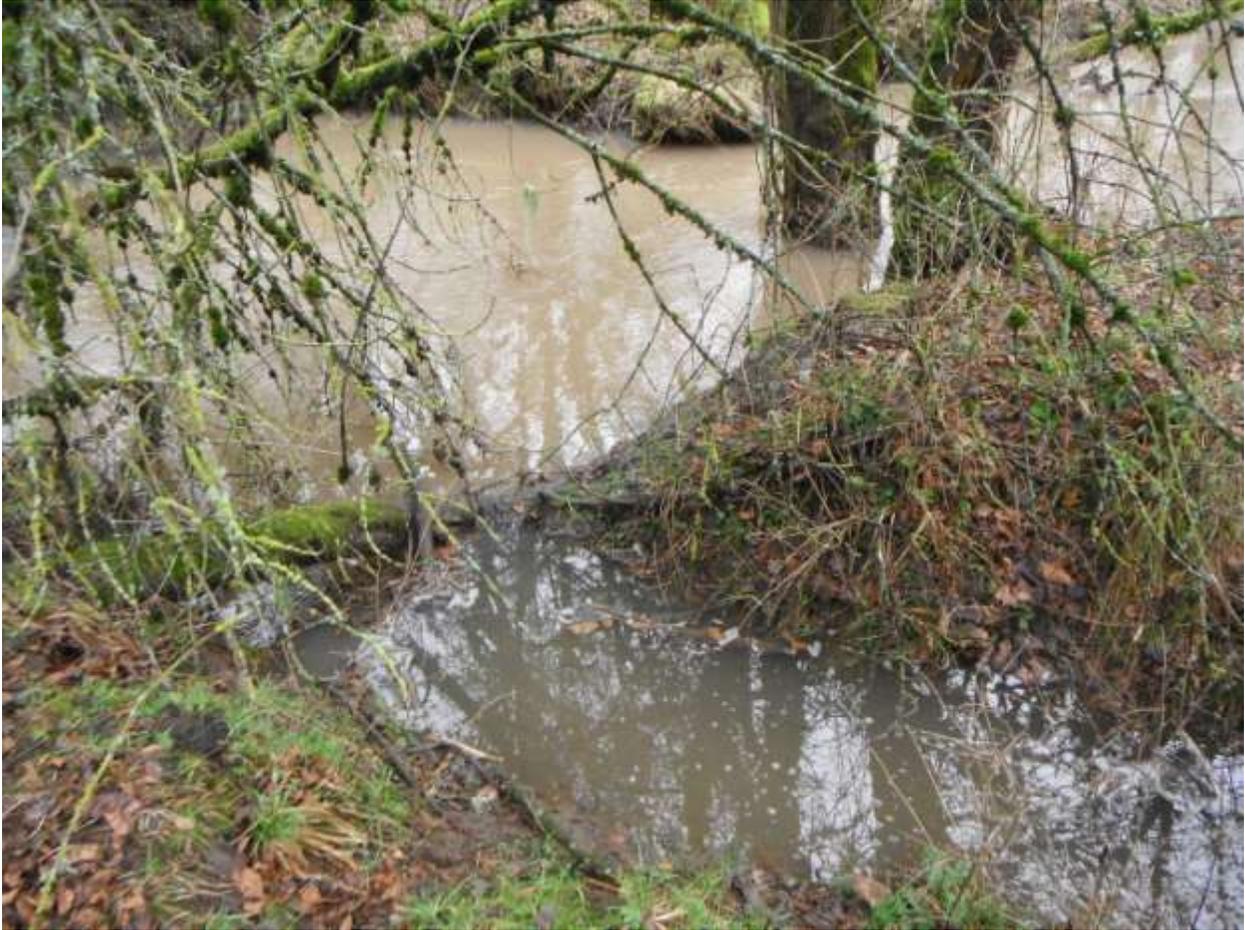
Photo # 16: McPhillips Creek, Leachate discharge location. The smaller channel in the foreground was the spill flowpath.

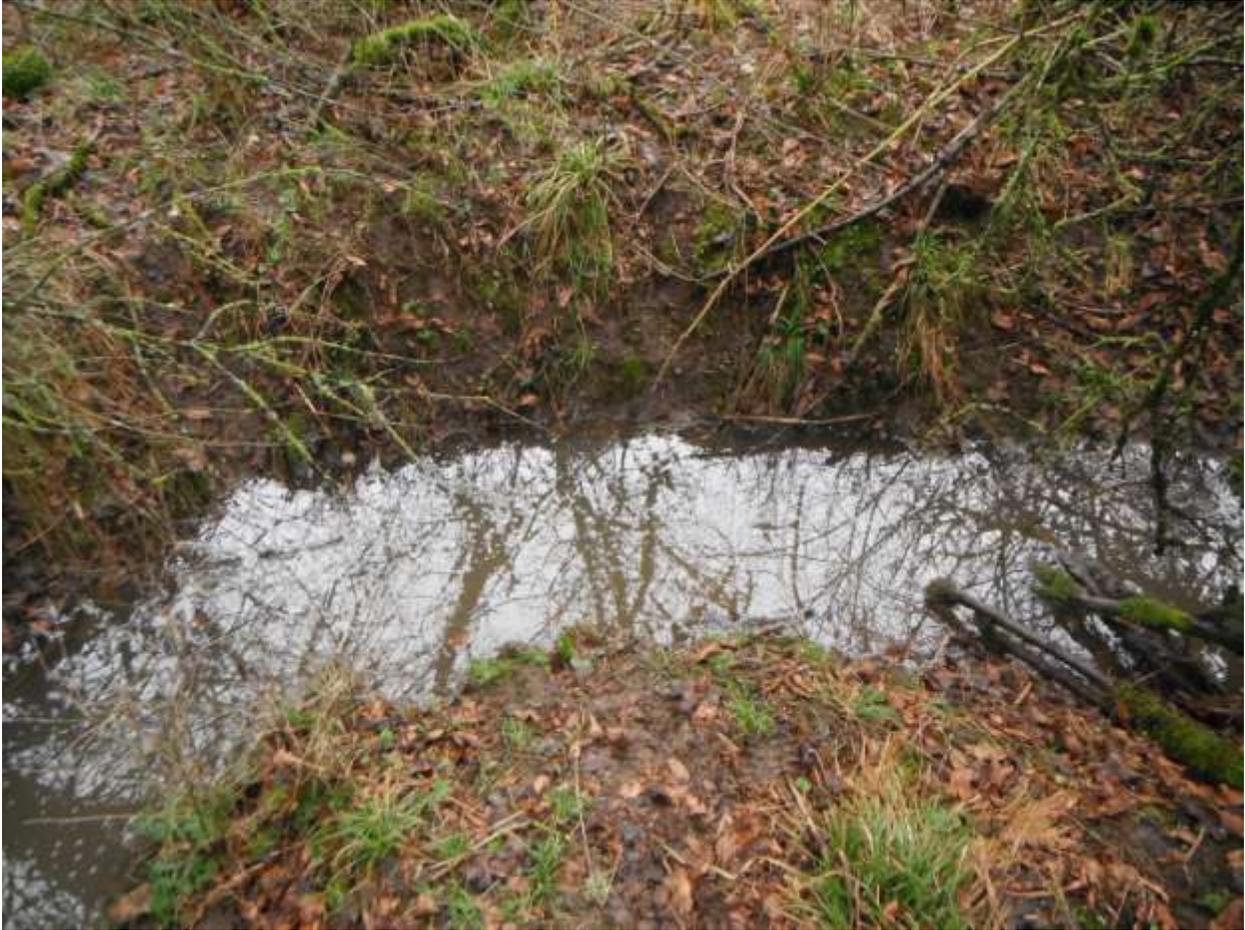
Photo # 17: Leachate flow path to McPhillips Creek depicted in photo # 16. Flow occurred within this narrow defined channel near the creek, in contrast to the more diffuse drainage conditions near the landfill.

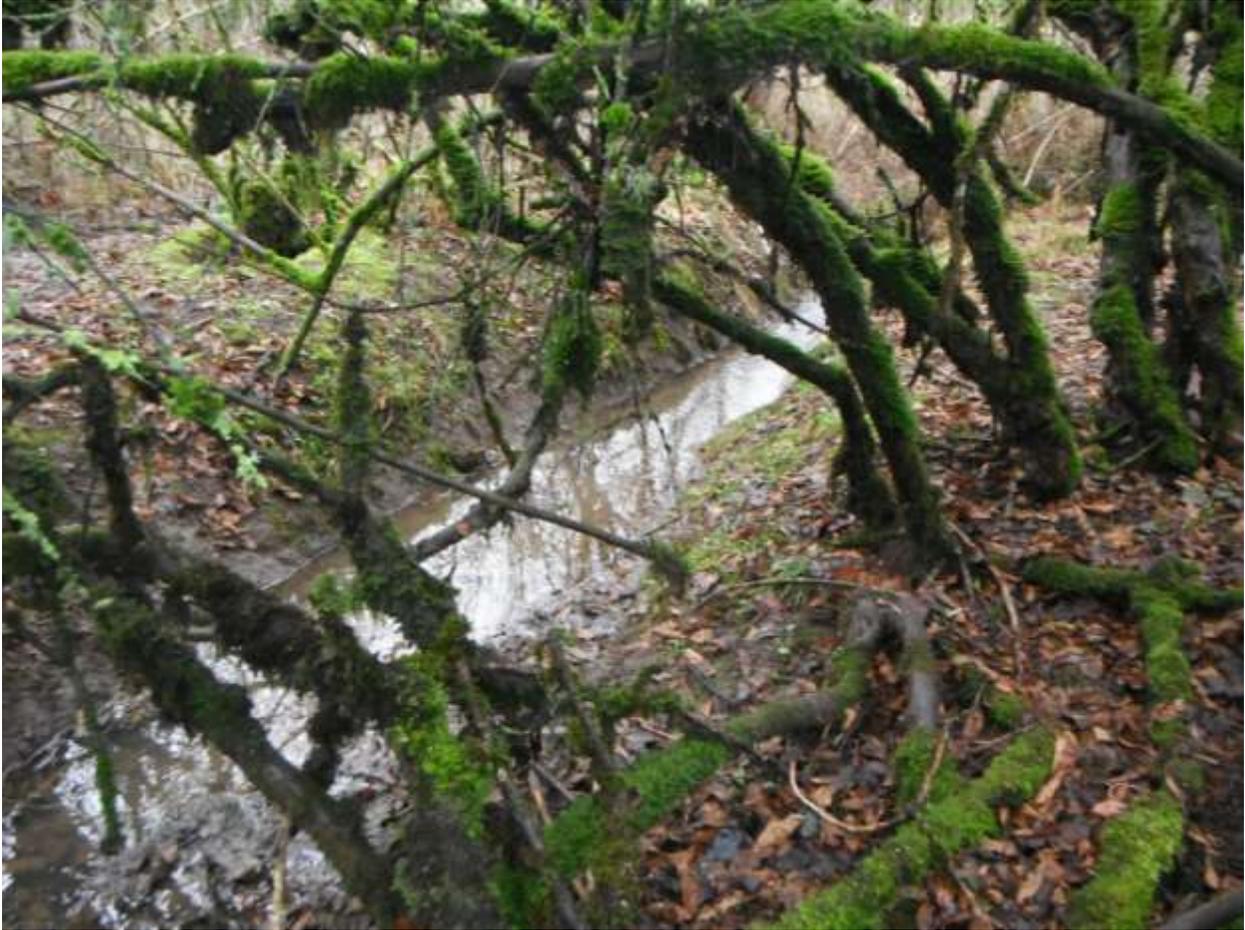
Photo # 18: Another view of the leachate flow path (stormwater drainage channel) near the creek.

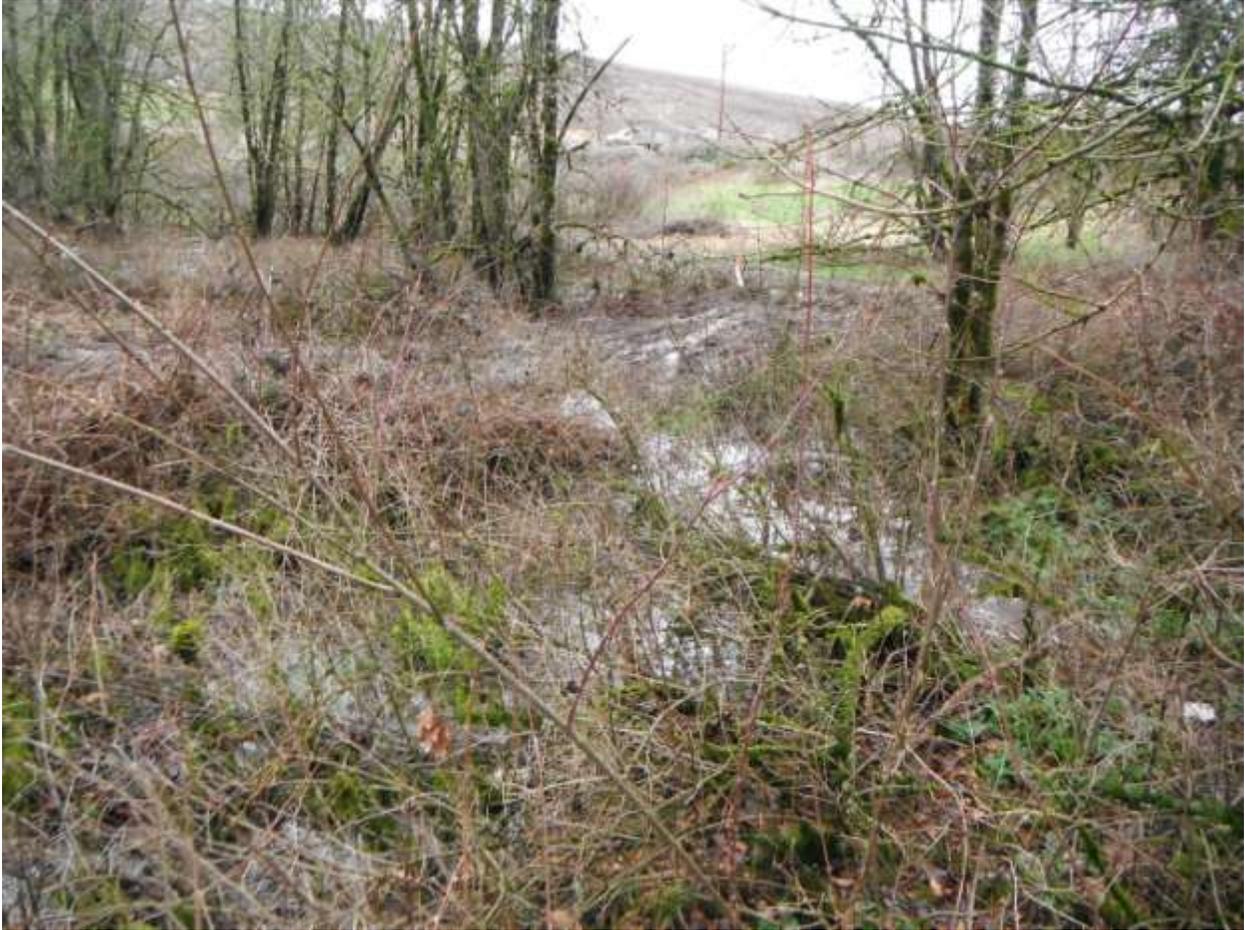
Photo # 19: Leachate flow-path looking southwest, back at the landfill.
