State of Oregon
Department of
Environmental
Quality

Subject: Investigation of Riverbend Landfill leachate spill of Feb. 9-10, 2014

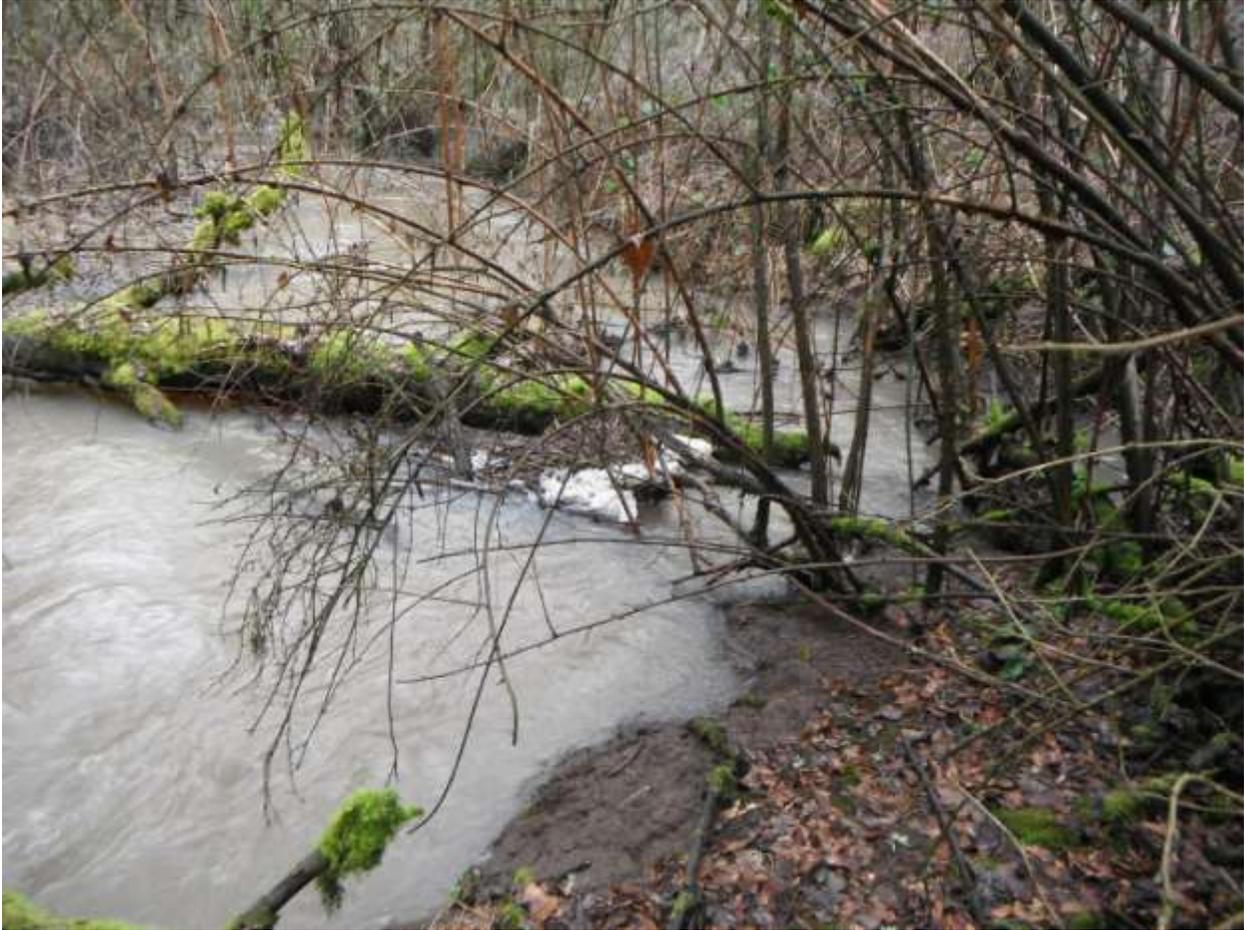
Photo # 20: View of McPhillips Creek downstream of the spill area. Note foam deposited on organic debris-s snag in the creek.

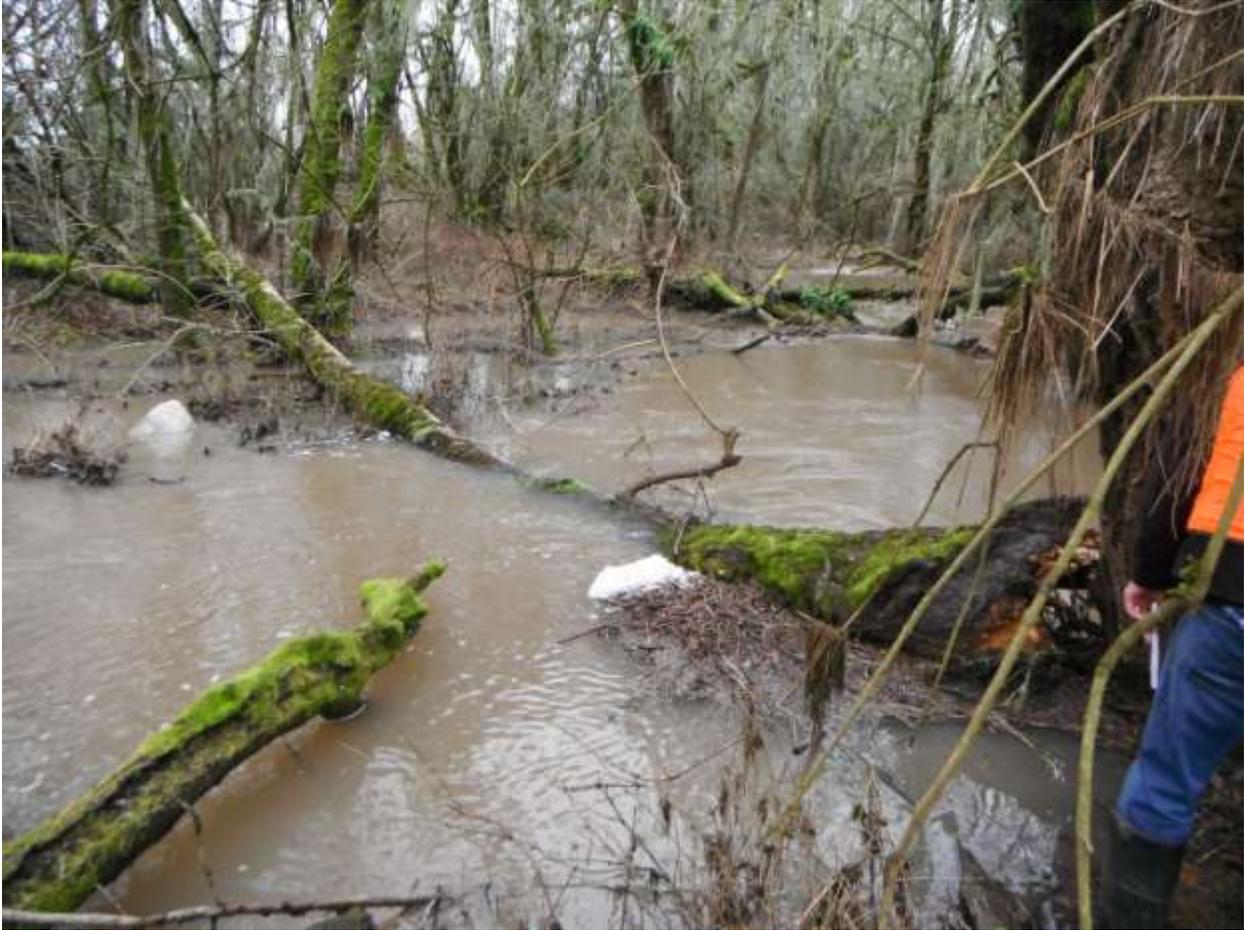
Photo # 21: McPhillips Creek downstream of landfill. Note high creek levels and small foam deposit on debris snag.

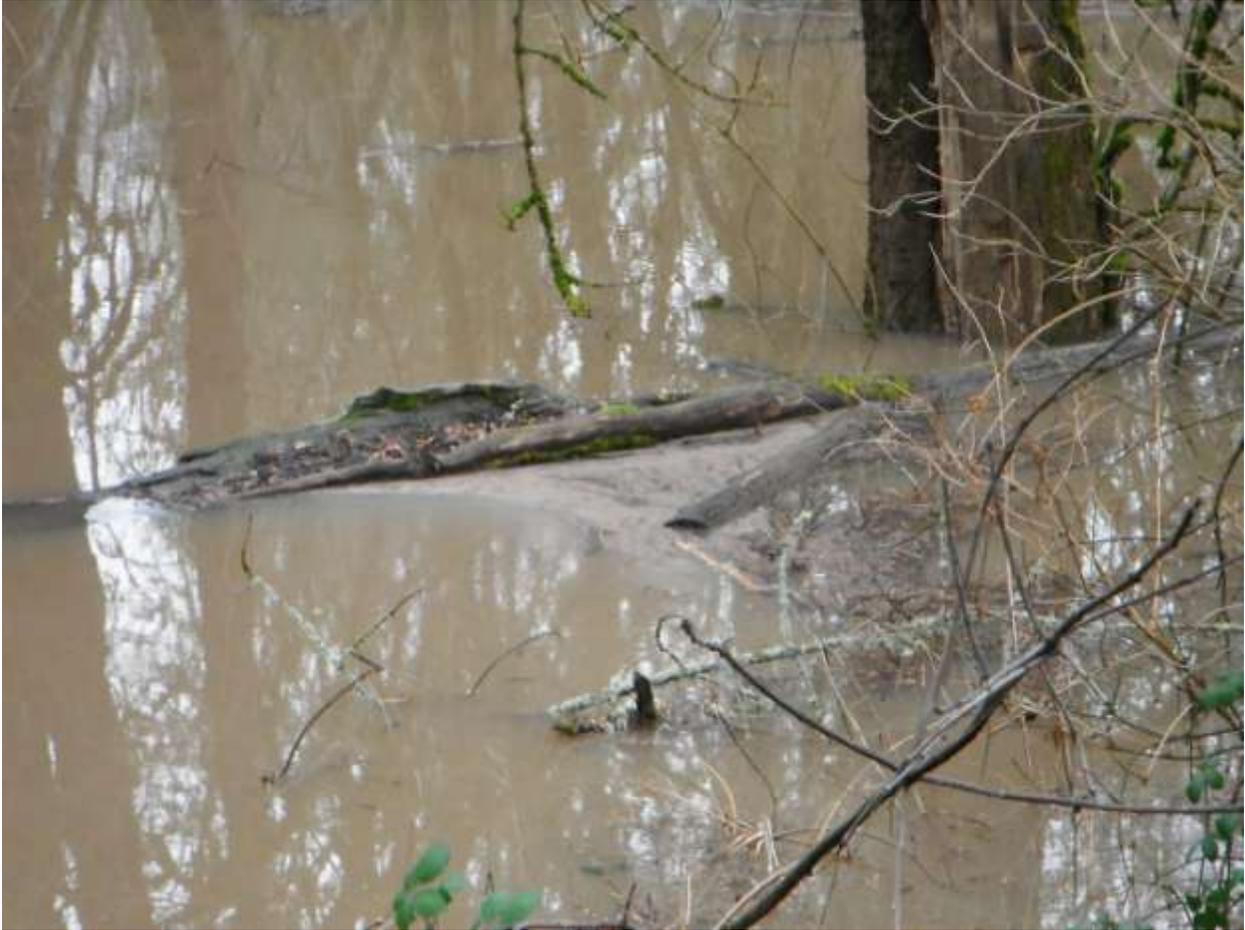
Photo # 22: McPhillips Creek , back-water area at the creek - Yamhill River confluence. Fine organic layer built up behind debris snag. No visible evidence of leachate noted.
