# NPDES Industrial Stormwater Inspection Worksheet

Facility Information	
Name of Facility	Riverbend Landfill Co.
Address of Location	13469 SW Highway 18 McMinnville, Yamhill County
Receiving Waterbody	Unnamed creek

DEQ Inspection Photo Log				Inspection Date	2/10/16
Facility Name	Riverbend Landfill	ID#	106959	Photographer	Jill A. Seale, DEQ Western Region Stormwater

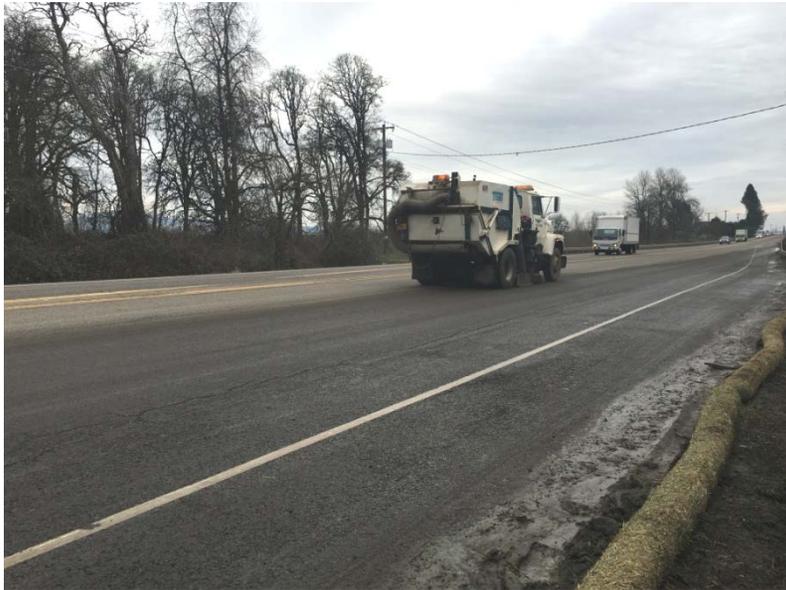
Photo # 1  
Description: SR 18, north of facility entrance, facing northeast

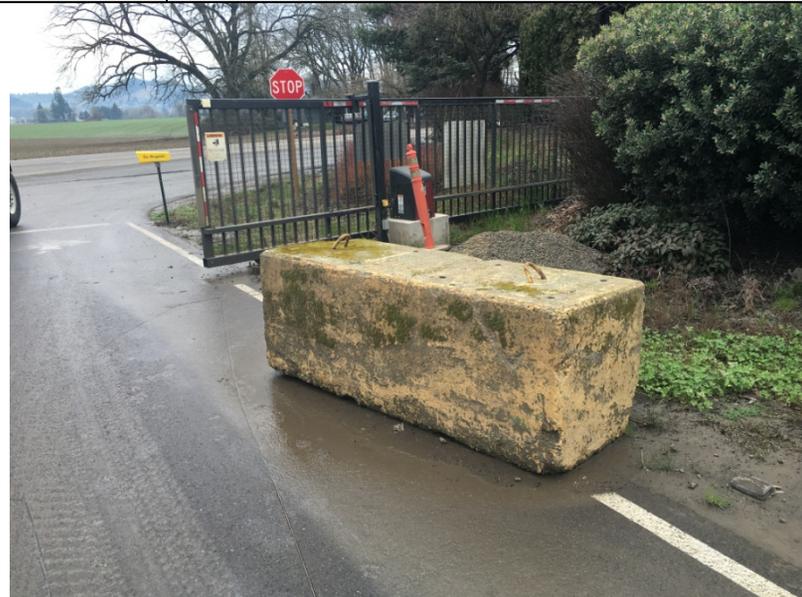
Photo # 2  
Description: at exit gate, facing west

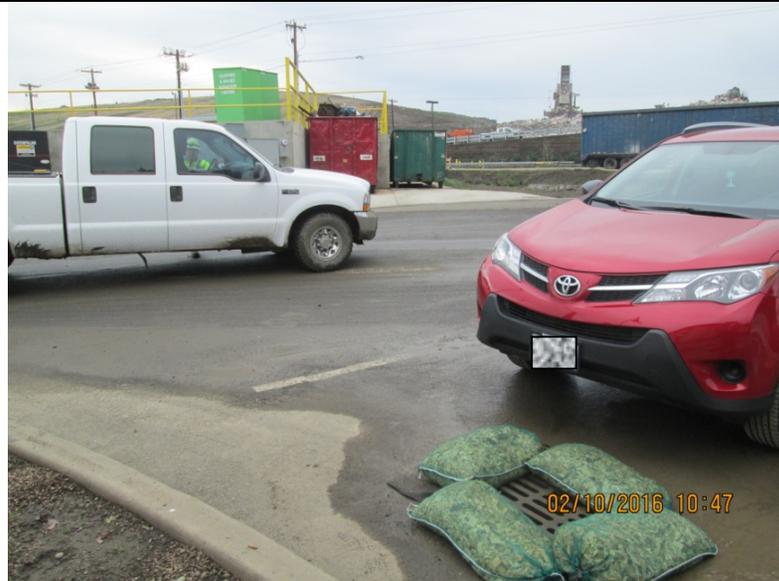
Photo # 3  
Description: catch basin to outfall 1B, facing south

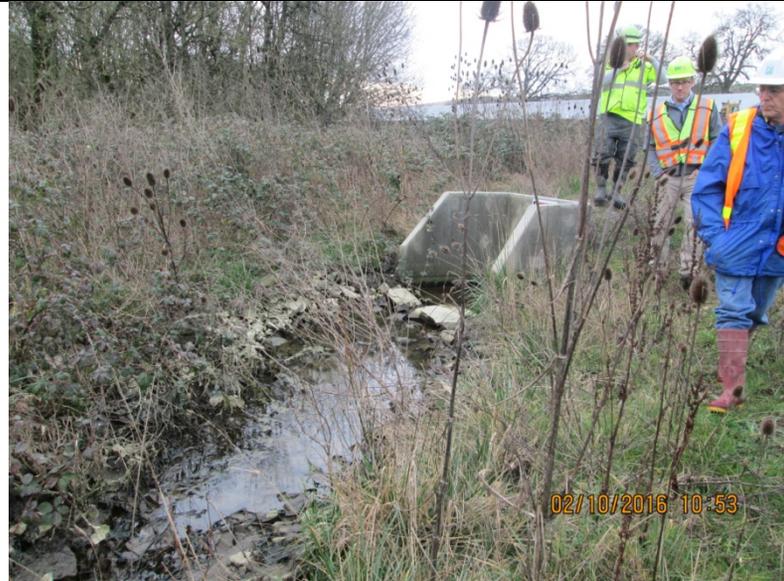
A review of Figure 1-3 of the February 2016 SWPCP indicates Outfall 1C currently accepts stormwater exposed to the primary SIC code (landfill operations) industrial activity as well as the transfer facility area, so as currently managed, assigning different monitoring requirements to Outfall 1C is not an option.

Photo # 4  
Description: Outfall 1C, facing southeast

However, if this facility wishes to pursue altering the facility and SWPCP to establish a co-located transfer facility from the primary landfill industrial activity, and can clearly establish a separation of stormwater associated with these two industrial activities, DEQ will review the proposal and provide comment regarding this issue if a specific plan is prepared and submitted.

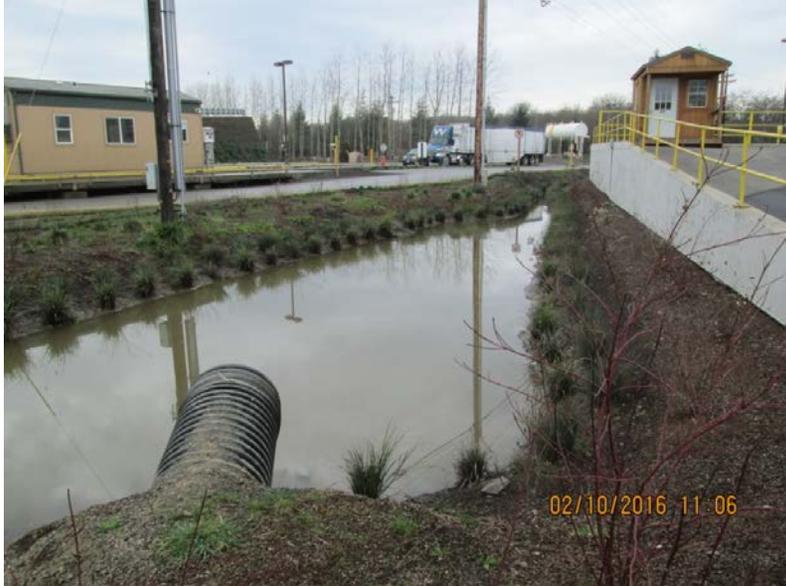
Photo # 5  
Description: sedimentation basin 1B, facing northwest

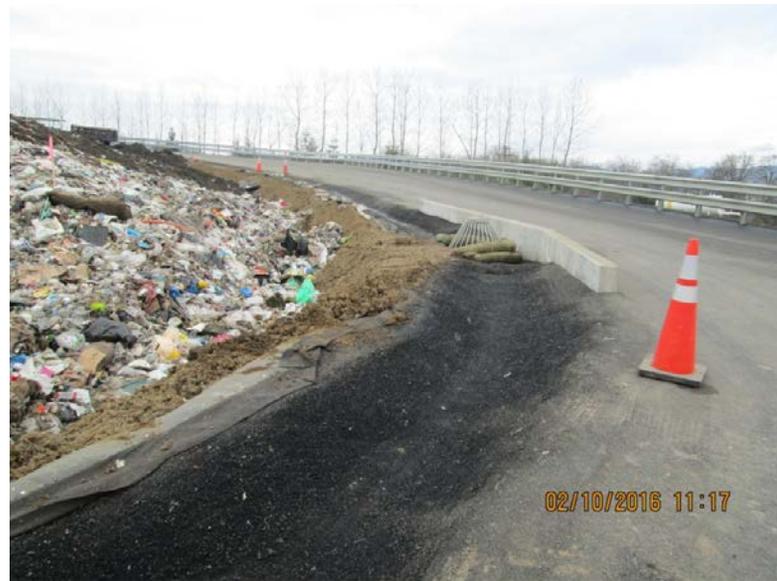
Photo # 6  
Description: active area, facing west/south

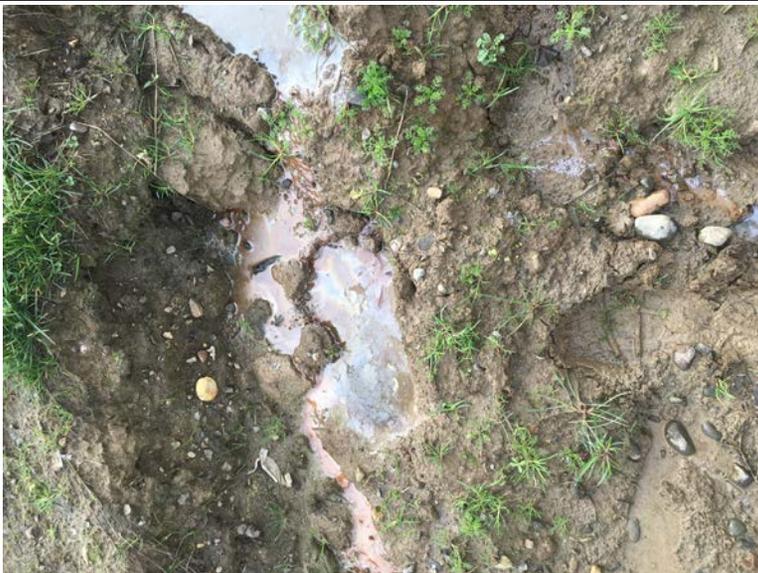
Photo # 7  
Description: along active face road, south side of road and black membrane

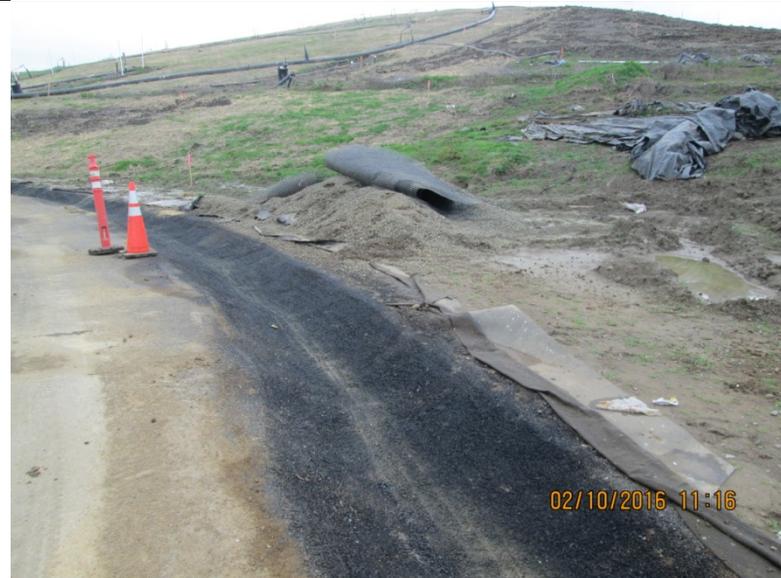
Photo # 8  
Description: along active face road, facing east/south towards Photo 7

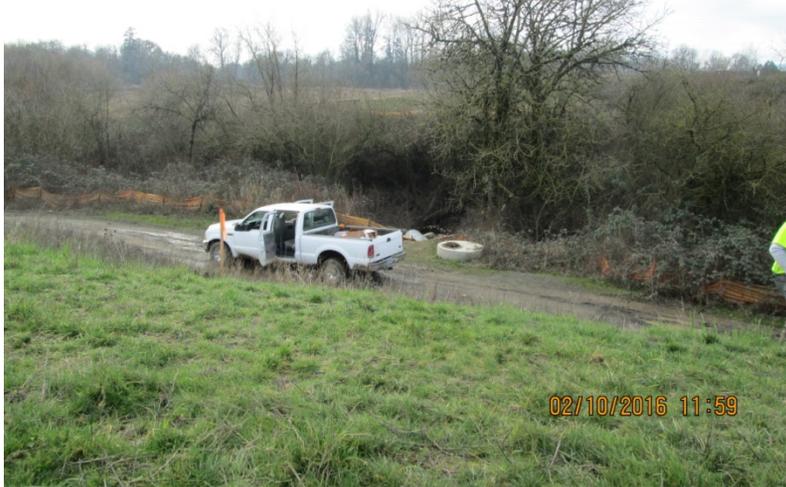
Photo # 9  
Description: from stormwater det. Pond 1, facing outfall 2, facing west

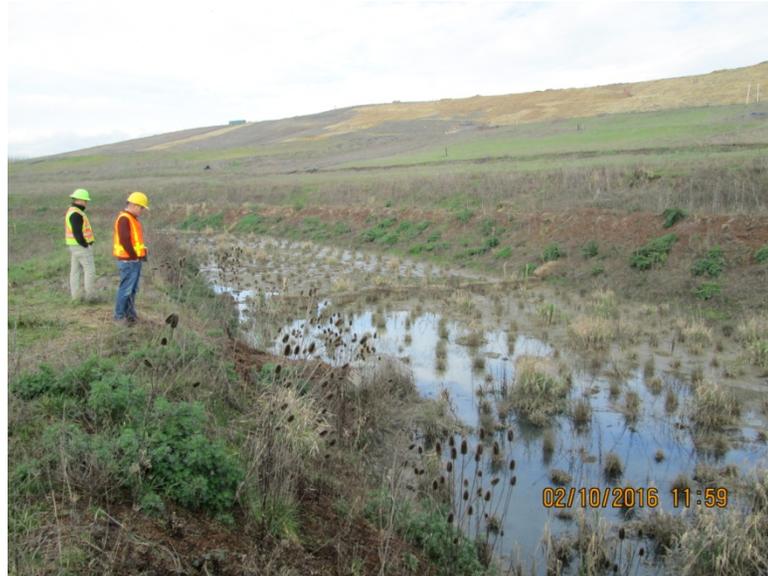
Photo # 10  
Description: stormwater detention Pond 2, facing northwest

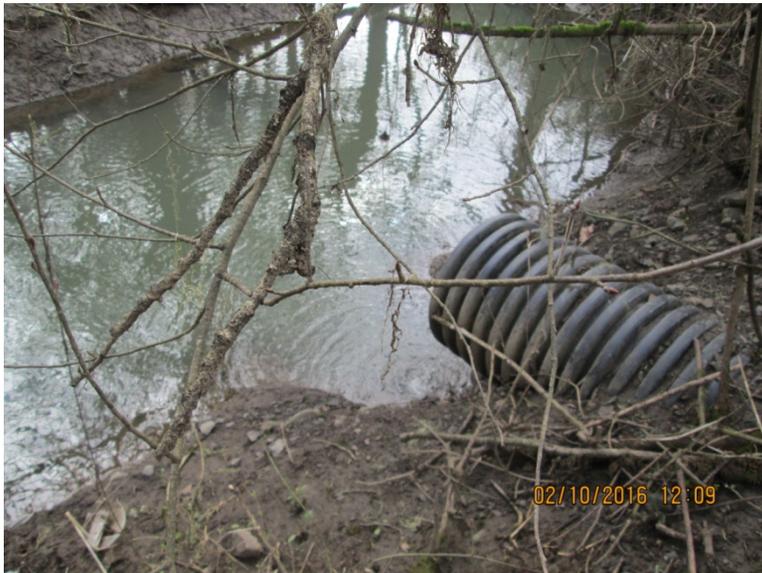
Photo # 11  
Description: Outfall 4, approximately 24" pipe; discharging, facing northeast

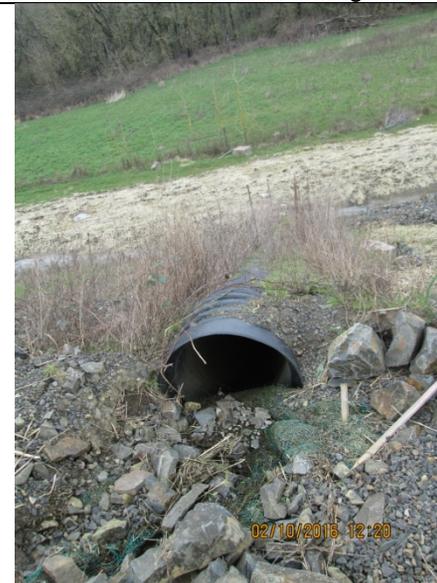
Photo # 12  
Description: leading to ditch to Outfall #4, facing north
