BARNES BUTTE QUICKSILVER MINE (Primeville Mine)

OCHOCO AREA

DESCHUTES COUNTY

April 19, 1941 John Eliot Allen Geologist

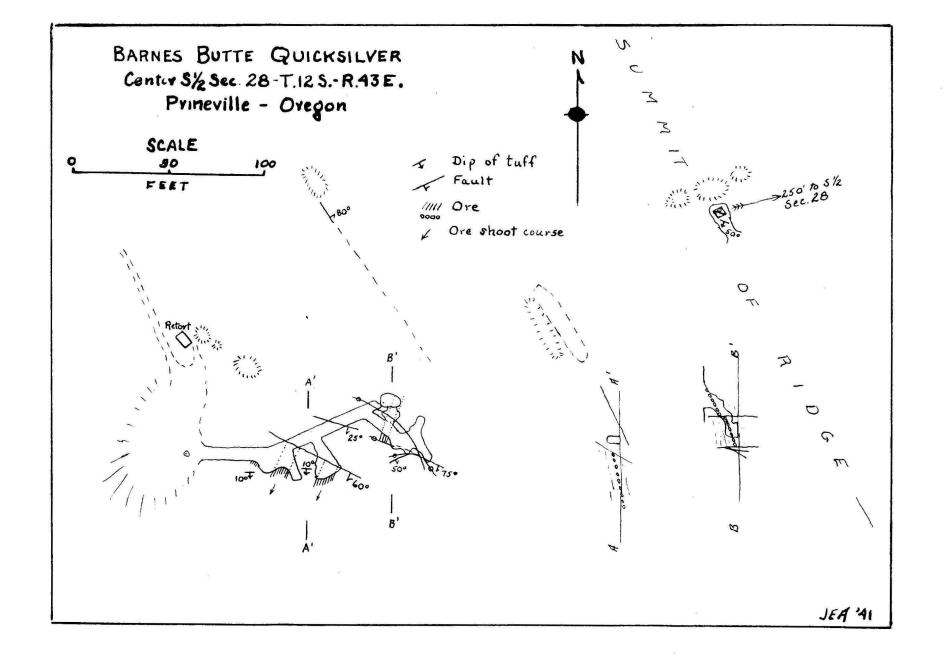
Development: One thirty foot shaft; 150 feet of open cut and tunnel on the lower (western) level; and numerous trenches and small open-cuts. See accompanying map.

A major fault has been reached at two points in the end of the tunnel, with red gouge and grey andesite occuring on the south side of a nearly vertical east-west trending fracture.
