State Department of Geology and Mineral Industries

HUMBOLDT METALLICS CORPORATION, LTD.

OCHOCO DISTRICT
JEFFERSON COUNTY

April 20, 1941
John Eliot Allen
Geologist

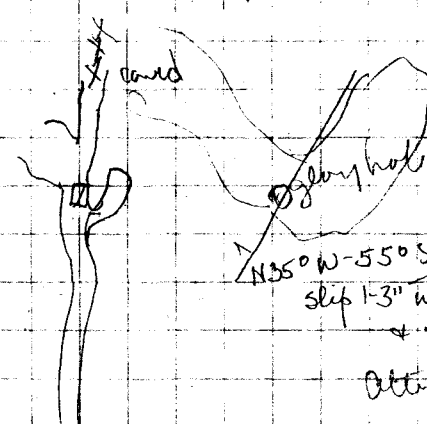
E-W ~~altered zone~~ 100 yds wide 350-600' N. of workings. Runs 3/4 mile. Springs along N. side
