<u>MEMORANDUM</u>

Investigation of sinking hole near intersection of Orenco road and Baseline road, morning, May 20, 1953.

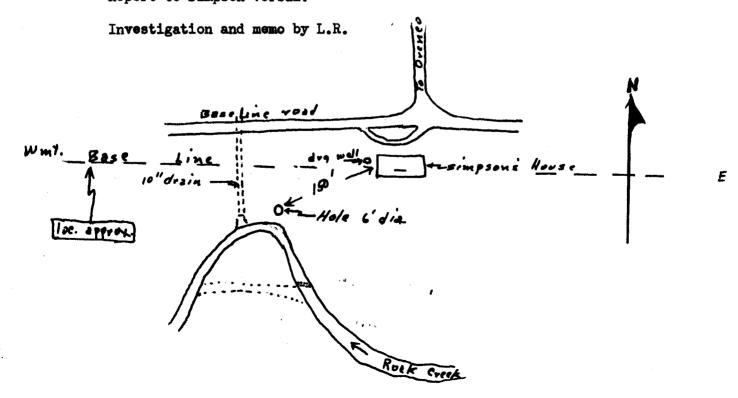
The hole in question is located about 150 feet southwest of a cement-brick house being built by R. W. Simpson, NW/NE sec. 3, T. 1 S., R. 2 W. At this point Rock Creek changes direction in a fairly sharp meander. The hole is about 6 feet in diameter, about 10 feet from the edge of the stream and 10 feet above the surface of the water. It is apparently being caused by water erosion from beneath the surface. Simpson claims considerable material has been thrown into the hole, but it constantly sinks. The area was searched to find possible sources of the subsurface water. A 10-inch drain from the Baseline road drainage ditch runs through the field and enters Rock Creek about 20 feet west of the hole. It is apparently open and has no connection with the hole.

The most probable cause is Rock Creek which could build up enough pressure during high water to create an underground water current sufficient to erode the fine, sandy soil which is present to considerable depth in this area.

Suggested solutions: (1) plant rapid growing trees in the hole to halt erosion, or (2) cut off meander by re-channeling Rock Creek.
