Oregon Seismic Status Report - 2017

Structural Seismic Evaluation Report

Days Creek Charter School

May, 2017

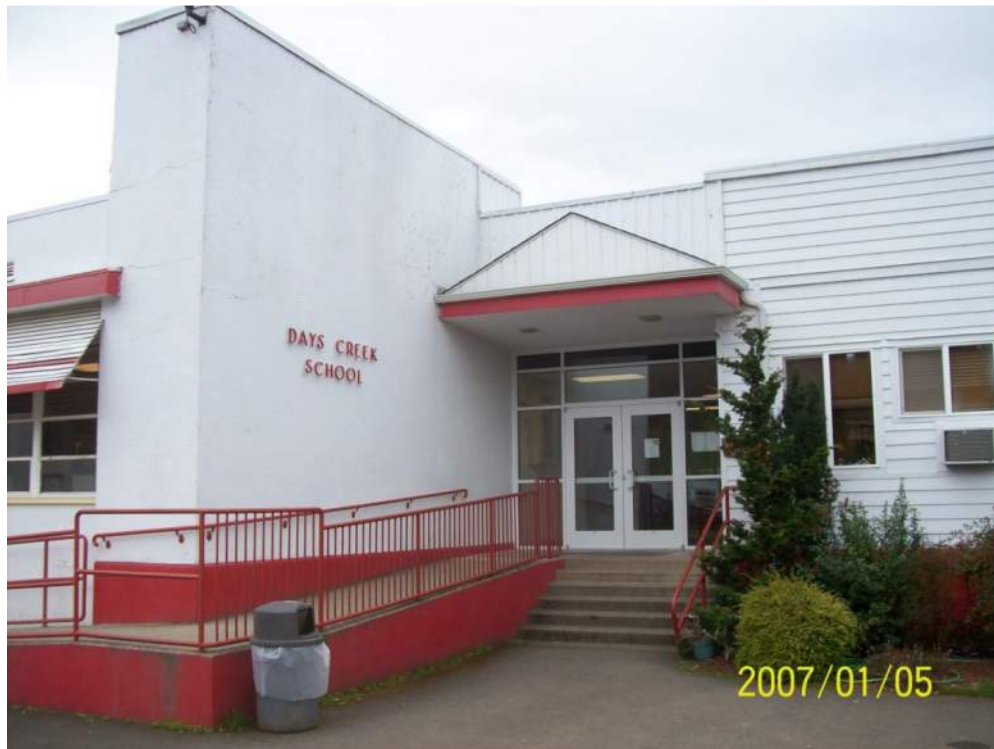
Days Creek Charter School -- Classroom Building Entrance

Original Classroom Seismic Hazard Rating: Moderate

- The straight sheathed and diagonally sheathed roof diaphragms do not have adequate capacity to resist seismic forces.
- The roof diaphragms are not properly attached to the shear walls below. In most cases these walls do not extend above the ceiling line. Very common for this age of construction.
- The shear walls do not have adequate capacity to resist seismic forces
- The plaster covered interior walls which are assumed to be shear walls do not have adequate capacity
- The shear walls are not properly attached to the foundation elements to resist sliding forces induced by a seismic event.
- Holdowns are not present to resist overturning forces resulting from seismic forces
- Reentrant corners are susceptible to damage from seismic induced tension forces.
- Post-to-beam connections are not adequate.

- Remove and replace the existing roof membranes to allow for the installation of a new layer of plywood over the existing sheathed diaphragms
- Provide blocking, clipping and nailing connections along top of walls to establish adequate connection between top of wall and diaphragm to ensure complete and well-defined load path for in-plane and out-of-plane loads.

- Sheath existing exterior and interior walls as required to increase the seismic force resisting capacity of the building
- Install new connection hardware between the sill plates and concrete foundation elements

- Remove and replace the existing roofing membrane for the 1965 addition to allow the inspection of the nailing pattern and re-nailing as required to provide an adequate diaphragm

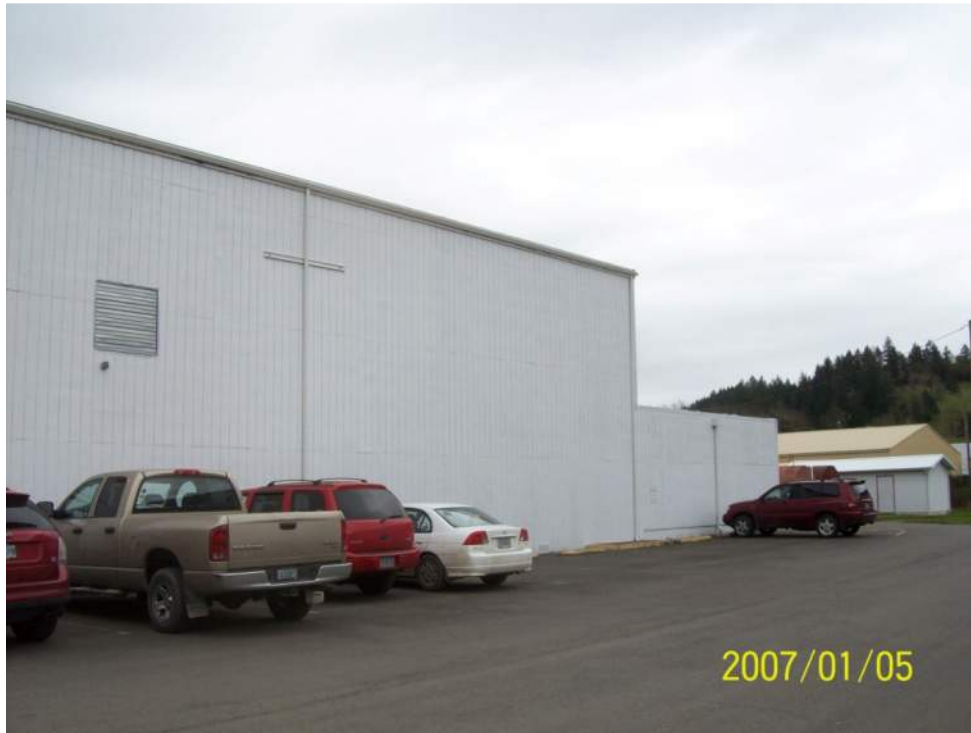
Days Creek Charter School – Gymnasium Building

Gymnasium Seismic Hazard Rating: Low

- In-plane connections are not adequate to transfer diaphragm loads to the foundation.
- The gymnasium portion of the building is taller than lower portions of the building. This creates a geometric irregularity. This geometric irregularity could result in pounding of the adjacent roof diaphragms into the gymnasium walls. The pounding effects increase the buckling loads on the walls.

- The bowstring trusses are not properly attached to the perimeter walls for in-plane and out-of-plane forces.
- The bowstring trusses are structurally inadequate to support gravity and seismic loading. The lack of redundancy in the connections of the web, top and bottom chords can lead to catastrophic collapse of the roof.

- Remove and replace the existing roof membranes to allow for the installation of a new layer of plywood over the existing sheathed diaphragms
- Provide blocking, clipping and nailing connections along top of walls to establish adequate connection between top of wall and diaphragm to ensure complete and well-defined load path for in-plane and out-of-plane loads. This applies to the entire building area.

- Strengthen gym wall using steel or wood strong backs as required to strengthen the taller gym walls
- Given our extensive knowledge of bowstring truss roofs and their lack of structural redundancy, it is our recommendation that the existing roof structure be strengthened or replaced. Strengthening would consist of establishing

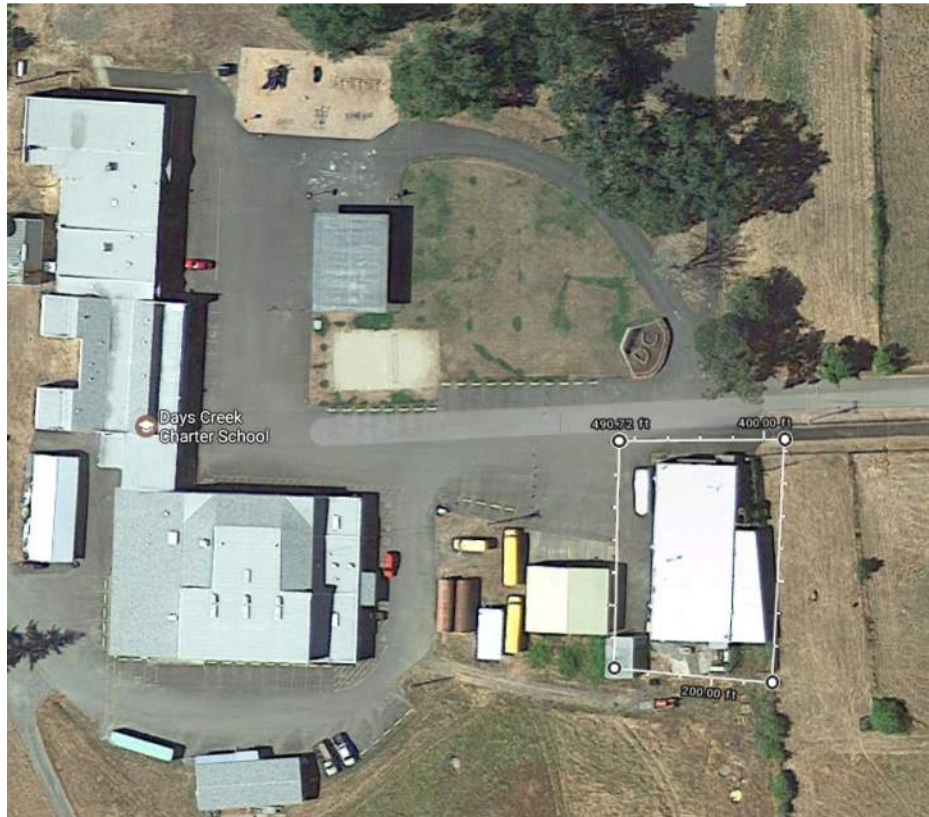
Days Creek Charter School – Shop/Vocational Building

Original Classroom Seismic Hazard Rating: Low

- No out-of-plane connection at the top of walls
- In-plane connections are not adequate to transfer diaphragm loads to the foundation.
- Diaphragm exceeds code prescribed aspect ratio.
- Diaphragm spans are greater than 40 feet.

- Remove and replace the roofing membrane and re-nail the existing roof sheathing to provide an adequate roof diaphragm
- Provide blocking, clipping and nailing connections along top of walls to establish adequate connection between top of wall and diaphragm to ensure complete and well-defined load path for in-plane and out-of-plane loading.
- Provide continuous blocking between diaphragm chords.
- All HVAC equipment found throughout the building shall be properly braced and attached to the structure to limit the potential damage.
- All piping found within the building that is greater than 12" from structure shall be properly attached and braced.
- All non-structural bracing deficiencies need additional bracing.
- After these are implemented the building will meet the "life safety" performance level per ASCE 41-13.
