Monroe RFPD

Building Type		County	
Fire - RFPD		Benton	
Street			
26764 Bellfountain Rd			
City	State	Zip	
Monroe	OR	97456	
Latitude		Longitude	
44.36502		123.35584	
Tracking Code		Inspection Date	
RVS in 2006		6/27/2006

FEMA 154 Rapid Visual Screening Score Card

Rapid Visual Screening - Senate Bill #2 - Seismic Needs Assessment
Oregon Department of Geology and Mineral Industries

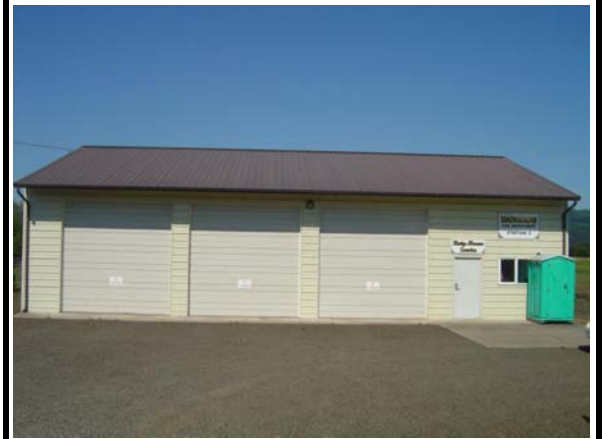
Type	Basic Score	Vert Irreg	Plan Irreg	Pre-Code	Post-Bench	Soil C	Soil D	Soil E	RVS Score
Primary	S3	3.2	0	-0.5	0	0	0	0	0	2.7
Secondary		0	0	0	0	0	0	0	0	0
Tertiary		0	0	0	0	0	0	0	0	0

Low (<1%)
