# Corvallis Fire Station #3

Bent\_fir04A

## FEMA 154 Rapid Visual Screening Score Card

Rapid Visual Screening - Senate Bill #2 - Seismic Needs Assessment  
Oregon Department of Geology and Mineral Industries

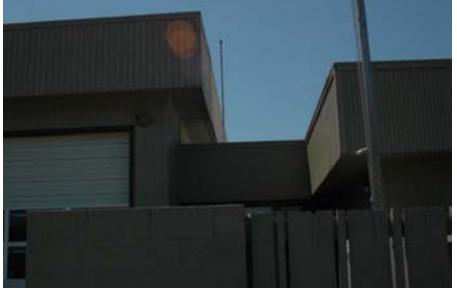
E	Vertical Irregularity Primary
