Monroe RFPD

Building Type		County	
Fire - RFPD		Benton	
Street			
680 Commercial St			
City	State	Zip	
Monroe	OR	97456	
Latitude		Longitude	
44.31462		123.30033	
Tracking Code		Inspection Date	
RVS in 2006		6/27/2006

FEMA 154 Rapid Visual Screening Score Card

Rapid Visual Screening - Senate Bill #2 - Seismic Needs Assessment
Oregon Department of Geology and Mineral Industries

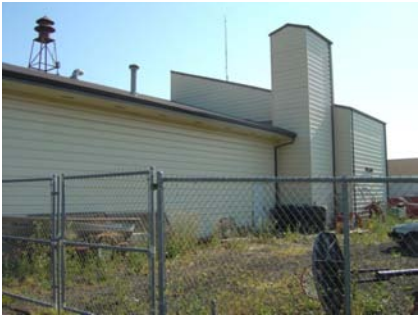
Plan Irregularities	Vertical Irregularities
Reentrant Corners: Other	Steps in Elevation View: 2 to 3 Changes
None	None
None	None

SW Vertical Irregularity Primary

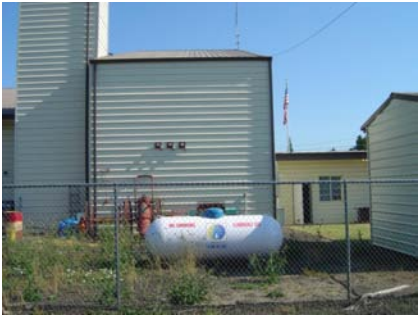
S Plan Irregularity Primary

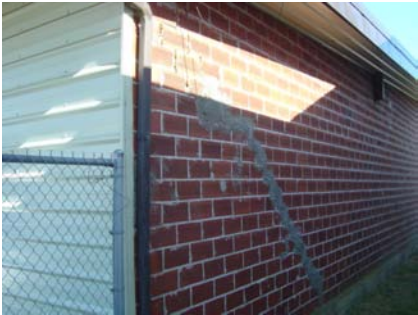
Falling Hazards	Poor Conditions
None	Cracks
None	Poor Masonry
None	None

E Poor Condition
