| EOC-Public Safety Answering P | Benton | |
| 200 Cascade Hall | | |
| RVS in 2006 | | 6/26/2006 |

## FEMA 154 Rapid Visual Screening Score Card

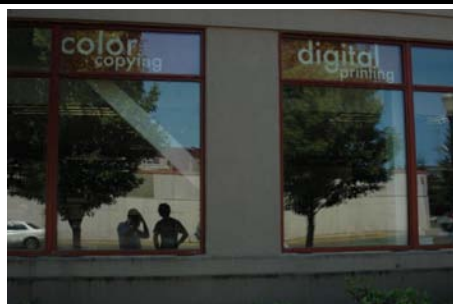
N Primary Structural Type  
brace behind glass

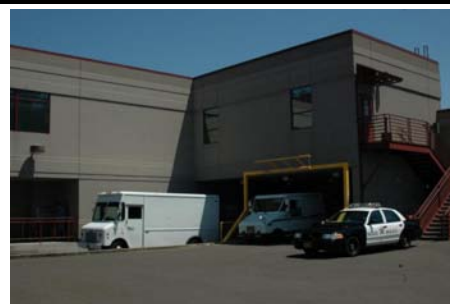
| Reentrant Corners: Other | Steps in Elevation View: Single Change |

SW Plan Irregularity Primary

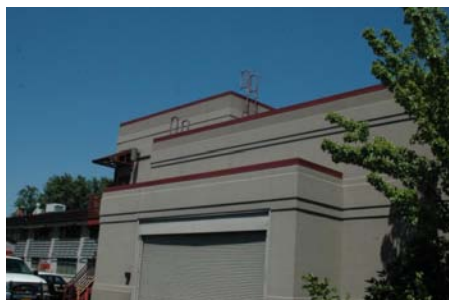
S Vertical Irregularity Primary
