Canby Fire District 62

FEMA 154 Rapid Visual Screening Score Card

Rapid Visual Screening - Senate Bill #2 - Seismic Needs Assessment
Oregon Department of Geology and Mineral Industries

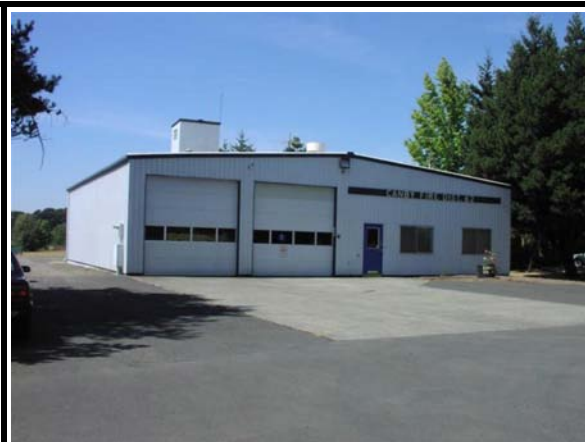
S General Site
