# Sunset Primary School

West Linn-Wilsonville SD 3J

## FEMA 154 Rapid Visual Screening Score Card

Rapid Visual Screening - Senate Bill #2 - Seismic Needs Assessment  
Oregon Department of Geology and Mineral Industries

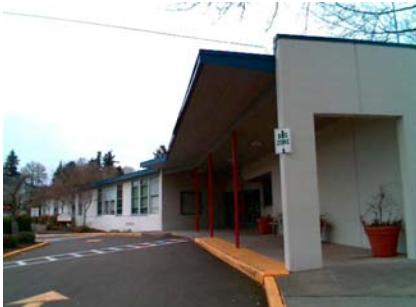
SE Falling Hazard

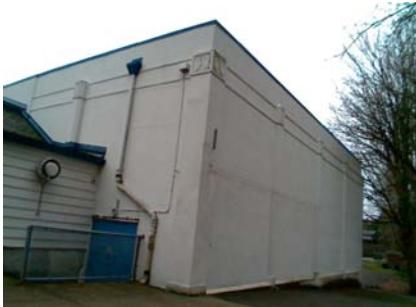
NE Vertical Irregularity Secondary

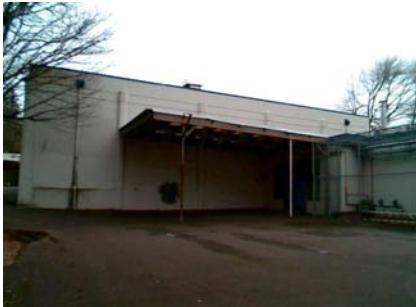
NW Falling Hazard

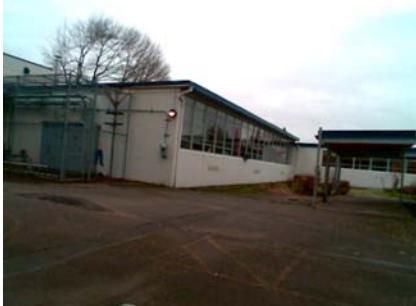
NW Plan Irregularity Tertiary

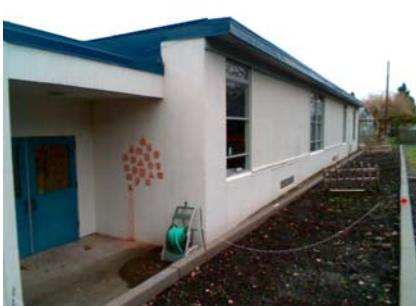
W Vertical Irregularity Secondary

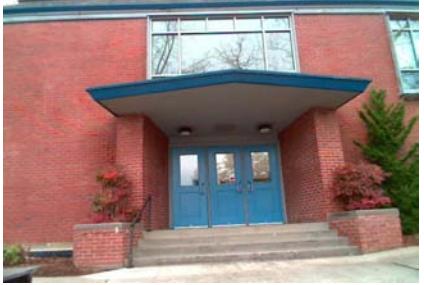
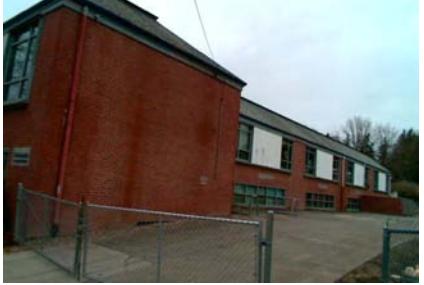
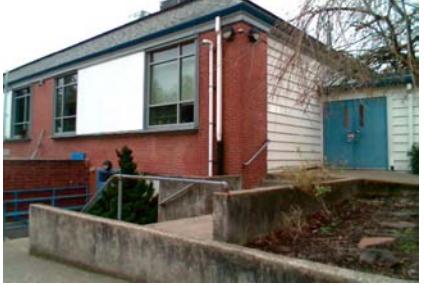
S Falling Hazard	SE Vertical Irregularity Tertiary	NE Primary Structural Type

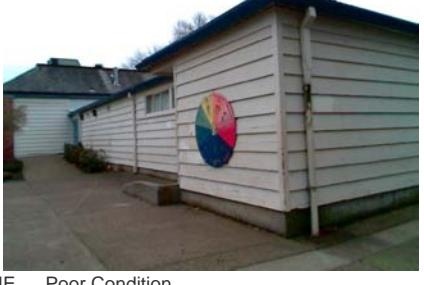
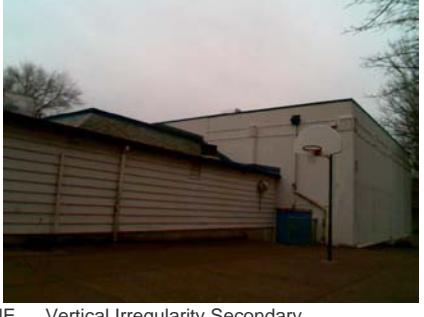
NE Poor Condition	NE Vertical Irregularity Secondary
