## North Clackamas SD 12

Clac sch21A

Riverside Elementary School

Rapid Visual Screening - Senate Bill #2 - Seismic Needs Assessment  
Oregon Department of Geology and Mineral Industries

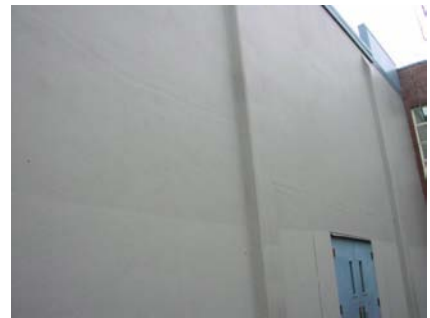
| Reentrant Corners: Other (Adjacent Build/Entity) | Steps in Elevation View: 2 to 3 Changes (Adjacent Building/Entity) |

SW Plan Irregularity Primary

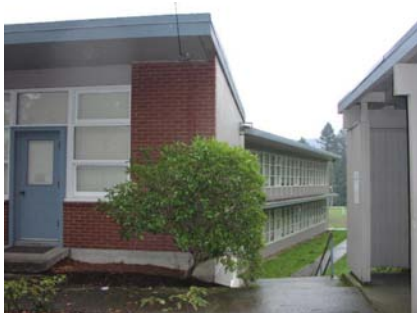
| Torsion: Eccentric Stiffness | Steps in Elevation View: Single Change (Adjacent Building/Entity) |

NE Vertical Irregularity Primary

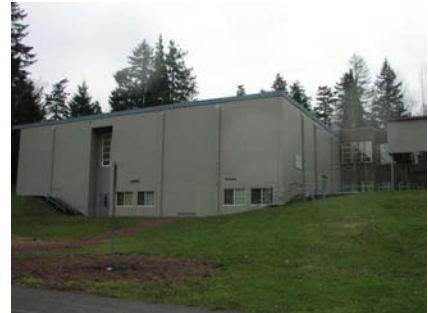
| Reentrant Corners: Other (Adjacent Build/Entity) | Building On Hill or Sloped Site |

W Plan Irregularity Primary

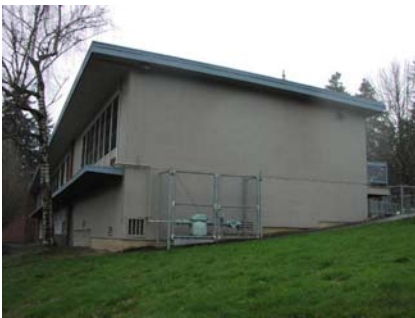
| Reentrant Corners: Other (Adjacent Build/Entity) | Building On Hill or Sloped Site |

S Vertical Irregularity Primary

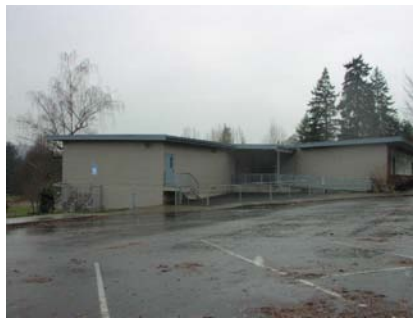
S Plan Irregularity Primary
