# Mt Pleasant Elementary School

Oregon City SD 62

## FEMA 154 Rapid Visual Screening Score Card

Rapid Visual Screening - Senate Bill #2 - Seismic Needs Assessment  
Oregon Department of Geology and Mineral Industries

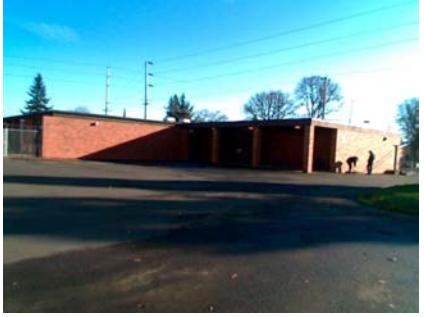
| | | NW Plan Irregularity Primary | |

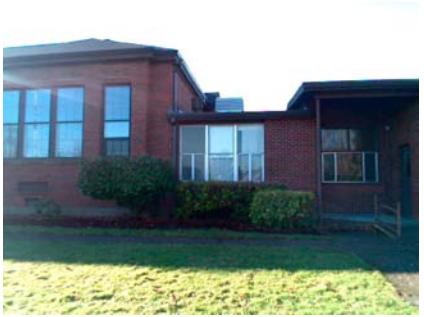
| Reentrant Corners: E Shaped | | Steps in Elevation View: 2 to 3 Changes | |
| E | Elevation View | E | Vertical Irregularity Secondary |

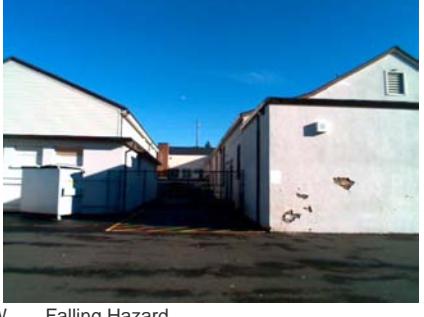
| Other: Brick Veneer | | None | |
| W | Secondary Structural Type | W | Falling Hazard |

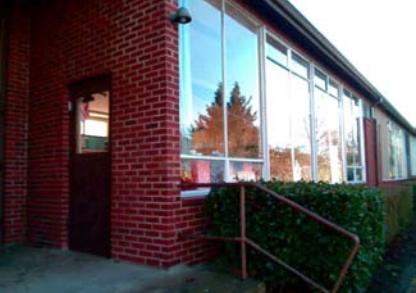
| NE Elevation View | | N Plan Irregularity Primary | |
| | | can see through to outside wall beyond, with also large window areas | |

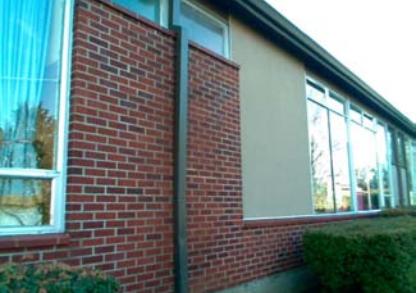
| | | N Seismic Upgrade | |
| | | could these be added shear wall panels? They can be found on both sides of building. | |
