Ogden Middle School

Oregon City SD 62

FEMA 154 Rapid Visual Screening Score Card

Rapid Visual Screening - Senate Bill #2 - Seismic Needs Assessment
Oregon Department of Geology and Mineral Industries

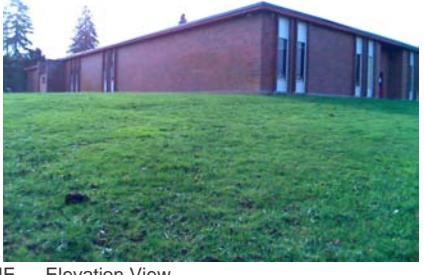
NE Elevation View

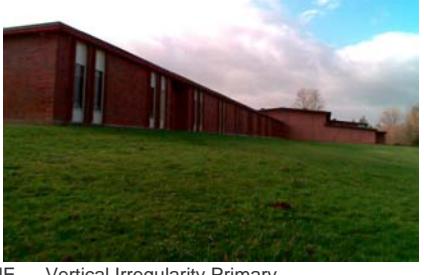
NE Vertical Irregularity Primary

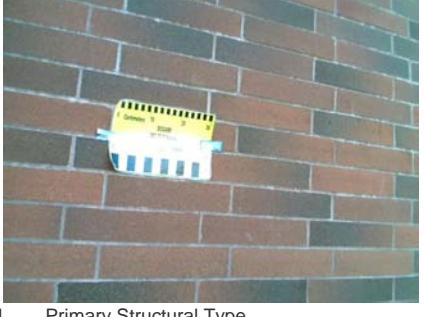
N Primary Structural Type

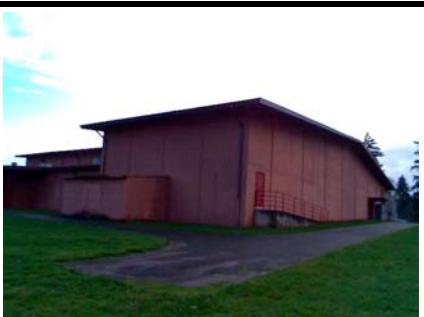
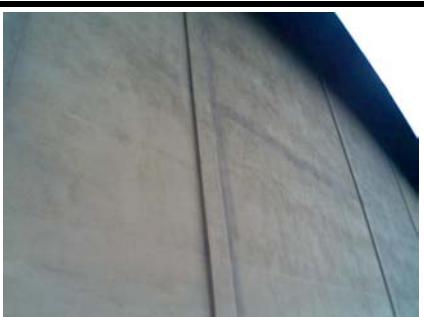
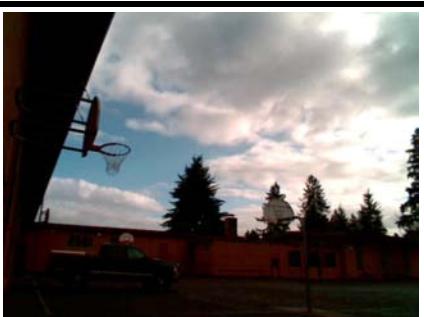
NW Vertical Irregularity Primary	W Poor Condition	W Plan Irregularity Primary

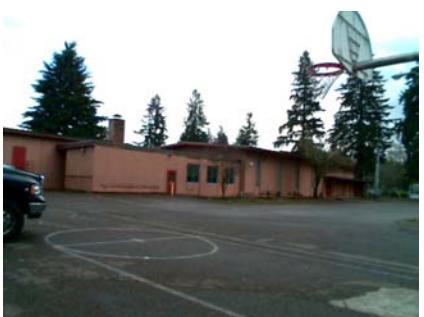
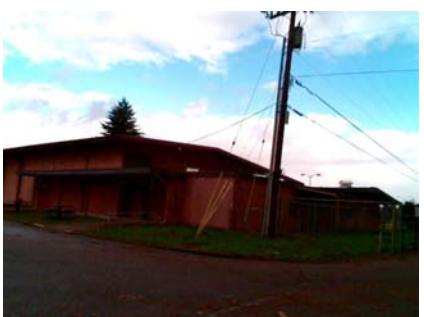
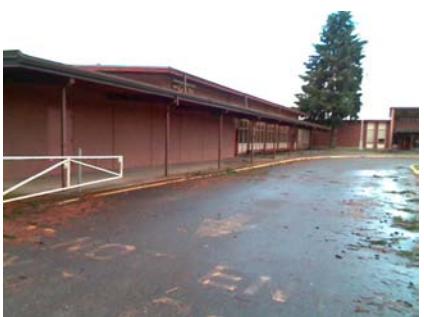
W Falling Hazard	SW Vertical Irregularity Primary	SE Plan Irregularity Tertiary

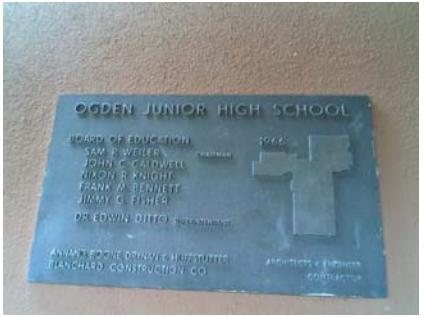
S Field Verified Year Built 1966
