Gladstone High School

Clac_sch64A

FEMA 154 Rapid Visual Screening Score Card

Rapid Visual Screening - Senate Bill #2 - Seismic Needs Assessment
Oregon Department of Geology and Mineral Industries

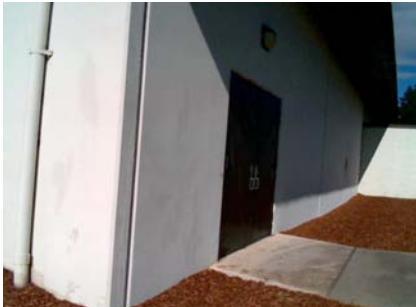
SW Secondary Structural Type CAULKED VERT JTS

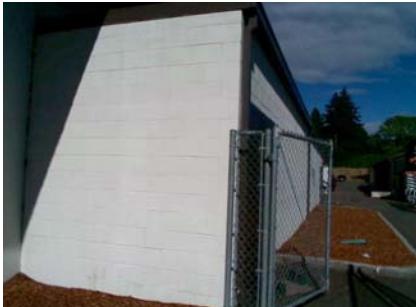
SW Tertiary Structural Type

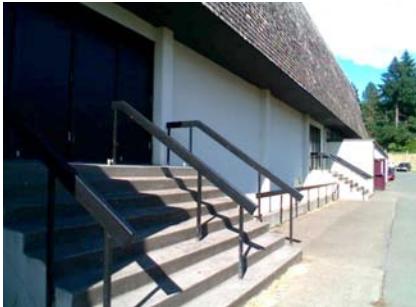
S Primary Structural Type

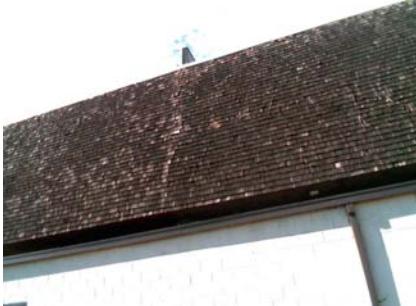
S Primary Structural Type PC TO C2 TRANSITION , FIREWALL

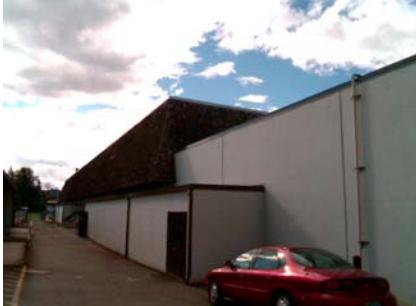
SE Secondary Structural Type PC, RM AND C2 SECTIONS VISIBLE

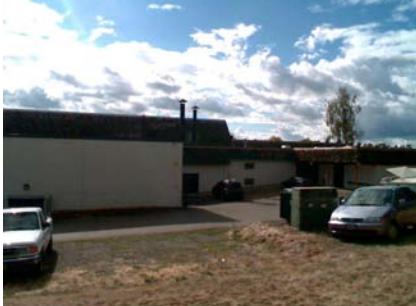
E Vertical Irregularity Primary

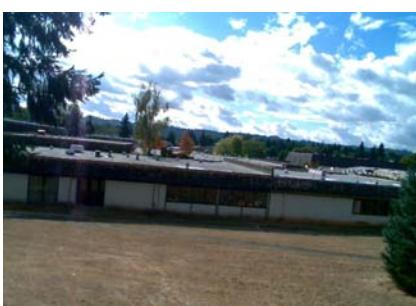
E Vertical Irregularity Secondary

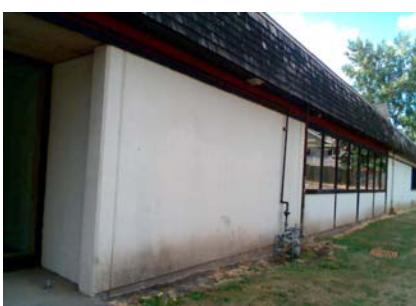
E Primary Structural Type

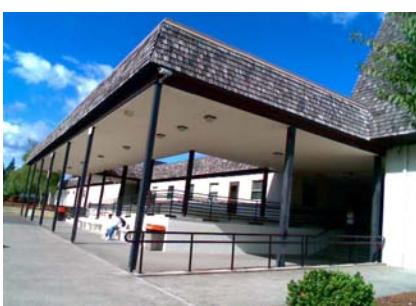
W Falling Hazard

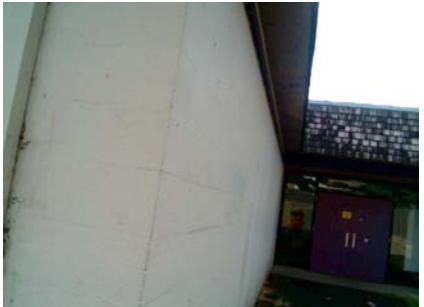
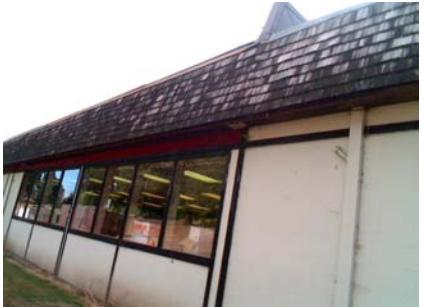
E Primary Structural Type		E General Site CONN TO A

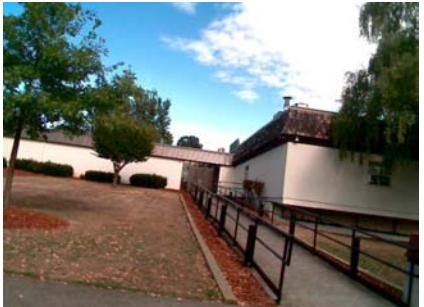
W Vertical Irregularity Secondary

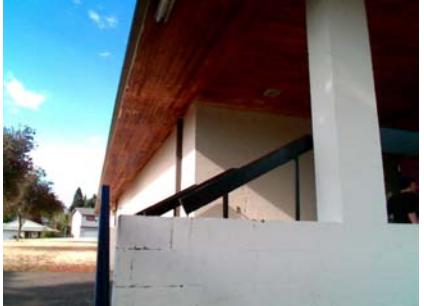
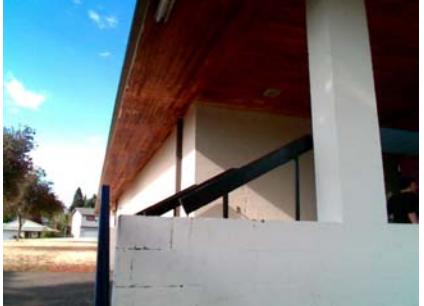
SW Plan Irregularity Primary		S Vertical Irregularity Primary

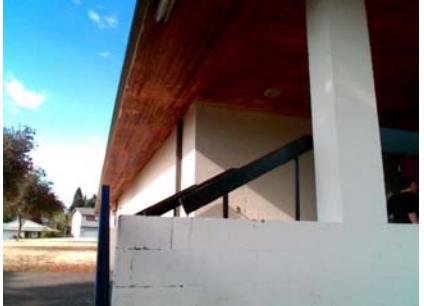
SW Primary Structural Type

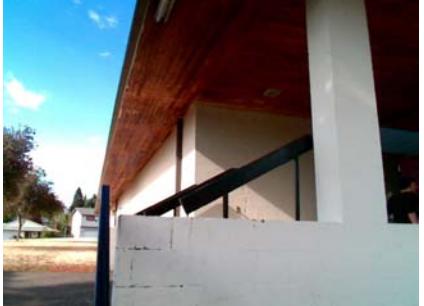
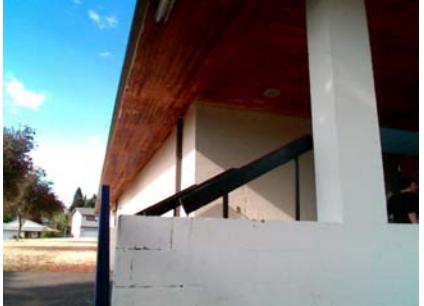
NW Elevation View		N Vertical Irregularity Primary

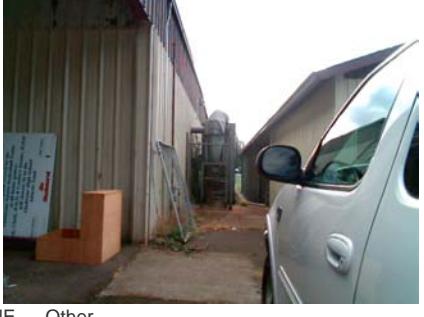
NE Other NO POUND

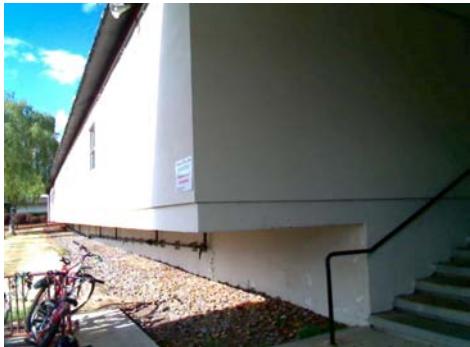
W Other
CANTILEVERED WALL

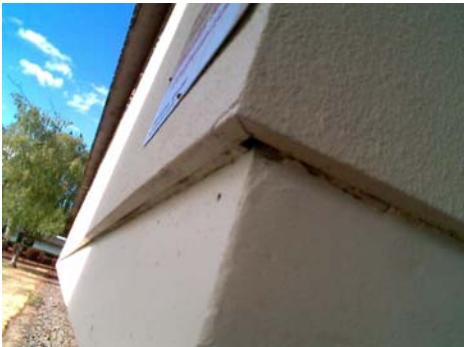
W Other
STUCCO BOARD FINISH
