Bolton Primary School

West Linn-Wilsonville SD 3J

Clac_sch82A

Rapid Visual Screening - Senate Bill #2 - Seismic Needs Assessment
Oregon Department of Geology and Mineral Industries

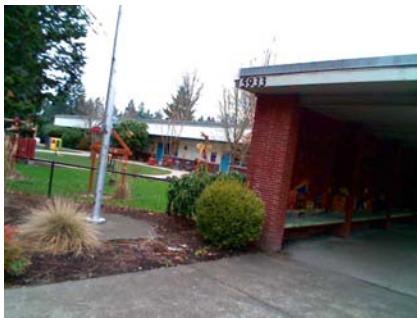
S Secondary Structural Type

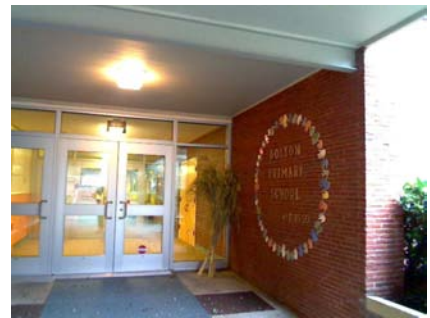
S Field Verified Year Built
1950 and interior brick

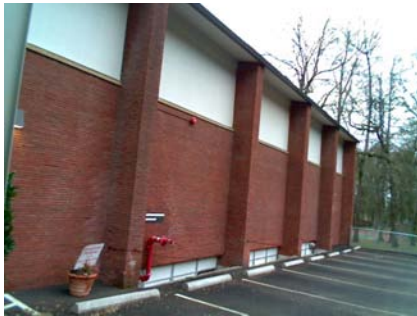
S Secondary Structural Type

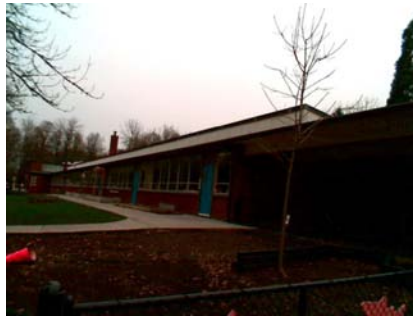
Falling Hazards	Poor Conditions
Unreinforced Chimneys	None
Other: Brick Veneer	None
None	None

NW Falling Hazard

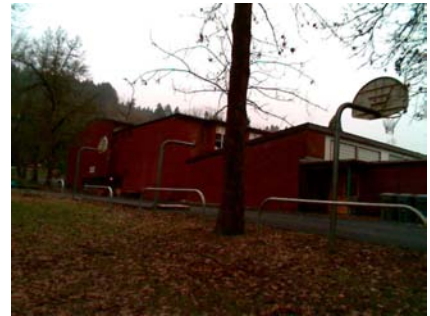
Plan Irregularities	Vertical Irregularities
Reentrant Corners: Other	Steps in Elevation View: Very Irregular Changes
None	Building On Hill or Sloped Site
None	None

E Vertical Irregularity Secondary

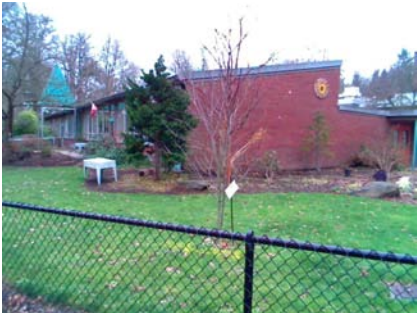
Plan Irregularities	Vertical Irregularities
Torsion: Eccentric Stiffness	Steps in Elevation View: 2 to 3 Changes
Reentrant Corners: Other	None
None	None

NW Plan Irregularity Primary
