# Lewelling Elementary School

Clac\_sch88A

## FEMA 154 Rapid Visual Screening Score Card

Rapid Visual Screening - Senate Bill #2 - Seismic Needs Assessment  
Oregon Department of Geology and Mineral Industries

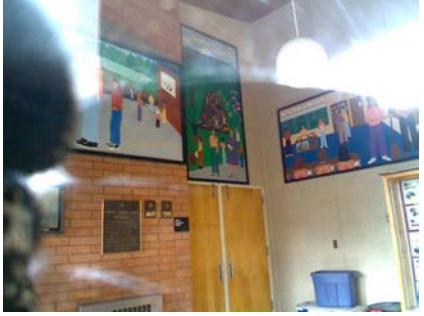
| Enrollment | Year Built (Field Verified) | Year Built (Alt. Source) | Est. Decade Built |
|---|--|---|---|
| S Field Verified Year Built<br>1963<br>also interior brick wall | S Primary Structural Type | S General Site<br>looking from part 1 to 2 and 3. | |

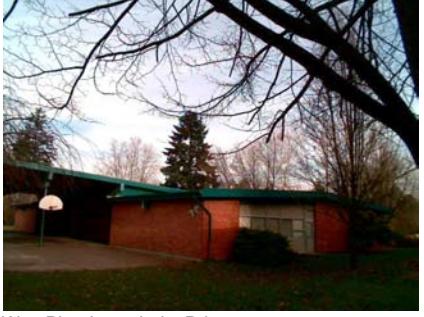
| Enrollment | Year Built (Field Verified) | Year Built (Alt. Source) | Est. Decade Built |
|---|--|---|---|
| SW Plan Irregularity Primary<br>pi and vi on 2 are typical. | S Falling Hazard<br>canopies | SE Elevation View<br>part 4 | |

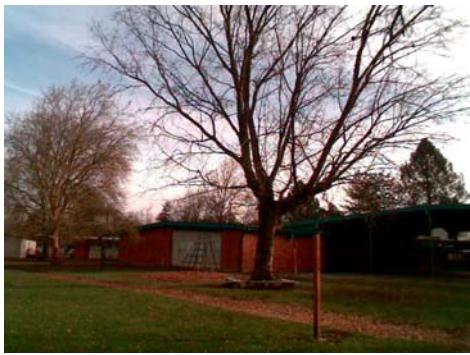
NW Falling Hazard  
part 3 and 4
