# Walter L Kraxberger Middle School

Gladstone SD 115

Clac\_sch90A

Rapid Visual Screening - Senate Bill #2 - Seismic Needs Assessment  
Oregon Department of Geology and Mineral Industries

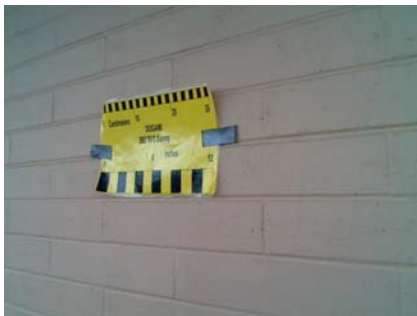
E Primary Structural Type  
kla-all type brick

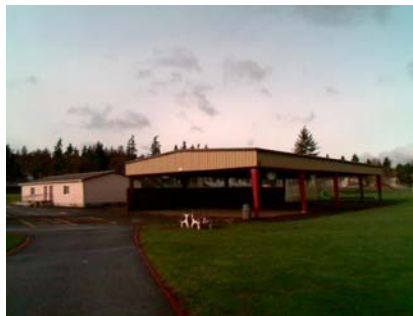
SE General Site

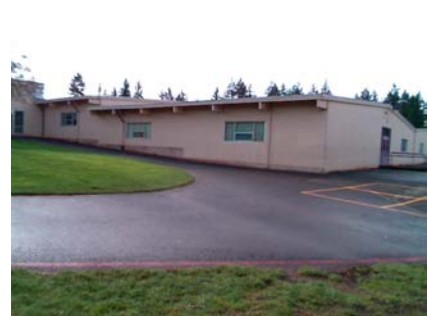
NE Vertical Irregularity Primary

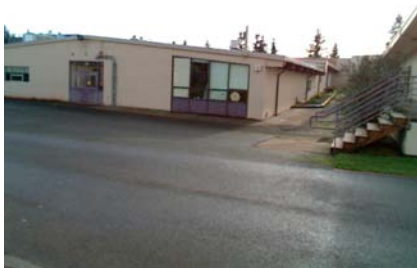
NW Plan Irregularity Secondary

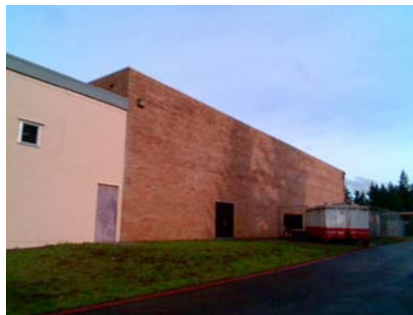
SW Vertical Irregularity Secondary

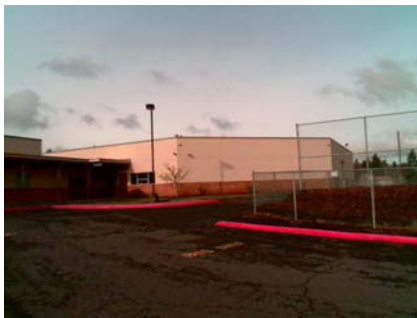
SE Elevation View

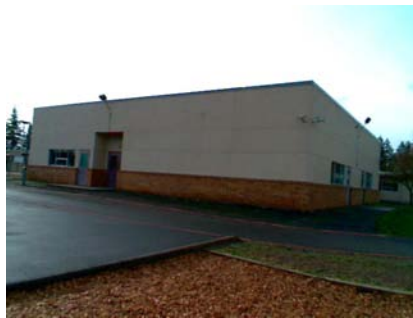
NE Elevation View

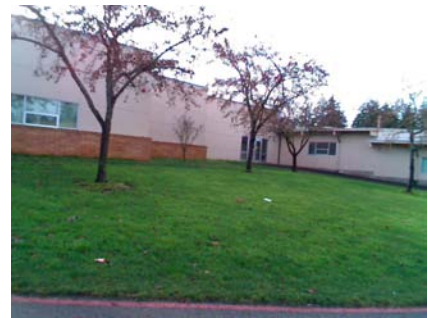
NE Plan Irregularity Primary

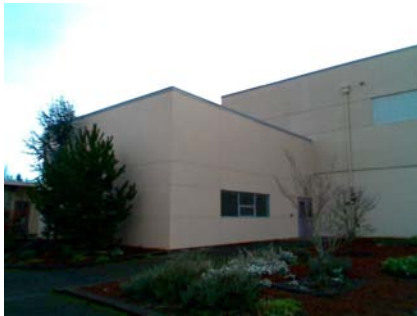
NW Vertical Irregularity Primary

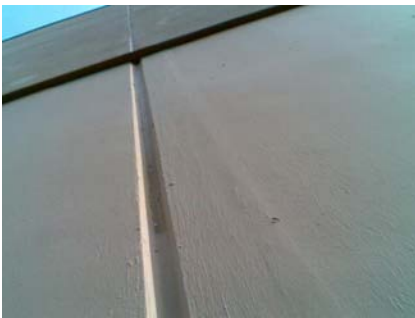
S Primary Structural Type  
caulked vert jts and cladding

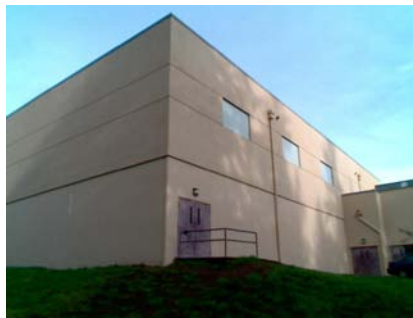
SW Plan Irregularity Primary

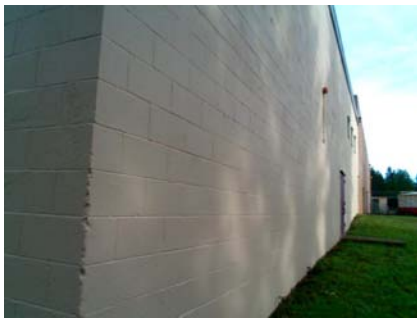
SW Primary Structural Type

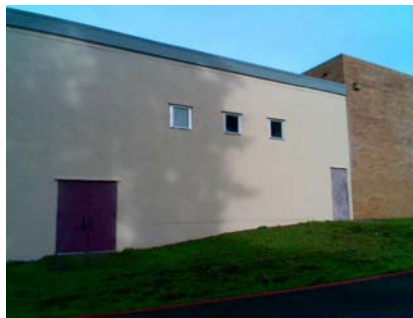
S Pounding Potential
