Seaside Fire & Rescue

Clat_fir06A

Building Type Fire - City	County Clatsop	
Street 150 S Lincoln		
City Seaside	State OR	Zip 97138
Latitude 45.9926	Longitude 123.91999	
Tracking Code RVS in 2006	Inspection Date 9/14/2006

Rapid Visual Screening - Senate Bill #2 - Seismic Needs Assessment
Oregon Department of Geology and Mineral Industries

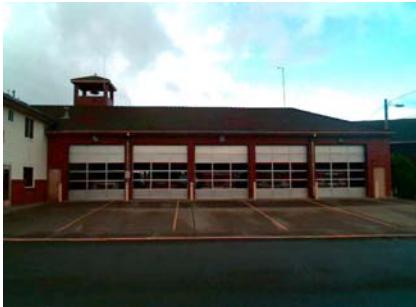
NE Plan Irregularity Secondary

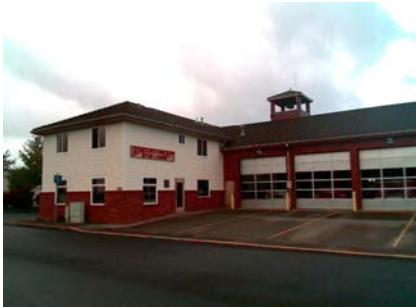
N Plan Irregularity Secondary

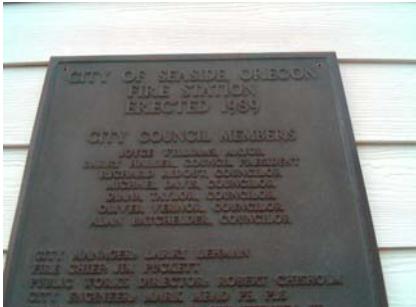
NW Field Verified Year Built
1989

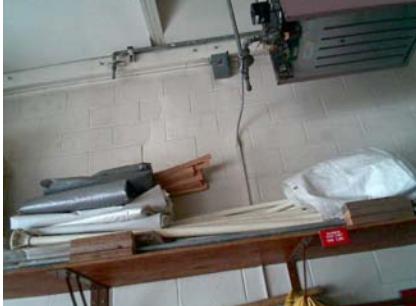
S Poor Condition

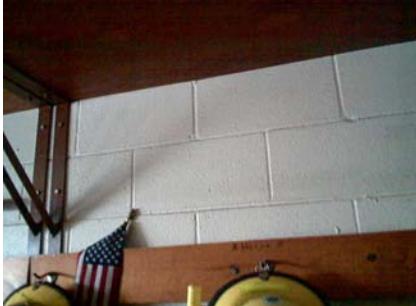
S Primary Structural Type
