# Knappa Svensen RFPD

Knappa Fire District

## FEMA 154 Rapid Visual Screening Score Card

Rapid Visual Screening - Senate Bill #2 - Seismic Needs Assessment  
Oregon Department of Geology and Mineral Industries

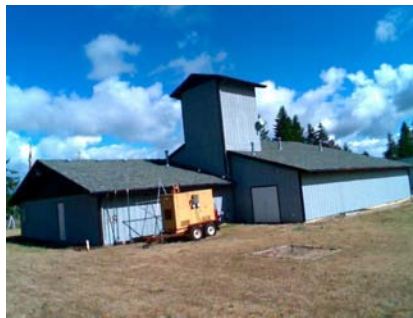
S Plan Irregularity Primary

| Reentrant Corners: L Shaped | Steps in Elevation View: Single Change |
| Torsion: Eccentric Stiffness | None |
