# Providence Seaside Hospital

Clat\_hos02A

Rapid Visual Screening - Senate Bill #2 - Seismic Needs Assessment  
Oregon Department of Geology and Mineral Industries

Clat\_hos02B

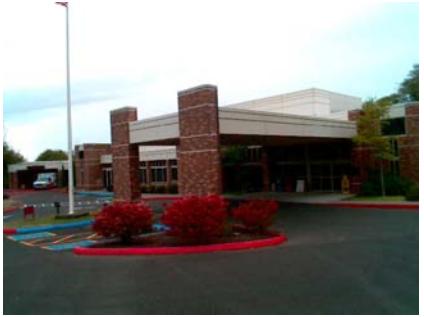
NE Elevation View		SW Primary Structural Type

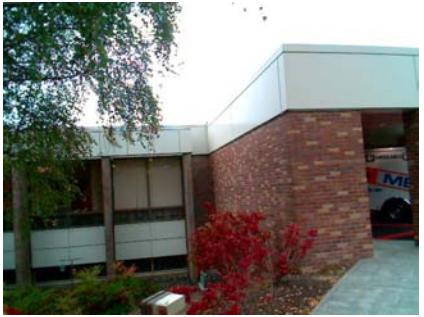
SE Plan Irregularity Secondary

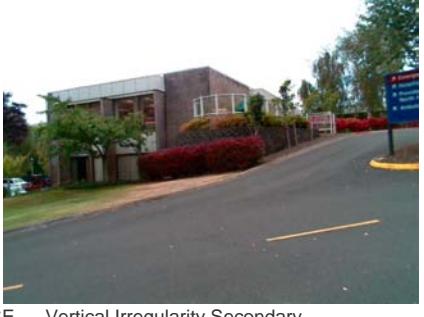
SE Vertical Irregularity Secondary

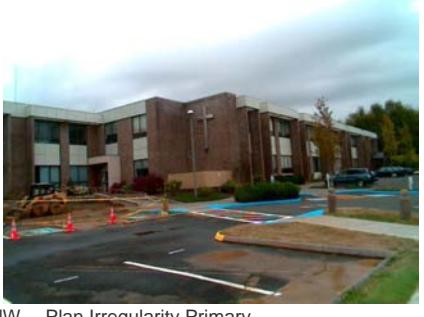
NW Plan Irregularity Primary

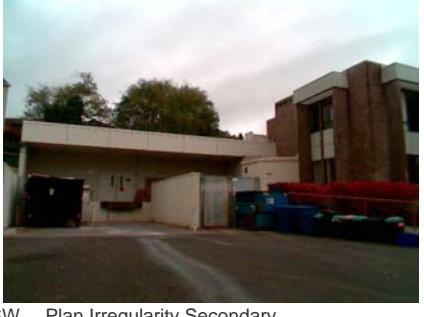
SW Plan Irregularity Secondary

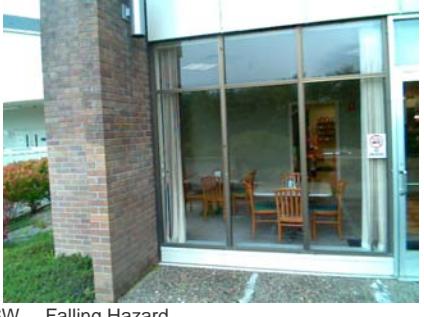
SW Falling Hazard

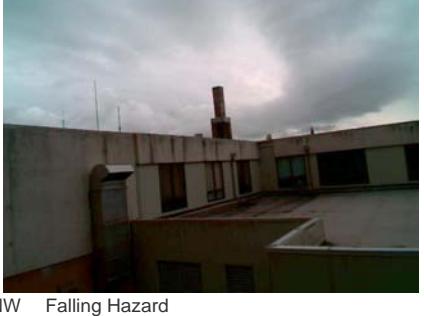
NW Falling Hazard
