# Broadway Middle School

Seaside SD 10

Clat\_sch03A

Rapid Visual Screening - Senate Bill #2 - Seismic Needs Assessment  
Oregon Department of Geology and Mineral Industries

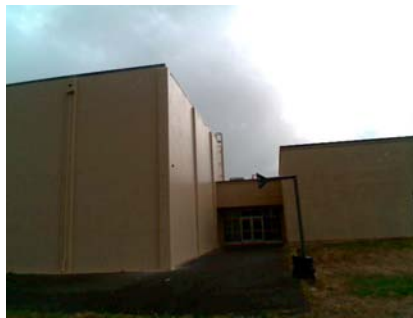
| Reentrant Corners: Other (Adjacent Build/Entity) | Steps in Elevation View: 2 to 3 Changes (Adjacent Building/Entity) |

N Vertical Irregularity Primary

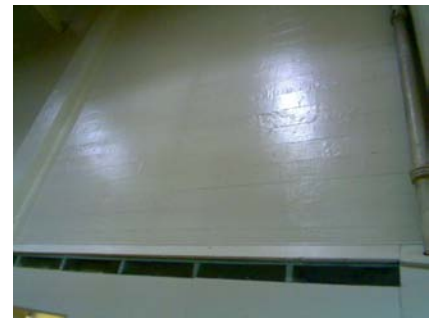
S Secondary Structural Type  
concrete form marks on inside walls.
