Gearhart Elementary School

Seaside SD 10

Clat_sch06A

FEMA 154 Rapid Visual Screening Score Card

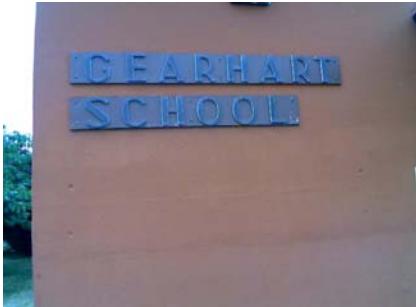
NE Building Name		SW Falling Hazard

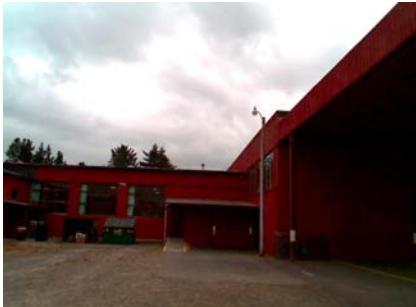
NE Plan Irregularity Secondary

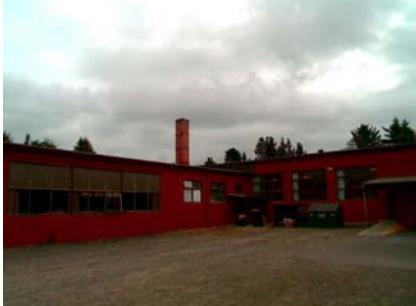
W Plan Irregularity Primary		W Falling Hazard

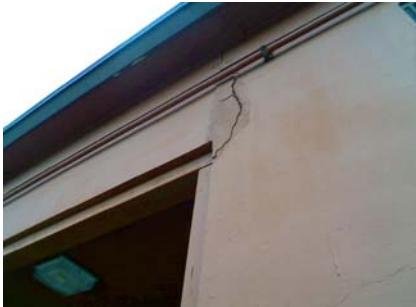
W Poor Condition		NE Poor Condition

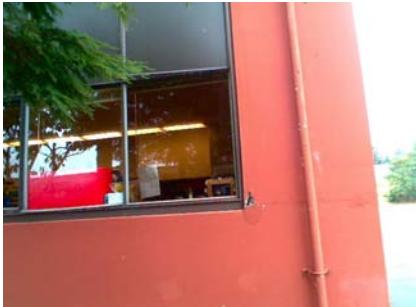
NE Poor Condition

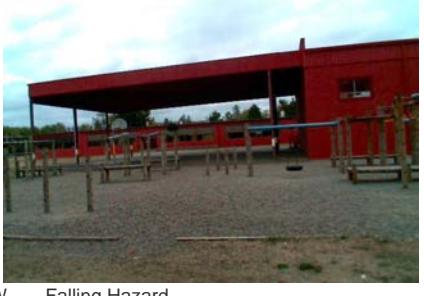
W Falling Hazard

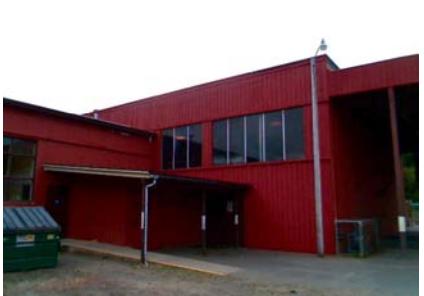
NE Plan Irregularity Primary

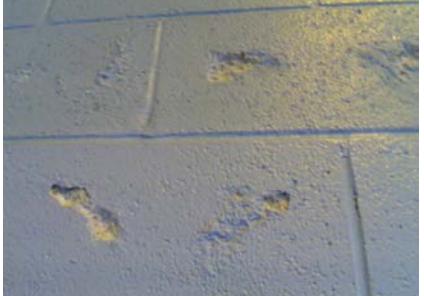
NW Poor Condition

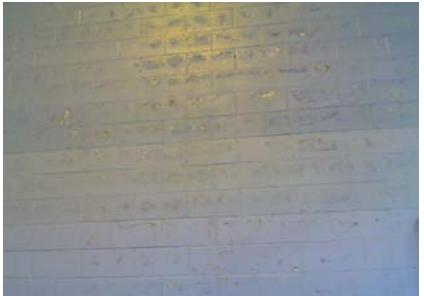
NW Poor Condition

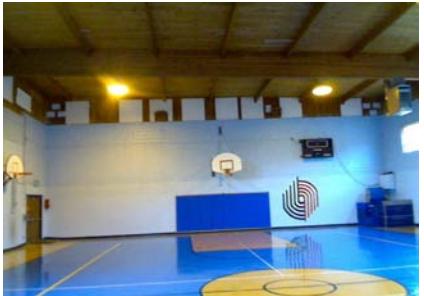
NW Poor Condition
