# Seaside High School

Clat\_sch07A

## FEMA 154 Rapid Visual Screening Score Card

Rapid Visual Screening - Senate Bill #2 - Seismic Needs Assessment  
Oregon Department of Geology and Mineral Industries

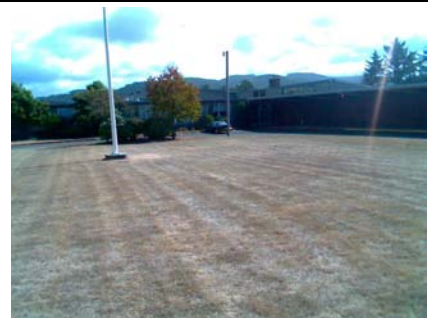
| Reentrant Corners: Other | Steps in Elevation View: Very Irregular Changes |

NW Plan Irregularity Primary

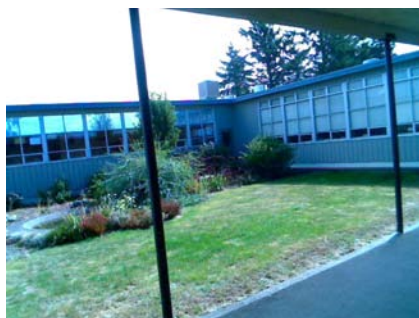
W Plan Irregularity Primary

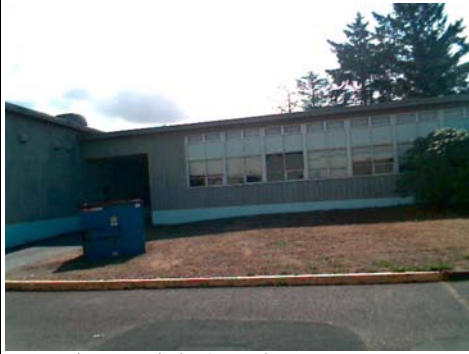
| Reentrant Corners: Other (Adjacent Build/Entity) | Steps in Elevation View: Very Irregular Changes (Adjacent Building/Ent |

NW Plan Irregularity Secondary

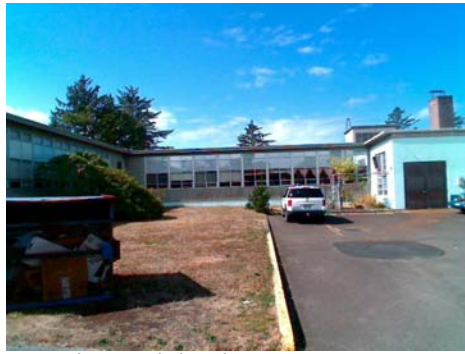
E Plan Irregularity Primary

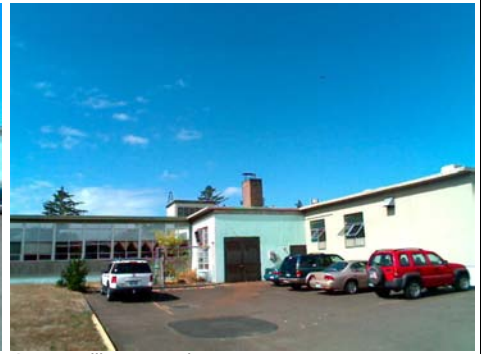
| Other: Light Cladding | None |

SE Falling Hazard

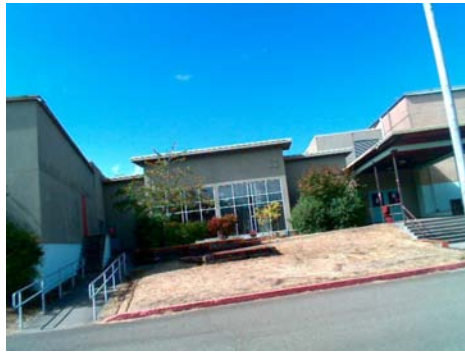
E Plan Irregularity Secondary

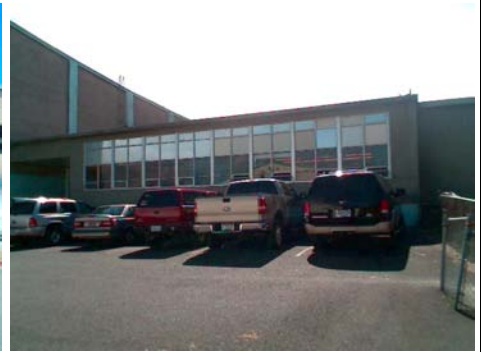
NW Vertical Irregularity Secondary

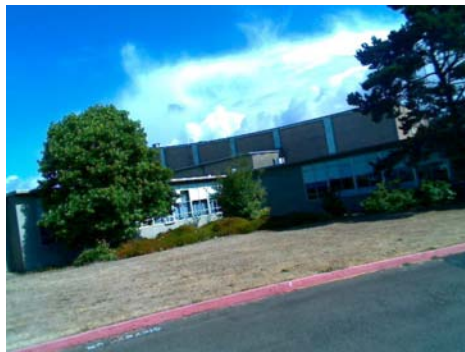
SW Vertical Irregularity Secondary

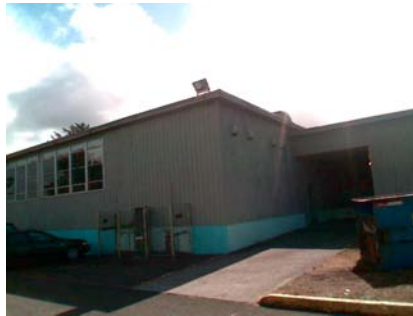
| Reentrant Corners:L shaped (Adjacent Build/Entity) | Steps in Elevation View: Single Change (Adjacent Building/Entity) |

NW Plan Irregularity Primary

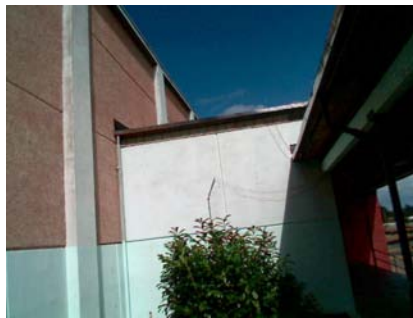
| Reentrant Corners: Other | Steps in Elevation View: 2 to 3 Changes |

SE Vertical Irregularity Primary

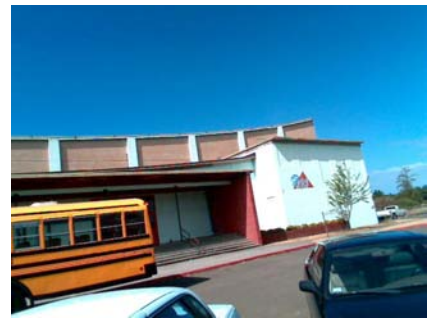
SE Plan Irregularity Primary

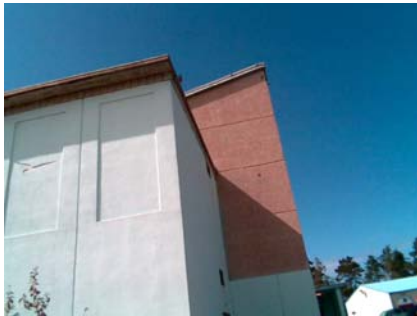
NE Vertical Irregularity Primary

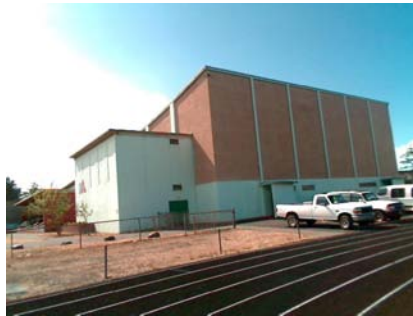
NE Vertical Irregularity Primary

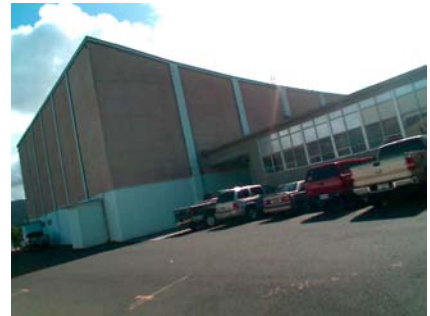
| Reentrant Corners: Other (Adjacent Build/Entity) | Steps in Elevation View: 2 to 3 Changes (Adjacent Building/Entity) |

NW Vertical Irregularity Secondary
