Warrenton High School

Warrenton-Hammond SD 30

FEMA 154 Rapid Visual Screening Score Card

Rapid Visual Screening - Senate Bill #2 - Seismic Needs Assessment
Oregon Department of Geology and Mineral Industries

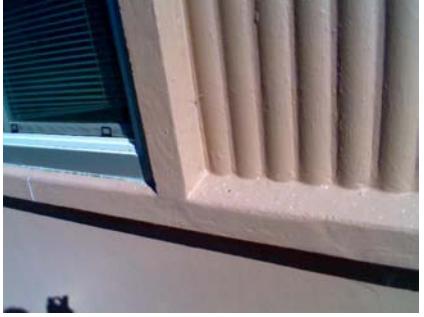
W Plan Irregularity Primary

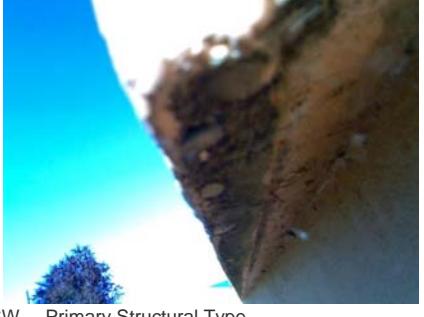
SW Primary Structural Type

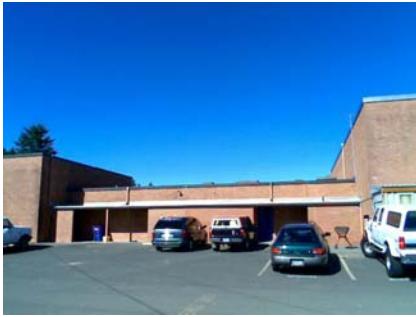
SW Elevation View		S Vertical Irregularity Primary

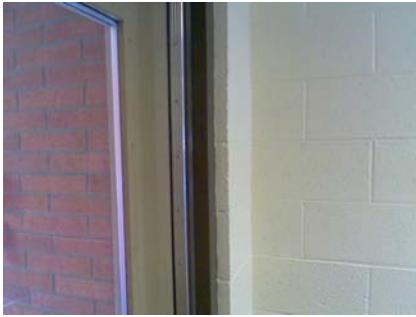
E Primary Structural Type

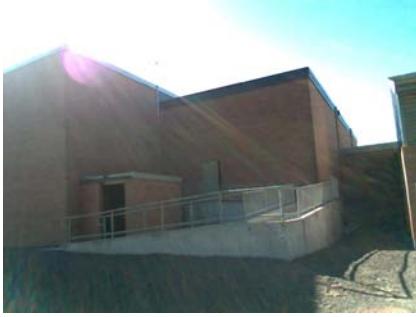
NE Plan Irregularity Primary

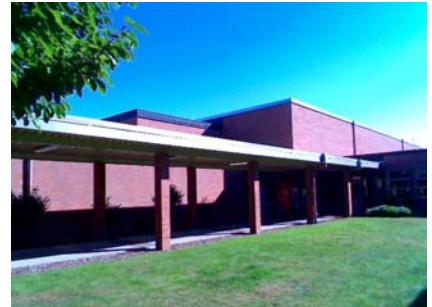
NW Vertical Irregularity Primary
