# Col R F&R Fire Station - Fairgrounds

Columbia River Fire & Rescue

Colu\_fir02A

## FEMA 154 Rapid Visual Screening Score Card

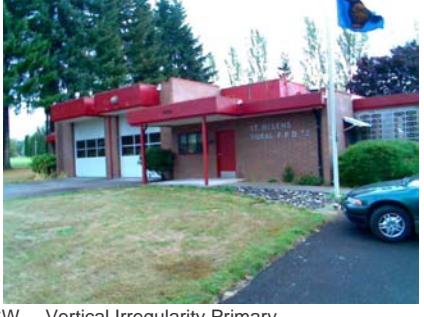
SW Vertical Irregularity Primary		SE Elevation View

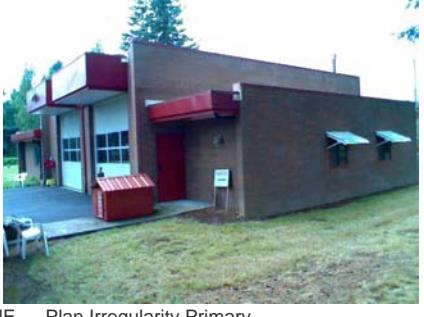
NE Plan Irregularity Primary

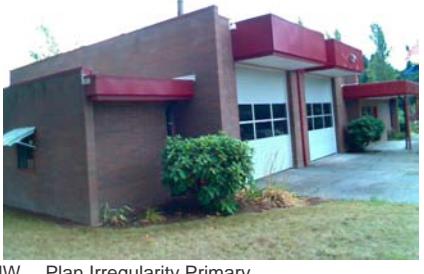
NW Plan Irregularity Primary		SW Primary Structural Type
