Scappoose RFPD

Colu_fir09A

Building Type Fire - RFPD	County Columbia	
Street 52751 Columbia River Hwy		
City Scappoose	State OR	Zip 97056
Latitude 45.76138	Longitude 122.87908	
Tracking Code RVS in 2006	Inspection Date 9/21/2006

FEMA 154 Rapid Visual Screening Score Card

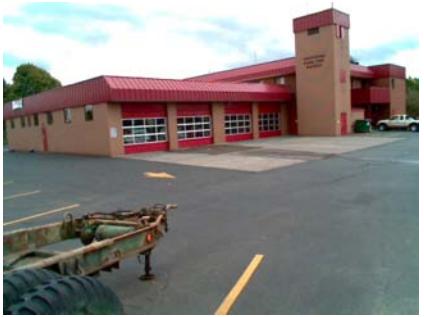
NE Plan Irregularity Primary

Enrollment	Year Built (Field Verified)	Year Built (Alt. Source)	Est. Decade Built		
	1988	1988	1980		
Total Area (square ft)	Number of Stories	Basement	Pounding Potential		
	2	No	No		
Plan Irregularities		Vertical Irregularities			
Reentrant Corners: Other		Steps in Elevation View: 2 to 3 Changes			
Lateral-Force-Resistance in One Direction Only		None			
None		None			
Falling Hazards		Poor Conditions			
None		None			
None		None			
None		None
