Scappoose Police Dept

FEMA 154 Rapid Visual Screening Score Card

Rapid Visual Screening - Senate Bill #2 - Seismic Needs Assessment
Oregon Department of Geology and Mineral Industries

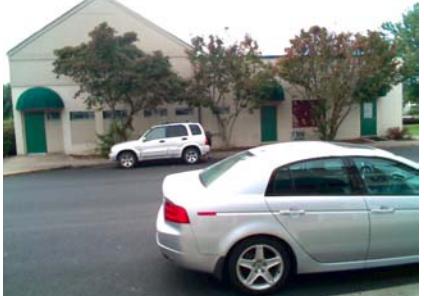
E	Elevation View	NW	Elevation View
