# Petersen Elementary School

Colu\_sch14A

## FEMA 154 Rapid Visual Screening Score Card

Rapid Visual Screening - Senate Bill #2 - Seismic Needs Assessment  
Oregon Department of Geology and Mineral Industries

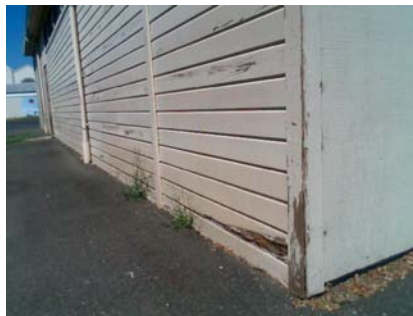
| Other: Ornamental Hazard Over Exit | Visable Dry Rot |

W Poor Condition

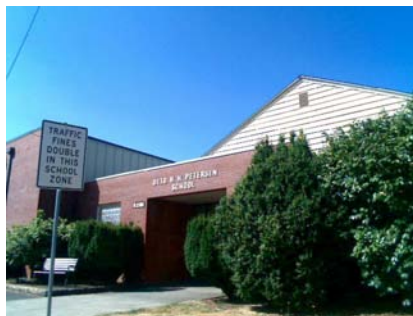
| Reentrant Corners: Other | Steps in Elevation View: 2 to 3 Changes |

S Vertical Irregularity Primary

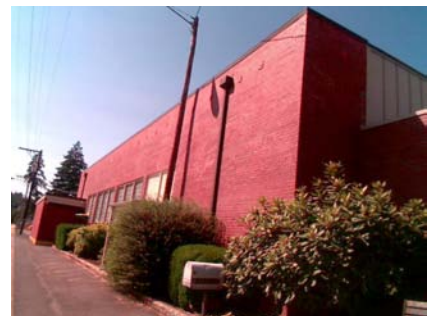
S Seismic Upgrade  
BOLT HEADS AT ROOF LINE

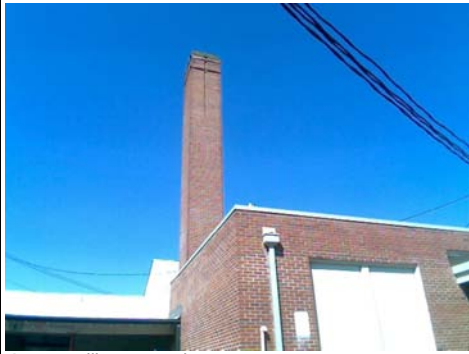
S Falling Hazard

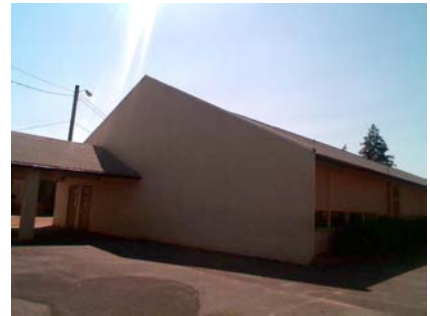
| 58760 | 1 | No | Yes |

NE Pounding Potential

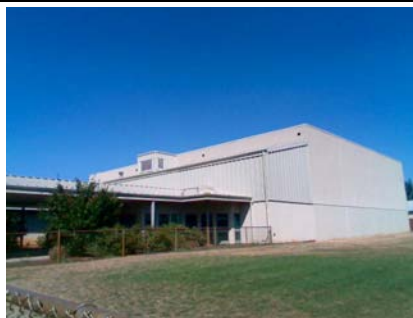
| Reentrant Corners: Other | Steps in Elevation View: 2 to 3 Changes |

SW Vertical Irregularity Primary

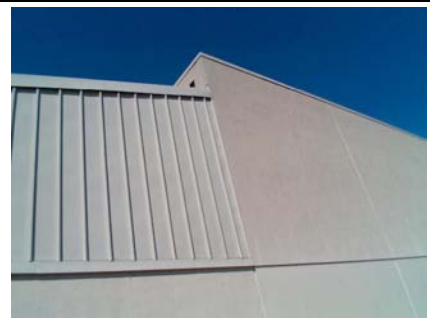
S Primary Structural Type  
CORNER JT IN PANEL

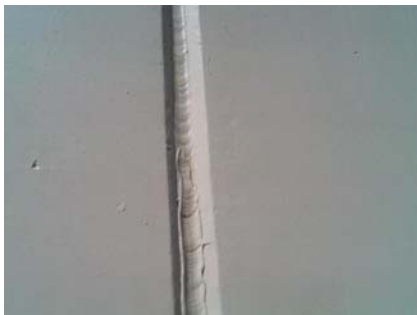
S Primary Structural Type  
caulked jts
