Scappoose Middle School

Colu_sch15A

Rapid Visual Screening - Senate Bill #2 - Seismic Needs Assessment
Oregon Department of Geology and Mineral Industries

Colu_sch15B

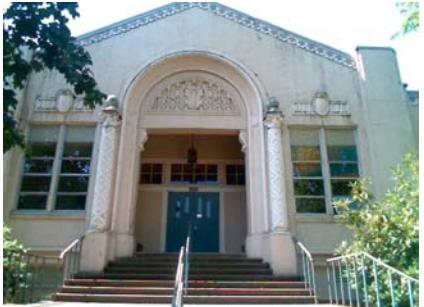
E Falling Hazard and cracks	E Poor Condition pour line at top of windows	SE Pounding Potential

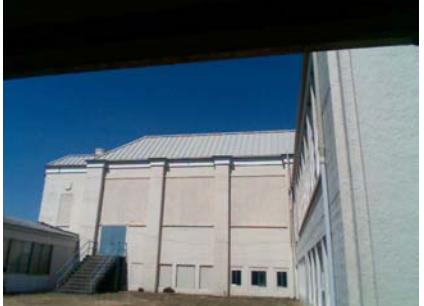
S Elevation View	W Primary Structural Type form marks	NW Vertical Irregularity Tertiary

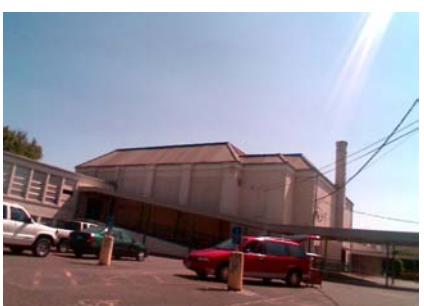
NW Falling Hazard	E Field Verified Year Built 1931

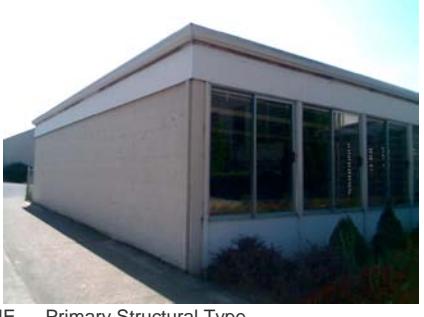
NE Primary Structural Type cmu endwall

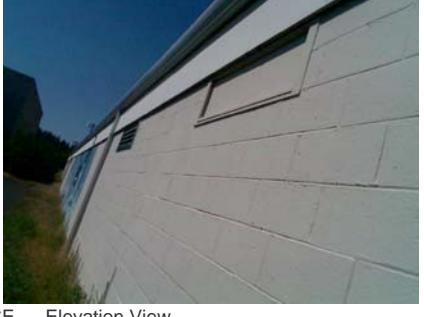
SE Elevation View s wall cmu

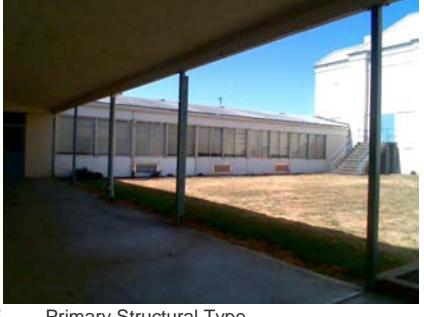
E Primary Structural Type both w and cmu

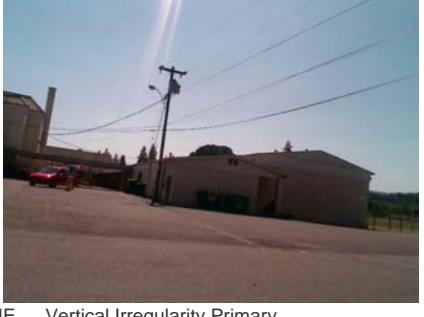
NE Vertical Irregularity Primary

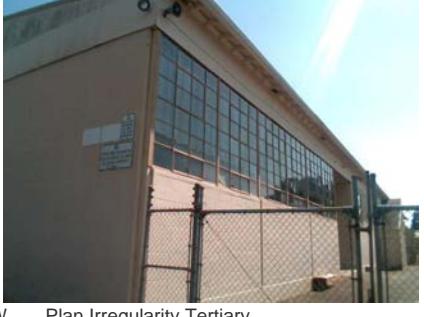
W Plan Irregularity Tertiary SKINNY STL COLS IN WINDOW BANK ALL ALONG W SIDE

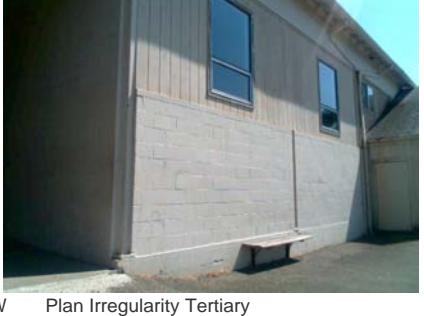
W Plan Irregularity Tertiary

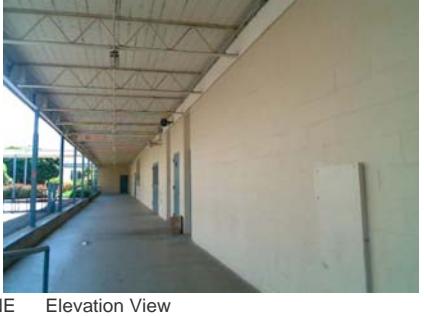
NE Elevation View E SIDE CMU

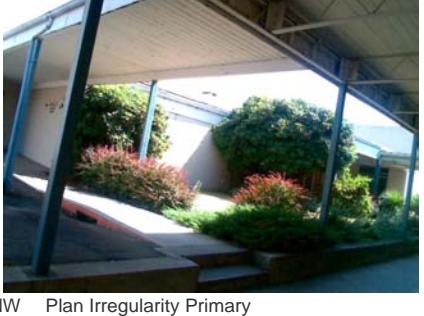
NW Plan Irregularity Primary

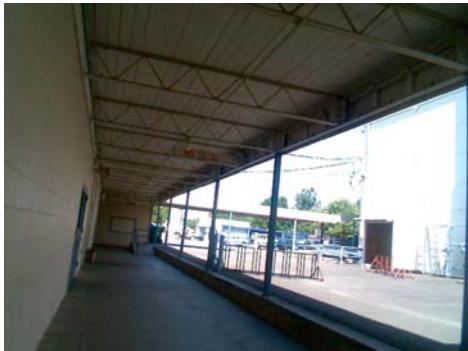
SE Pounding Potential
