Eden Hall

Southwest Oregon CC

FEMA 154 Rapid Visual Screening Score Card

Rapid Visual Screening - Senate Bill #2 - Seismic Needs Assessment
Oregon Department of Geology and Mineral Industries

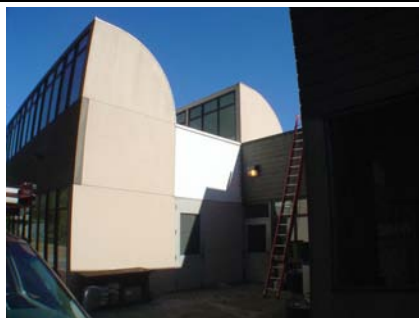
N Vertical Irregularity Primary

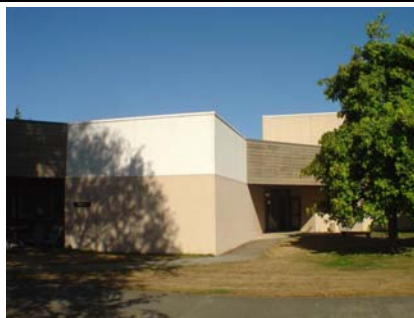
W Vertical Irregularity Primary
