Fairview Hall

Southwest Oregon CC

Coos_coc08A

Rapid Visual Screening - Senate Bill #2 - Seismic Needs Assessment
Oregon Department of Geology and Mineral Industries

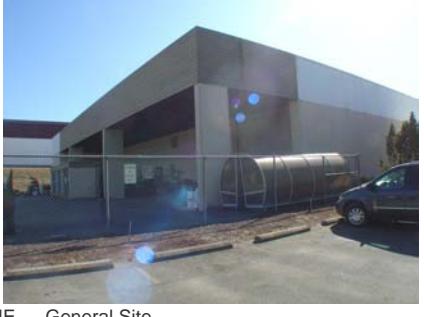
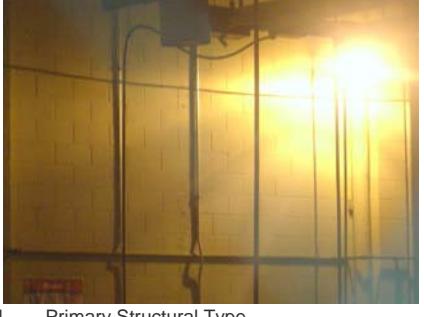
NE	General Site	N	Primary Structural Type

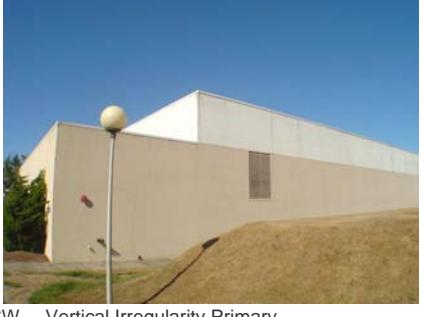
SW	Vertical Irregularity Primary
