Fairview RFPD

Coos_fir06A

Building Type		County	
Fire - RFPD		Coos	
Street			
96755 Fairview Summer Ln			
City	State	Zip	
Coquille	OR	97423	
Latitude	Longitude		
43.21611	124.07768		
Tracking Code	Inspection Date		
RVS in 2006	8/10/2006

FEMA 154 Rapid Visual Screening Score Card

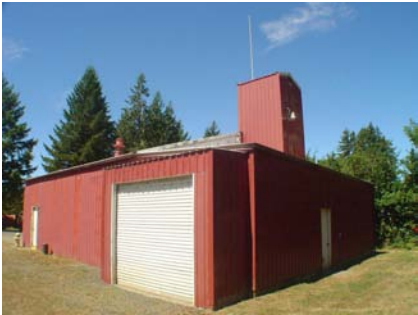
SE Vertical Irregularity Primary

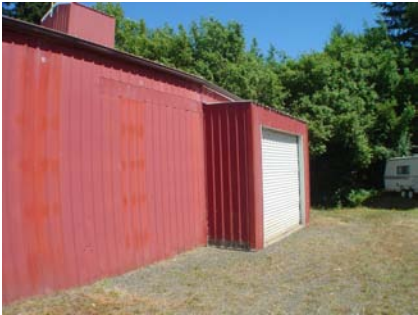
S Plan Irregularity Secondary
