# Bandon RFPD

Coos\_fir09A

Building Type Fire - RFPD	County Coos	
Street 555 Hwy 1010		
City Bandon	State OR	Zip 97411
Latitude 43.11717	Longitude 124.41381	
Tracking Code RVS in 2006	Inspection Date 8/10/2006

Rapid Visual Screening - Senate Bill #2 - Seismic Needs Assessment  
Oregon Department of Geology and Mineral Industries

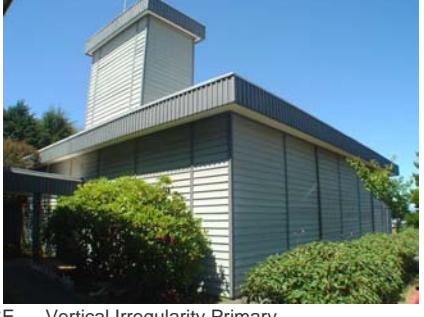
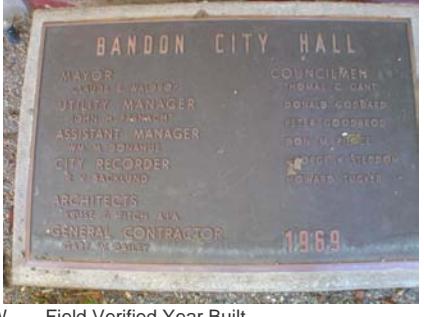
SE	Vertical Irregularity Primary	W	Field Verified Year Built
