Lakeside RFPD

Coos_fir15A

Rapid Visual Screening - Senate Bill #2 - Seismic Needs Assessment
Oregon Department of Geology and Mineral Industries

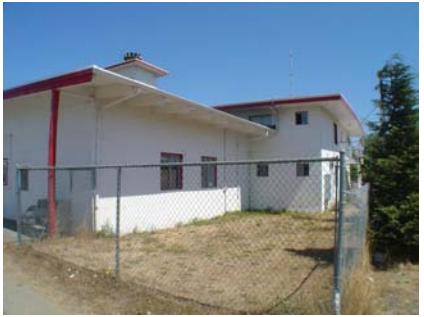
<p>SW Vertical Irregularity Secondary</p>	
E	Field Verified Year Built	SW	Plan Irregularity Secondary

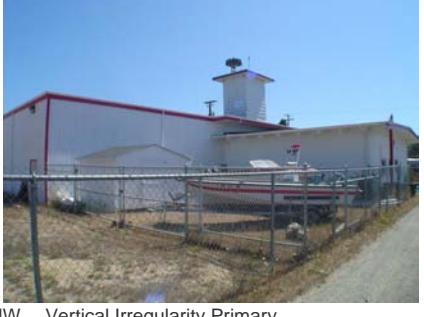
<p>NW Vertical Irregularity Primary</p>

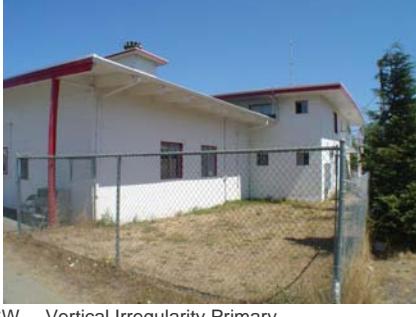
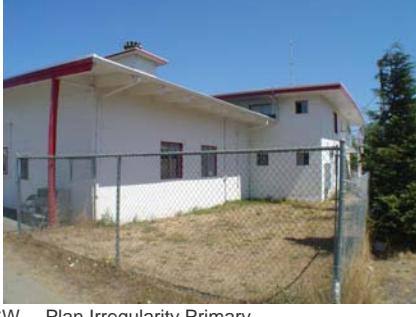
SW Vertical Irregularity Primary		SW Plan Irregularity Primary

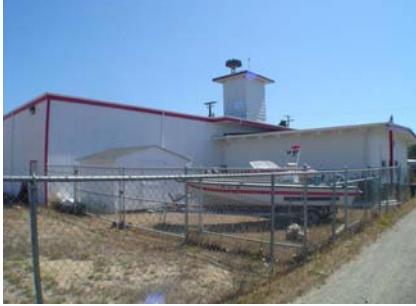
NW Plan Irregularity Secondary
